**DEPARTMENT OF TRANSPORTATION**

Contract #: 04-0120F4Cty: SF/ALA Rte: 80 PM: 13.2/13.9File #: 1.28**WELDING INSPECTION REPORT****Resident Engineer:** Casey, William**Address:** 333 Burma Road**City:** Oakland, CA 94607**Report No:** WIR-029921**Date Inspected:** 15-Aug-2013**Project Name:** SAS Superstructure**OSM Arrival Time:** 700**Prime Contractor:** American Bridge/Fluor Enterprises, a JV**OSM Departure Time:** 1730**Contractor:** American Bridge/Fluor Enterprises, a JV**Location:** Job Site**CWI Name:** Bernie Docena, Jesse Cayabyab**CWI Present:** Yes No**Inspected CWI report:** Yes No N/A**Rod Oven in Use:** Yes No N/A**Electrode to specification:** Yes No N/A**Weld Procedures Followed:** Yes No N/A**Qualified Welders:** Yes No N/A**Verified Joint Fit-up:** Yes No N/A**Approved Drawings:** Yes No N/A**Approved WPS:** Yes No N/A**Delayed / Cancelled:** Yes No N/A**Bridge No:** 34-0006**Component:** SAS Tower**Summary of Items Observed:**

**NDT Inspection of Electroslag Welds (ESW)**

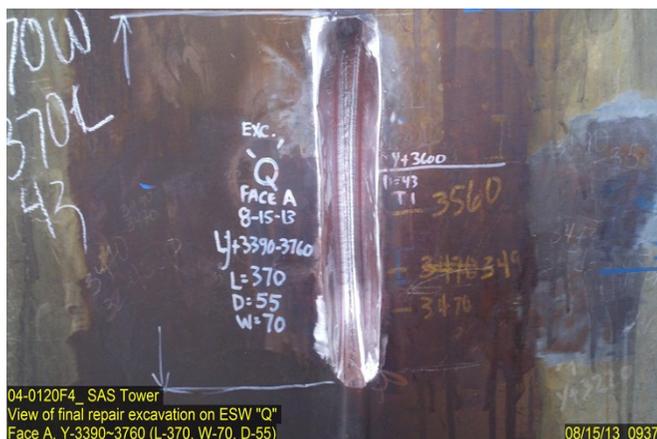
ESW E-043,"Q"-Face A:

The QA Inspector observed ABF/JV welder Donald Plumb (WID-0891) performing excavation of Electroslag Weld (ESW) "Q" face A, to verify indications observed during Ultrasonic Testing with pulse/echo & pitch/catch. Mr. Plumb was performing air carbon arc gouging and grinding on the excavation. After grinding to bright metal the ABF QC Inspector Bernie Docena performed MT testing of the excavation. Details of the final repair excavation are as follows:

WeId excavated at 55mm-No indications observed.

Excavation Length (Y=3390mm~3760mm) L-370mm, W= 70mm, D= 55mm.

The QC Inspector stated the excavation appears to be free of discontinuities and he would complete ABF daily inspection report and magnetic particle testing report to detail the findings. The QA Inspector also performed MT inspection of the final excavation See TL-6028 for additional details on items inspected on this date.
