**DEPARTMENT OF TRANSPORTATION**

Contract #: 04-0120F4Cty: SF/ALA Rte: 80 PM: 13.2/13.9File #: 1.28**WELDING INSPECTION REPORT****Resident Engineer:** Casey, William**Address:** 333 Burma Road**City:** Oakland, CA 94607**Report No:** WIR-029922**Date Inspected:** 16-Aug-2013**Project Name:** SAS Superstructure**OSM Arrival Time:** 700**Prime Contractor:** American Bridge/Fluor Enterprises, a JV**OSM Departure Time:** 1730**Contractor:** American Bridge/Fluor Enterprises, a JV**Location:** Job Site**CWI Name:** Bernie Docena, Jesse Cayabyab**CWI Present:** Yes No**Inspected CWI report:** Yes No N/A**Rod Oven in Use:** Yes No N/A**Electrode to specification:** Yes No N/A**Weld Procedures Followed:** Yes No N/A**Qualified Welders:** Yes No N/A**Verified Joint Fit-up:** Yes No N/A**Approved Drawings:** Yes No N/A**Approved WPS:** Yes No N/A**Delayed / Cancelled:** Yes No N/A**Bridge No:** 34-0006**Component:** SAS Tower**Summary of Items Observed:**

## WELDING INSPECTION REPORT

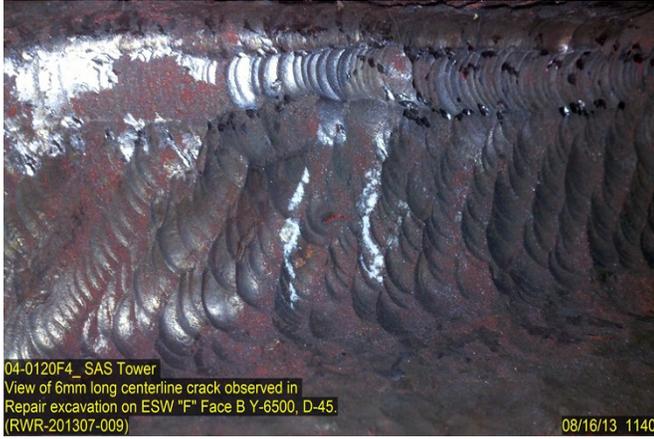
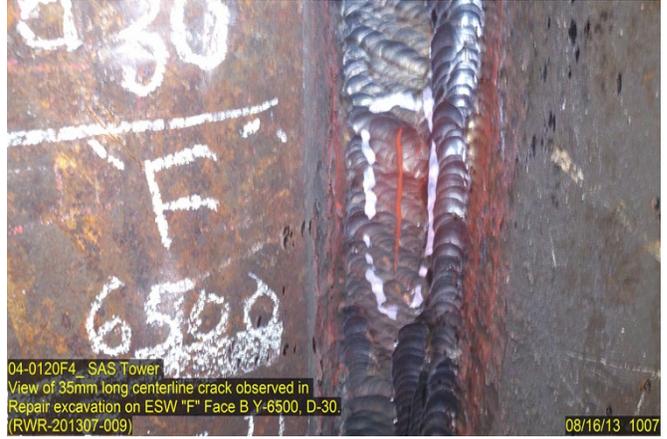
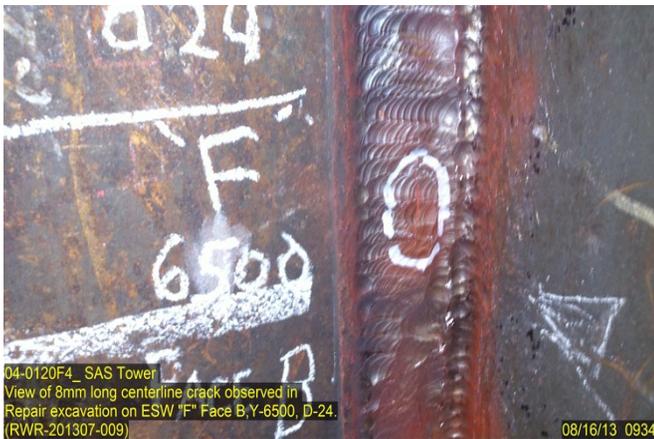
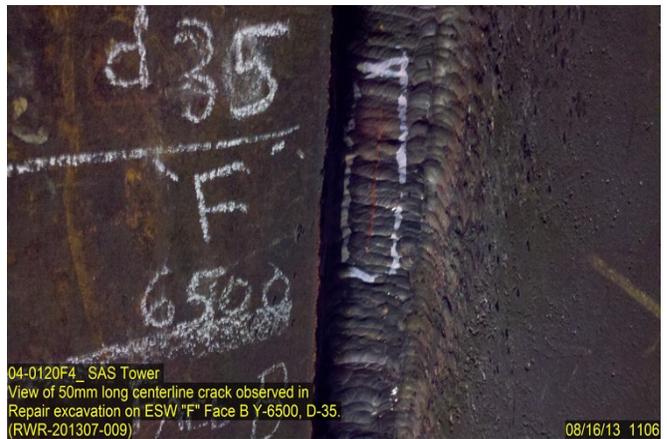
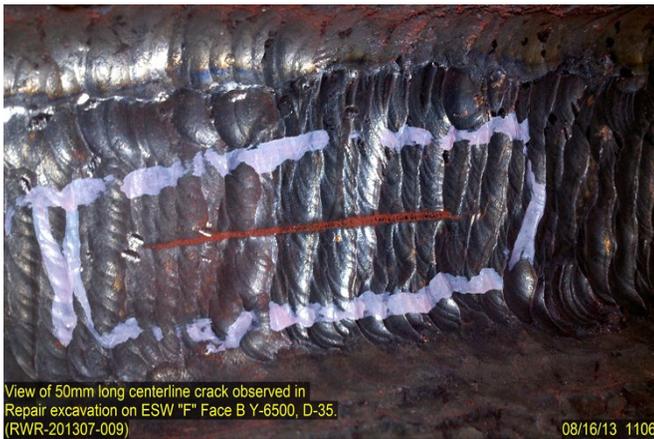
ESW E-045, Location "F"- B:

The QA Inspector was later present to observe ABF welder Kit Lai (WID-2953) performing excavation of ESW "F" Face B @ Y-6470mm to verify indications observed during Ultrasonic Testing pulse/echo & pitch/catch. Mr. Lai was performing the excavation using an air carbon arc gouging and a grinder and was instructed by ABF QC Inspector Bernie Docena notify him when indications are visible to allow QC/QA to inspect the excavation.

Weld excavated at 24mm- 8mm long planar indication (centerline crack) observed @6500.

Weld excavated at 30mm- 35mm long planar indication (centerline crack) observed @6500.

Weld excavated at 35mm- 50mm long planar indication (centerline crack) observed @6500.

Weld excavated at 40mm- 20mm long planar indication (centerline crack) observed @6500.

Weld excavated at 45mm- 6mm long planar indication (centerline crack) observed @6500.

Excavation Y=6350mm~6690mm, Current depth-45mm.

The QA Inspector and the QC Inspector performed MT testing on the excavation and observed that the planar indication remained at the above mentioned depths. Mr. Docena stated that the excavation work will continue on 8/17/13. The information regarding the centerline crack was passed along to ABF and CT METS representatives for additional review. The QA Inspector also informed Tower SMR Aaron Prchlik of the issue observed. See TL-6028 for additional details on items inspected on this date.
