DEPARTMENT OF TRANSPORTATION

Contract #: 04-0120F4Cty: SF/ALA Rte: 80 PM: 13.2/13.9File #: 01.28**WELDING INSPECTION REPORT****Resident Engineer:** Casey, William**Address:** 333 Burma Road**City:** Oakland, CA 94607**Report No:** WIR-029928**Date Inspected:** 20-Aug-2013**Project Name:** SAS Superstructure**OSM Arrival Time:** 700**Prime Contractor:** American Bridge/Fluor Enterprises, a JV**OSM Departure Time:** 1730**Contractor:** American Bridge/Fluor Enterprises, a JV**Location:** Job Site

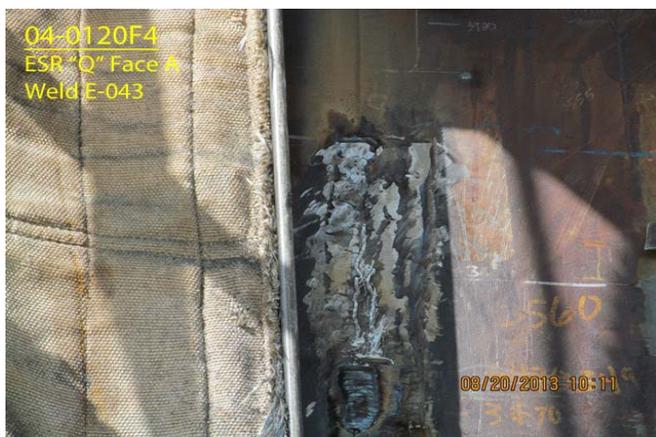
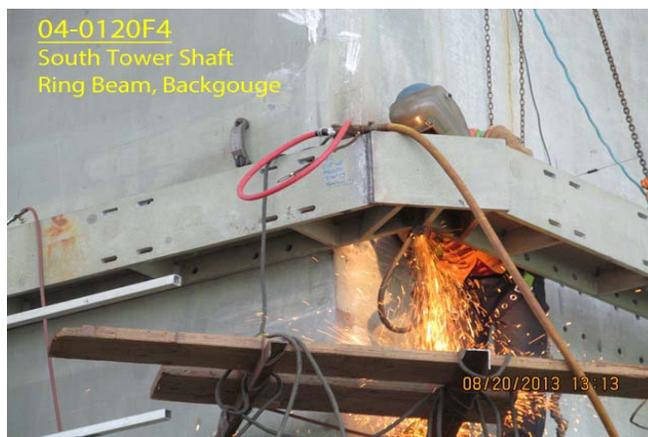
The welding & workmanship observed on this date appeared to be in general compliance with the contract specifications. The following pictures below detail some of the observations made on this date.
