**DEPARTMENT OF TRANSPORTATION**

Contract #: 04-0120F4Cty: SF/ALA Rte: 80 PM: 13.2/13.9File #: 01.28**WELDING INSPECTION REPORT****Resident Engineer:** Casey, William**Address:** 333 Burma Road**City:** Oakland, CA 94607**Report No:** WIR-029929**Date Inspected:** 21-Aug-2013**Project Name:** SAS Superstructure**OSM Arrival Time:** 700**Prime Contractor:** American Bridge/Fluor Enterprises, a JV**OSM Departure Time:** 1730**Contractor:** American Bridge/Fluor Enterprises, a JV**Location:** Job Site

**Tower Skirt Ring Beam South Shaft**

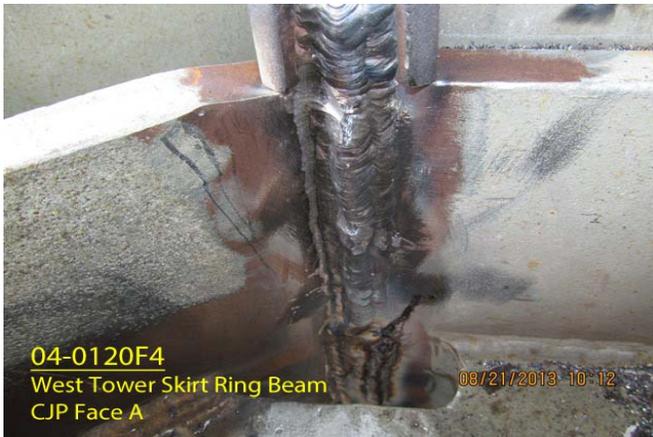
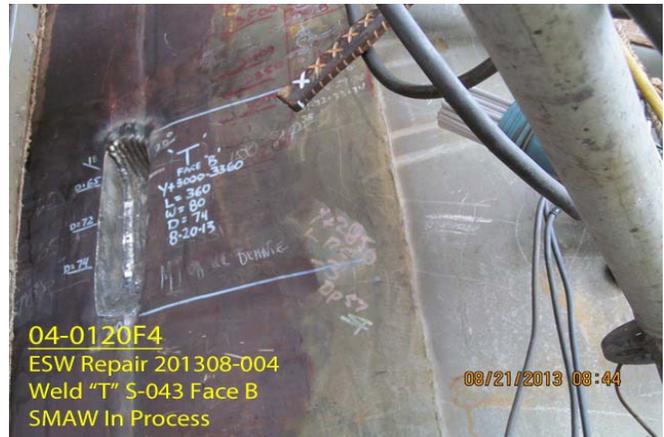
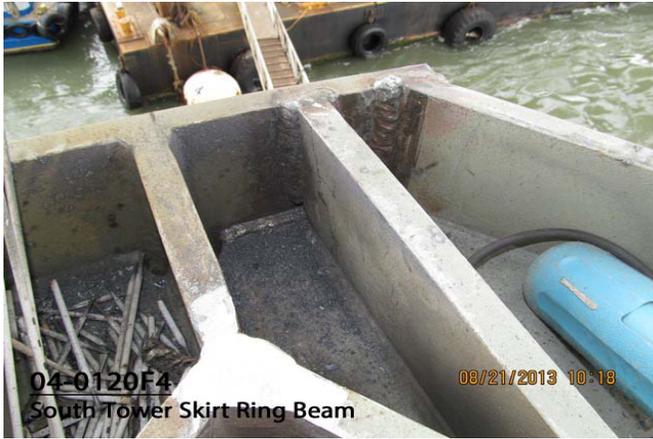
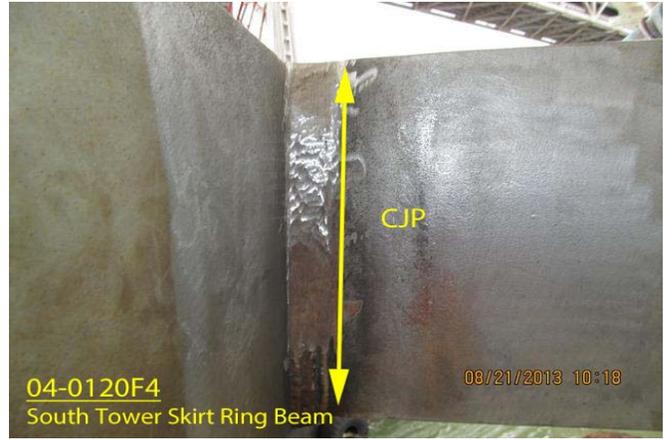
The QAI periodically observed ABF welding personnel Gue Wu Chen utilizing the Shielded Metal Arc Welding (SMAW) process in the vertical (3G) position with Atom Arc E7018-1 HR4, 1/8" diameter electrode to complete welding for side A of the Complete Joint Penetration (CJP) joint. As welding continued the QAI verified welding parameters at approximately 138 amperes per Welding Procedure Specification (WPS) ABF-WPS-D1.5-1020, Rev1. The welder was also observed using proper interpass cleaning methods with a slag hammer and a wire brush. QC Inspector Bernie Docena was monitoring the work at this location on this date. Once the welding was complete the welder was in the process of grinding the weld on side A flush and preparing the weld joint for Ultrasonic Testing (UT) examination.

The QAI periodically observed ABF welding personnel Mike Jimenez utilizing the Shielded Metal Arc Welding (SMAW) process in the vertical (3G) position with Atom Arc E7018-1 H4R, 5/32" diameter electrode to begin welding excavation for weld repair. The welding is taking place on the exterior (west) side at joint T, weld #S-043 #13 on Face B side for a repair designated as 201308-004. Excavation dimensions are noted as Y=3000mm-3360mm, Length=360mm, Width=80mm, Depth=74mm. The QAI observed the interpass

temperature was maintained at approximately 360 degrees Fahrenheit with electric heating coil blankets through a heat induction system and a rose bud torch. The QAI verified interpass temperature with a thermal heat gun. As welding continued the QAI periodically verified welding parameters at approximately 140 amperes per ABF-WPS-D1.5-ESW-80-100TR. The welder was also observed using proper interpass cleaning methods with a slag hammer and a wire brush. QC Inspector Jesus Cayabyab was monitoring the progress of this repair on this date.

The QAI periodically observed ABF welding personnel Rick Chounard at the above location utilizing the Shielded Metal Arc Welding (SMAW) process in the vertical (3G) position with Atom Arc E7018-1 HR4, 1/8" diameter electrode to complete in process welding for side A of Complete Joint Penetration (CJP) joint splice weld. As welding continued the QAI verified welding parameters at approximately 145 amperes per Welding Procedure Specification (WPS) ABF-WPS-D1.5-1020, Rev1. The welder was also observed using proper interpass cleaning methods with a slag hammer and a wire brush. Once welding was complete ABF moved tower ring beam away from tower face to provide access to side B for back gouge. The QAI later observed QC Inspector Bernie Docena perform Magnetic Particle Testing (MT) examination on the weld groove after back gouging and prior to welding. No relevant indications were noted and SMAW welding proceeded on side B. The QAI and QC Inspector also performed visual weld inspection on fillet & Partial Joint Penetration (PJP) welds. The QC Inspector marked up several visual discrepancies for repair by welding and grinding. These areas were addressed by ABF personnel, later re-evaluated and accepted by QC Inspector Bernie Docena.
