DEPARTMENT OF TRANSPORTATION

Contract #: 04-0120F4Cty: SF/ALA Rte: 80 PM: 13.2/13.9File #: 01.28**WELDING INSPECTION REPORT****Resident Engineer:** Casey, William**Address:** 333 Burma Road**City:** Oakland, CA 94607**Report No:** WIR-029930**Date Inspected:** 22-Aug-2013**Project Name:** SAS Superstructure**OSM Arrival Time:** 700**Prime Contractor:** American Bridge/Fluor Enterprises, a JV**OSM Departure Time:** 1730**Contractor:** American Bridge/Fluor Enterprises, a JV**Location:** Job Site

Tower Skirt Ring Beam South Shaft

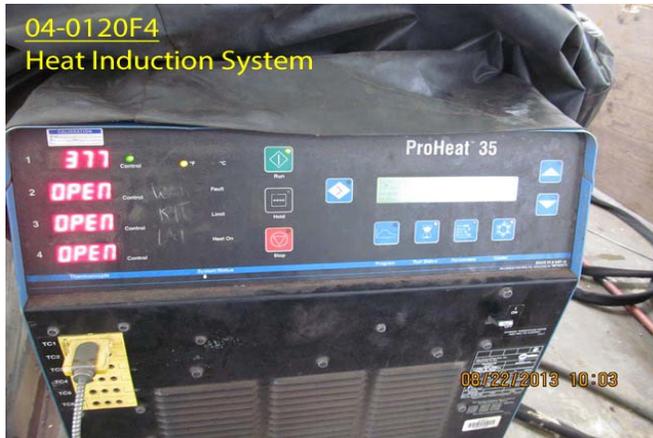
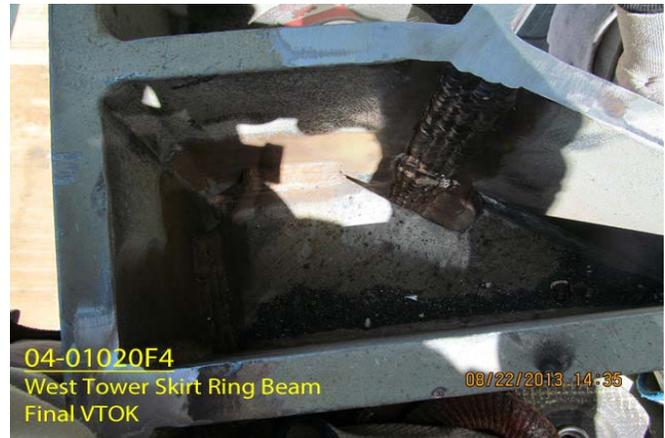
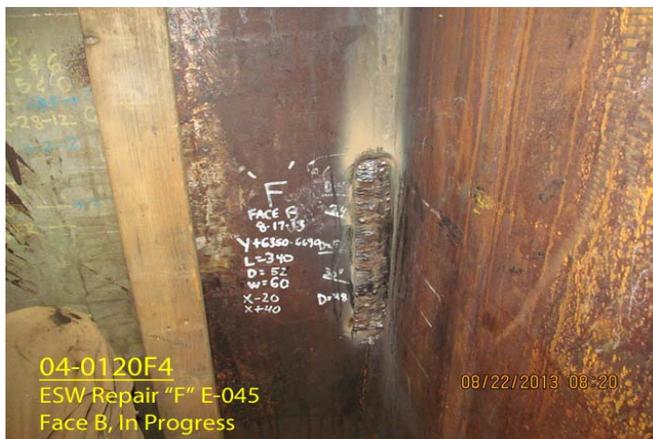
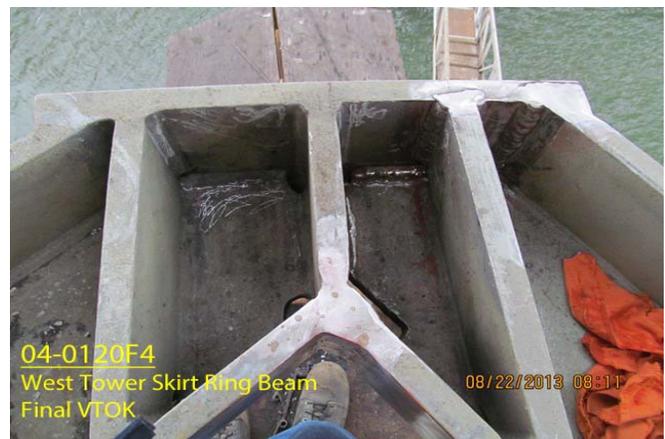
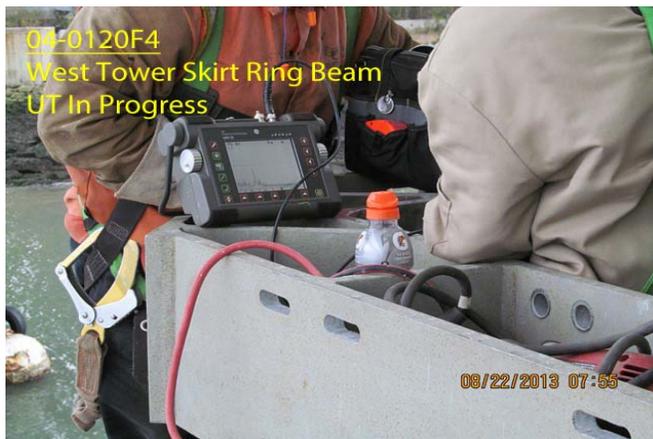
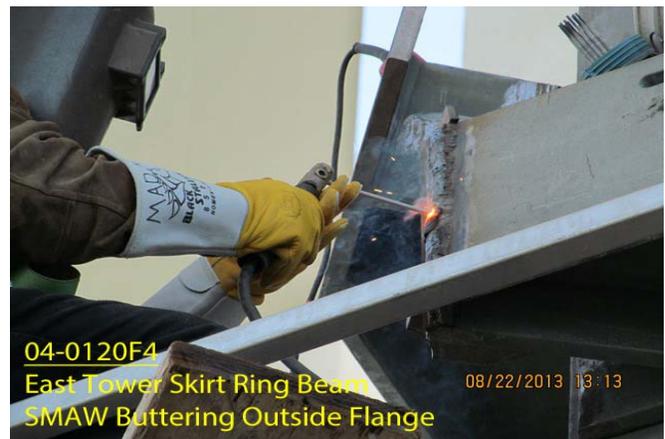
The welding & workmanship observed on this date appeared to be in general compliance with the contract specifications. The following pictures below detail some of the observations made on this date.
