**DEPARTMENT OF TRANSPORTATION**

Quality Assurance and Source Inspection

Contract #: 04-0120F4Cty: SF/ALA Rte: 80 PM: 13.2/13.9File #: 1.28**WELDING INSPECTION REPORT****Resident Engineer:** Casey, William**Address:** 333 Burma Road**City:** Oakland, CA 94607**Report No:** WIR-029934**Date Inspected:** 21-Aug-2013**Project Name:** SAS Superstructure**OSM Arrival Time:** 700**Prime Contractor:** American Bridge/Fluor Enterprises, a JV**OSM Departure Time:** 1730**Contractor:** American Bridge/Fluor Enterprises, a JV**Location:** Job Site

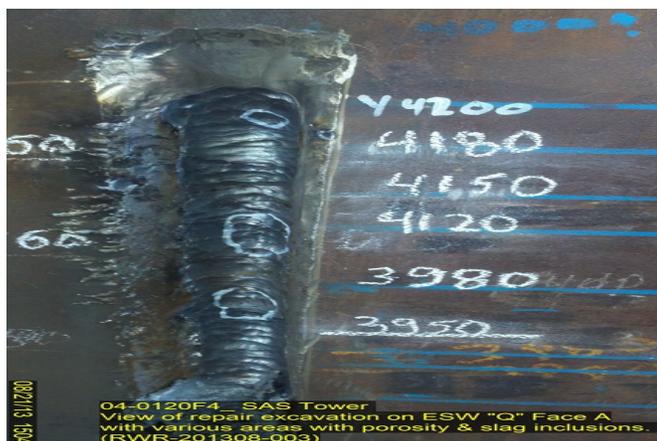
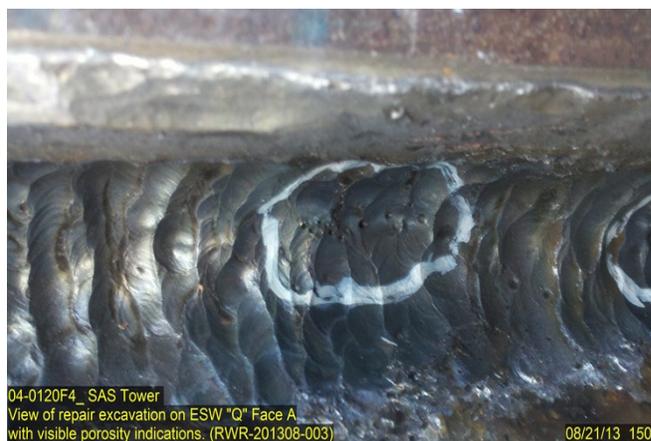
ESW E-043, Location "Q"-Face A:

The QA Inspector observed ABF welder Donald Plumb (WID-0891) performing excavation of ESW "Q" Face A @ Y=3980mm to verify indications observed during Ultrasonic Testing pulse/echo & pitch/catch. Mr. Plumb was performing the excavation using an air carbon arc gouging and a grinder. Mr. Plumb was instructed by ABF QC Inspector Bernie Docena to notify him when indications are visible to allow QC/QA time to inspect the excavation.

Weld excavated at 32mm dp- slag observed @ 4170.

Weld excavated at 40mm dp- slag observed @ 4200.

Weld excavated at 50mm dp- slag/porosity observed @3950, 3980,4120,4150,4180.

Weld excavated at 60mm dp- slag/porosity observed @3980, 4120, 4180.

Excavation Y=3800mm~4300mm, Current depth-60/65mm. The QA Inspector observed the QC Inspector perform an informational MT inspection of the unground excavation and observed that the indications remained at the above mentioned depths. Mr. Docena stated that the porosity and slag observed was possibly from a previous weld repair using FCAW. Mr. Docena also mentioned that the excavation work on this repair will continue on 8/22/13. The information regarding the indication observed was passed along to ABF and CT METS representatives for additional review.
