**DEPARTMENT OF TRANSPORTATION**

Contract #: 04-0120F4Cty: SF/ALA Rte: 80 PM: 13.2/13.9File #: 1.28**WELDING INSPECTION REPORT****Resident Engineer:** Casey, William**Address:** 333 Burma Road**City:** Oakland, CA 94607**Report No:** WIR-029937**Date Inspected:** 24-Aug-2013**Project Name:** SAS Superstructure**OSM Arrival Time:** 700**Prime Contractor:** American Bridge/Fluor Enterprises, a JV**OSM Departure Time:** 1530**Contractor:** American Bridge/Fluor Enterprises, a JV**Location:** Job Site

# WELDING INSPECTION REPORT

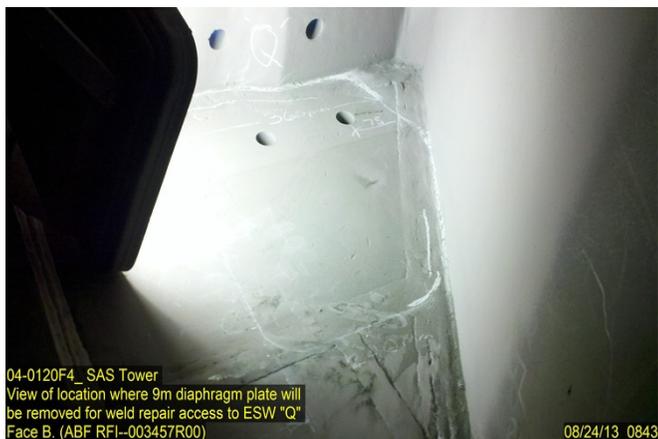
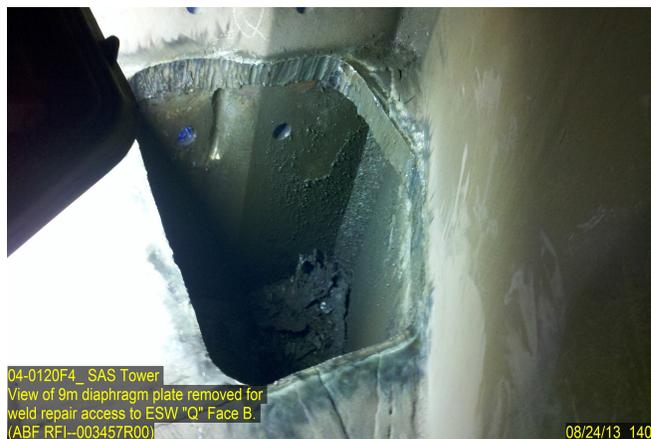
## Diaphragm plate Removal

@ ESW E-043, Location "Q"-Face B:

ABF-RFI-003457R00

The QA Inspector was present to observe ABF welder Wai Kit Lai (WID-2953) performing work to remove a predetermined section of 9m Diaphragm plate as per ABF Request for Information (RFI) -003457R00. The RFI describes that due to access constraints, ABF could not complete a weld repair on Weld "Q" (E-043), Face B. ABF QC had previously discovered an MT indication present in the current excavation (below the 9m diaphragm) and UT had also detected the indication to be present above the 9m diaphragm. ABF proposed to remove the section of the 9m diaphragm to obtain access for excavation and completion of this repair. After the ESW repair is completed and determined to be UT acceptable, a new 9m diaphragm plate will be replaced and PJP welded to the existing 9m diaphragm and tower skin. The Departments response was that they take no exception to the Contractor's proposal for removal and repair of the 9m Diaphragm to provide access for the repair of the referenced Weld Q (E-043). The fill plate shall be the same grade and thickness (45 mm) as the diaphragm plate, with an effective 36 mm PJP perimeter weld.

Mr. Lai was observed preheating the Diaphragm with a rosebud torch to approximately 200° Fahrenheit. The Welder was later observed cutting the diaphragm plate with a propylene torch at the layout location marked and punched on the plate. Mr. Lai was assisted by ABF welder Donald Plumb (wid-0891) with securing and extracting the piece without additional damage to the adjacent material. ABF QC Inspector Jesse Cayabyab stated that on 8/26/13 Mr. Lai will grind the flame cut surface of the Diaphragm section with the existing hole so ABF QC can MT inspect the area for discontinuities. The weld repair of ESW "Q", Face B at the 9m location will be performed once ABF has been given approval to proceed.
