**DEPARTMENT OF TRANSPORTATION**

Contract #: 04-0120F4Cty: SF/ALA Rte: 80 PM: 13.2/13.9File #: 1.28**WELDING INSPECTION REPORT****Resident Engineer:** Casey, William**Address:** 333 Burma Road**City:** Oakland, CA 94607**Report No:** WIR-029949**Date Inspected:** 26-Aug-2013**Project Name:** SAS Superstructure**OSM Arrival Time:** 700**Prime Contractor:** American Bridge/Fluor Enterprises, a JV**OSM Departure Time:** 1730**Contractor:** American Bridge/Fluor Enterprises, a JV**Location:** Job Site

# WELDING INSPECTION REPORT

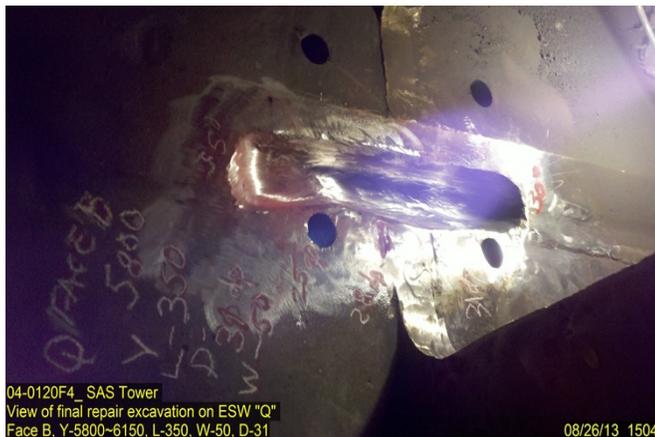
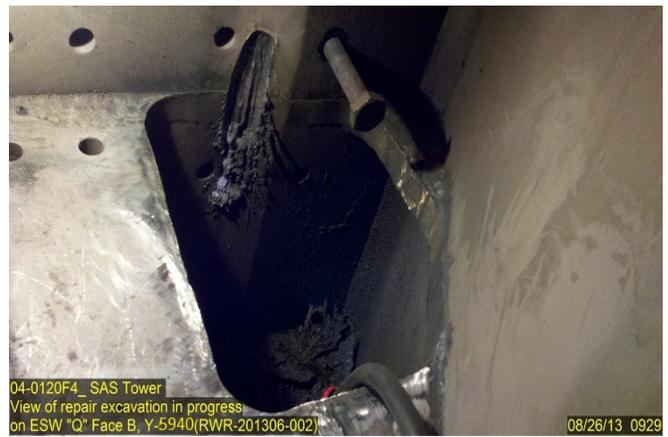
ESW E-043, Location "Q"-Face B:

The QA Inspector was present to observe ABF welder Wai Kit Lai (WID-2953) completing work to remove a section of 9m Diaphragm plate as per ABF Request for Information (RFI) -003457R00. Mr. Lai was then observed performing excavation of ESW "Q" Face B@ Y-6000mm (Actual 9m) to remove indications observed during visual and magnetic particle inspection. Mr. Lai was performing the excavation using an air carbon arc gouging and a grinder. Mr. Lai was instructed by ABF QC Inspector Jesse Cayabyab to notify him when indications are visible to allow QC/QA time to inspect the excavation. Location of the repair is as follows:

Excavation Y=5800mm~6150mm, L=350mm, W=50mm, D=31mm.

After grinding to bright metal the QC Inspector performed MT testing of the excavation. The QC Inspector stated the excavation appears to be free of discontinuities and he would complete ABF daily inspection report and magnetic particle testing report to detail the findings. The QA Inspector also performed MT inspection of the final excavation. After excavation Mr. Lai was observed setting up to perform SMAW repair welding on this date. See TL-6028 for additional details on items inspected on this date.
