DEPARTMENT OF TRANSPORTATION

Contract #: 04-0120F4Cty: SF/ALA Rte: 80 PM: 13.2/13.9File #: 99.28**WELDING INSPECTION REPORT****Resident Engineer:** Casey, William**Address:** 333 Burma Road**City:** Oakland, CA 94607**Report No:** WIR-029973**Date Inspected:** 29-Aug-2013**Project Name:** SAS Superstructure**OSM Arrival Time:** 700**Prime Contractor:** American Bridge/Fluor Enterprises, a JV**OSM Departure Time:** 1530**Contractor:** USA Hoist**Location:** Crest Hill, IL

Bridge No: 34-0006**Component:** SAS Tower Elevator**Summary of Items Observed:**

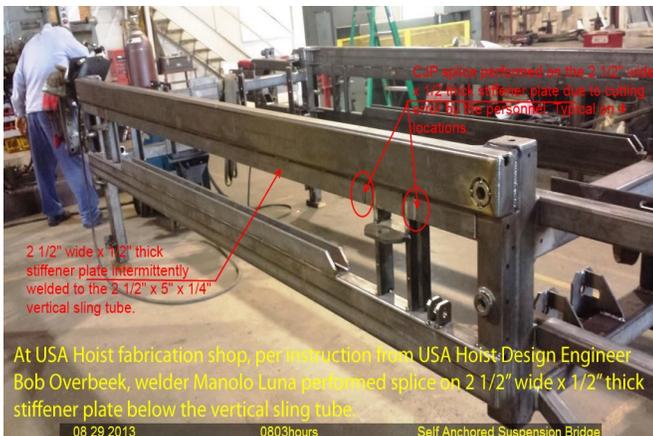
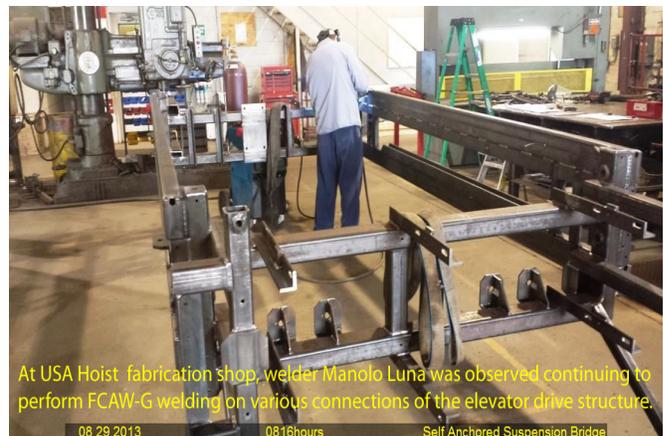
At the 2 ½” wide x ½” thick stiffener welded to the side of 2 ½” x 5” x ¼” tube steel left/right rear vertical sling tubes per shop drawing 916232-63, the two (2) outer stiffeners and one (1) middle stiffener were noted short and CJP welded a splice pop piece to compensate for the short length dimension. The more than 2” long pop piece spliced to the stiffeners was noted prepped to double bevel with 45 degree bevel and 3/16” deep with 1/8” root opening then welded both sides. Since this was an unscheduled splice, the issue was brought to the attention of USA Hoist Design Engineer Bob Overbeek. Mr. Overbeek informed this QA that there was an error during cutting and that per elevator code they are allowed to do splice. He also added that the splice locations will be incorporated to the “as built” drawing that will be submitted to Caltrans. During the presence of SMR Saied Khan and Gary Thomas who visited the shop, the issue was also brought to their attention. SMR Saied Khan informed this QA that per arrangement of USA Hoist and Caltrans, USA Hoist could make changes as long as the changes made will be incorporated in the “as built” drawing.

During the shop visit of SMR Gary Thomas and Saied Khan, the issue of the stiffener plate CJP splice was brought to their attention. The joint itself was shown as detailed. According to USA Hoist Design Engineer Bob Overbeek, the change or the CJP splice on the stiffener plate will be incorporated in the "as built" drawing to be submitted to Caltrans.
