Contract #: 04-0120F4Cty: SF/ALA Rte: 80 PM: 13.2/13.9File #: 1.28**WELDING INSPECTION REPORT****Resident Engineer:** Casey, William**Address:** 333 Burma Road**City:** Oakland, CA 94607**Report No:** WIR-029975**Date Inspected:** 29-Aug-2013**Project Name:** SAS Superstructure**OSM Arrival Time:** 700**Prime Contractor:** American Bridge/Fluor Enterprises, a JV**OSM Departure Time:** 1930**Contractor:** American Bridge/Fluor Enterprises, a JV**Location:** Job Site

ESW Repair excavation

NDT Inspection of Electroslag Welds (ESW)

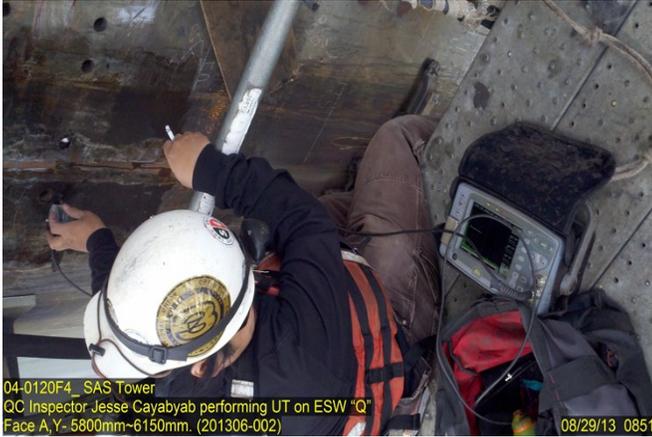
The QA Inspector observed ABF QC Inspector Jesse Cayabyab perform Ultrasonic Testing (UT) on Tower Electroslag Complete Joint Penetration (CJP) weld designated as ESW "Q" face A, B. The inspection was being performed on SMAW repairs. Y Locations were noted as: Y=5800mm~6150mm and additional HAZ areas located 300mm above and below the prosed repair.

No rejectable or recordable indications were observed.

The QA Inspector also performed UT of the above mentioned ESW location in accordance with the ABF approved supplemental procedure for confirmation and evaluation of planar type defects. Tandem report for work performed on this date will be completed by Mr. Cayabyab and signed by both QA/QC parties. Items listed on tandem report reflect indications agreed upon by QA/QC. See TL-6027 for additional details on the items inspected on this date
