DEPARTMENT OF TRANSPORTATION

Contract #: 04-0120F4Cty: SF/ALA Rte: 80 PM: 13.2/13.9File #: 1.28**WELDING INSPECTION REPORT****Resident Engineer:** Casey, William**Address:** 333 Burma Road**City:** Oakland, CA 94607**Report No:** WIR-029976**Date Inspected:** 03-Sep-2013**Project Name:** SAS Superstructure**OSM Arrival Time:** 700**Prime Contractor:** American Bridge/Fluor Enterprises, a JV**OSM Departure Time:** 1530**Contractor:** American Bridge/Fluor Enterprises, a JV**Location:** Job Site**CWI Name:** Bernie Docena**CWI Present:** Yes No**Inspected CWI report:** Yes No N/A**Rod Oven in Use:** Yes No N/A**Electrode to specification:** Yes No N/A**Weld Procedures Followed:** Yes No N/A**Qualified Welders:** Yes No N/A**Verified Joint Fit-up:** Yes No N/A**Approved Drawings:** Yes No N/A**Approved WPS:** Yes No N/A**Delayed / Cancelled:** Yes No N/A**Bridge No:** 34-0006**Component:** SAS Tower**Summary of Items Observed:**

ESW Repair excavation

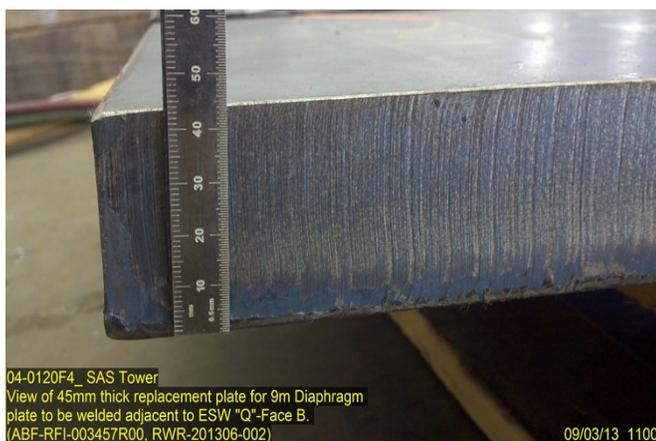
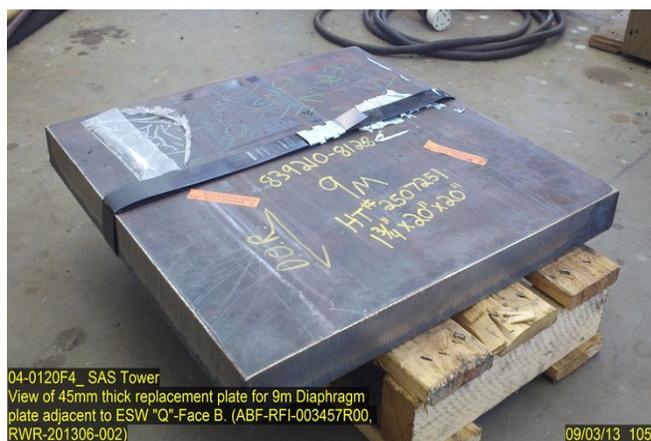
ESW E-043, Location "Q"-Face B:

The QA Inspector observed that ABF have received replacement diaphragm material to complete the repair at the 9m location adjacent to ESW "Q" Face B. Per approved RFI 003457R00, the contractor removed the Elevation 9m Diaphragm to provide access for the repair of ESW Weld "Q" (E-043). The QA Inspector spoke to Tower SMR Aaron Prchlik to inquire of the replacement plate material had been verified and approved. Mr. Prchlik stated that the plate was verified upon receipt at the jobsite warehouse and is acceptable for installation. ABF QC Inspector Bernie Docena stated that the fill plate material is the same grade and thickness (45 mm) as the original diaphragm plate that was removed. Mr. Docena also stated that ABF would trace a template of the existing hole and cut the plate to the required size. Currently the existing hole at the 9m elevation has been ground and Magnetic particle tested by ABF QC with no relevant indications observed.
