DEPARTMENT OF TRANSPORTATION

Quality Assurance and Source Inspection

Contract #: 04-0120F4Cty: SF/ALA Rte: 80 PM: 13.2/13.9File #: 1.28**WELDING INSPECTION REPORT****Resident Engineer:** Casey, William**Address:** 333 Burma Road**City:** Oakland, CA 94607**Report No:** WIR-029980**Date Inspected:** 04-Sep-2013**Project Name:** SAS Superstructure**OSM Arrival Time:** 700**Prime Contractor:** American Bridge/Fluor Enterprises, a JV**OSM Departure Time:** 1730**Contractor:** American Bridge/Fluor Enterprises, a JV**Location:** Job Site**CWI Name:** Bernie Docena, Jesse Cayabyab**CWI Present:** Yes No**Inspected CWI report:** Yes No N/A**Rod Oven in Use:** Yes No N/A**Electrode to specification:** Yes No N/A**Weld Procedures Followed:** Yes No N/A**Qualified Welders:** Yes No N/A**Verified Joint Fit-up:** Yes No N/A**Approved Drawings:** Yes No N/A**Approved WPS:** Yes No N/A**Delayed / Cancelled:** Yes No N/A**Bridge No:** 34-0006**Component:** SAS Tower**Summary of Items Observed:**

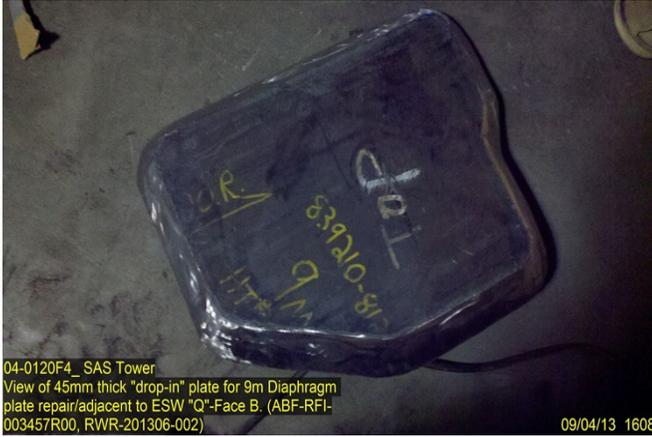
The QA Inspector observed ABF welding personnel Kit Lai (WID-2953) performing cutting and grinding on replacement diaphragm material to complete the repair at the 9m location adjacent to ESW "Q" Face B. Per approved RFI 003457R00, the contractor removed the Elevation 9m Diaphragm to provide access for the repair of

ESW Weld "Q" (E-043). The 45 mm diaphragm plate was cut to size and Mr. Lai was observed preparing the plate edges to a 45° bevel. The remainder of the shift was spent trial fitting the plate to the existing hole and layout punch marks for ring beam angle stiffener bolt holes.
