Contract #: 04-0120F4Cty: SF/ALA Rte: 80 PM: 13.2/13.9File #: 1.28**WELDING INSPECTION REPORT****Resident Engineer:** Casey, William**Address:** 333 Burma Road**City:** Oakland, CA 94607**Report No:** WIR-029982**Date Inspected:** 06-Sep-2013**Project Name:** SAS Superstructure**OSM Arrival Time:** 700**Prime Contractor:** American Bridge/Fluor Enterprises, a JV**OSM Departure Time:** 1730**Contractor:** American Bridge/Fluor Enterprises, a JV**Location:** Job Site**CWI Name:** Bernie Docena, Jesse Cayabyab**CWI Present:** Yes No**Inspected CWI report:** Yes No N/A**Rod Oven in Use:** Yes No N/A**Electrode to specification:** Yes No N/A**Weld Procedures Followed:** Yes No N/A**Qualified Welders:** Yes No N/A**Verified Joint Fit-up:** Yes No N/A**Approved Drawings:** Yes No N/A**Approved WPS:** Yes No N/A**Delayed / Cancelled:** Yes No N/A**Bridge No:** 34-0006**Component:** SAS Tower**Summary of Items Observed:**

NDT Inspection of Electroslag Welds (ESW)

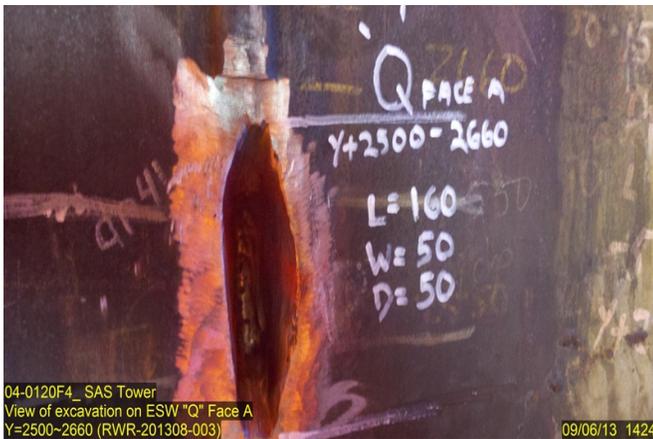
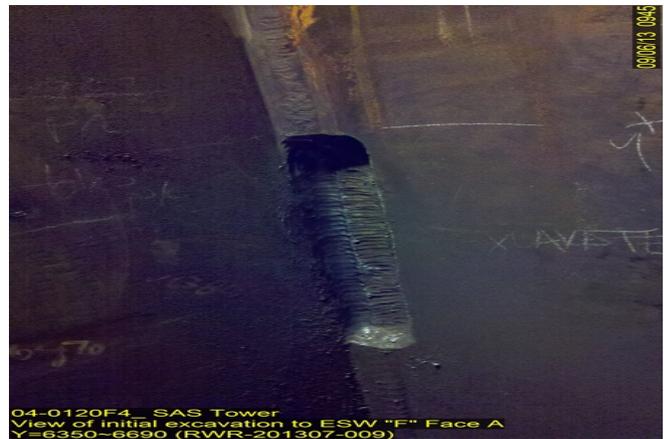
The QA Inspector observed ABF welder Rick Clayborn (WID-2773) performing excavation of Electroslag Weld (ESW) "Q" face A@ Y-2550mm, to verify indications observed during Ultrasonic Testing with pulse/echo & pitch/catch. Mr. Clayborn was performing air carbon arc gouging and grinding on the excavation. After grinding to

bright metal the ABF QC Inspector Bernie Docena performed MT testing of the excavation. Details of the final repair excavation are as follows:

Y= 2500mm~2660mm

L= 160mm

W= 50mm

D= Weld excavated at 50mm-No indications observed.

The QC Inspector stated the excavation appears to be free of discontinuities and he would complete ABF daily inspection report and magnetic particle testing report to detail the findings. Mr. Docena and the QA Inspector also discussed the importance of preparing the excavation in a proper U groove in lieu of a V groove to completely eliminate weld discontinuities. The QC Inspector also stated that ABF Field Engineer Eric Blue had given ABF the approval to proceed with weld repair at this location. The QA Inspector also performed MT inspection of the final excavation. See TL-6028 for additional details on items inspected on this date.
