**DEPARTMENT OF TRANSPORTATION**

Contract #: 04-0120F4Cty: SF/ALA Rte: 80 PM: 13.2/13.9File #: 1.28**WELDING INSPECTION REPORT****Resident Engineer:** Casey, William**Address:** 333 Burma Road**City:** Oakland, CA 94607**Report No:** WIR-029983**Date Inspected:** 07-Sep-2013**Project Name:** SAS Superstructure**OSM Arrival Time:** 700**Prime Contractor:** American Bridge/Fluor Enterprises, a JV**OSM Departure Time:** 1530**Contractor:** American Bridge/Fluor Enterprises, a JV**Location:** Job Site**CWI Name:** Bernie Docena, Jesse Cayabyab**CWI Present:** Yes No**Inspected CWI report:** Yes No N/A**Rod Oven in Use:** Yes No N/A**Electrode to specification:** Yes No N/A**Weld Procedures Followed:** Yes No N/A**Qualified Welders:** Yes No N/A**Verified Joint Fit-up:** Yes No N/A**Approved Drawings:** Yes No N/A**Approved WPS:** Yes No N/A**Delayed / Cancelled:** Yes No N/A**Bridge No:** 34-0006**Component:** SAS Tower**Summary of Items Observed:**

# WELDING INSPECTION REPORT

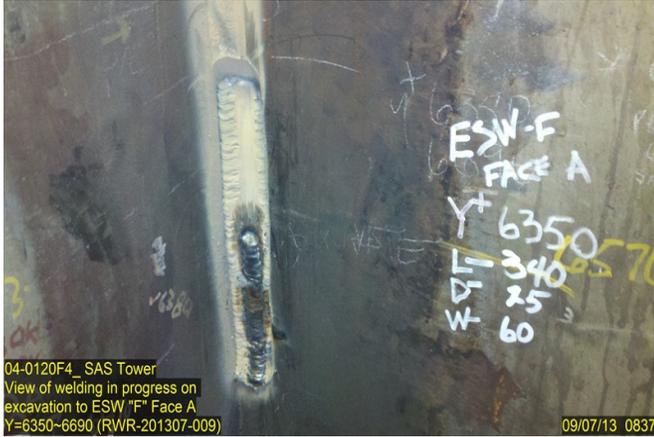
The QA Inspector observed ABF welder Wai Kit Lai (WID-2953) performing Shield Metal Arc Welding (SMAW) on the repair excavation on Electroslag Weld (ESW) Location "F", at face A. The locations and repair information are listed in Request for Weld Repair (RWR) 201307-009 from Ultrasonic Testing indications designated for repair. The repair locations were noted as:

Prior to welding, Mr. Lai was observed preheating the weld to over 350° Fahrenheit using the Miller ProHeat 35 with heat induction blankets. The welder was using 4.0mm diameter electrode (E7018-1 HR4) per ABF Welding Procedure Specification (WPS) ABF-WPS-D15-1000-Repair Rev.3. The welding process in use was the Shielded Metal Arc Welding process (SMAW). The welding parameters were verified by ABF QC Inspector Bernie Docena with a Fluke 337 current Clampmeter and preheat was verified with temperature indicators. The QC Inspector performed welding parameters verifications at random intervals throughout the shift. The welding observed appeared to be in compliance with the WPS noted above. The welding at this location was completed on this date. Mr. Lai performed grinding of the weld reinforcement the rest of the shift in preparation for final inspection of the repair.
