DEPARTMENT OF TRANSPORTATION

Contract #: 04-0120F4Cty: SF/ALA Rte: 80 PM: 13.2/13.9File #: 1.28**WELDING INSPECTION REPORT****Resident Engineer:** Casey, William**Address:** 333 Burma Road**City:** Oakland, CA 94607**Report No:** WIR-029984**Date Inspected:** 09-Sep-2013**Project Name:** SAS Superstructure**OSM Arrival Time:** 700**Prime Contractor:** American Bridge/Fluor Enterprises, a JV**OSM Departure Time:** 1730**Contractor:** American Bridge/Fluor Enterprises, a JV**Location:** Job Site**CWI Name:** Bernie Docena, Jesse Cayabyab**CWI Present:** Yes No**Inspected CWI report:** Yes No N/A**Rod Oven in Use:** Yes No N/A**Electrode to specification:** Yes No N/A**Weld Procedures Followed:** Yes No N/A**Qualified Welders:** Yes No N/A**Verified Joint Fit-up:** Yes No N/A**Approved Drawings:** Yes No N/A**Approved WPS:** Yes No N/A**Delayed / Cancelled:** Yes No N/A**Bridge No:** 34-0006**Component:** SAS Tower**Summary of Items Observed:**

WELDING INSPECTION REPORT

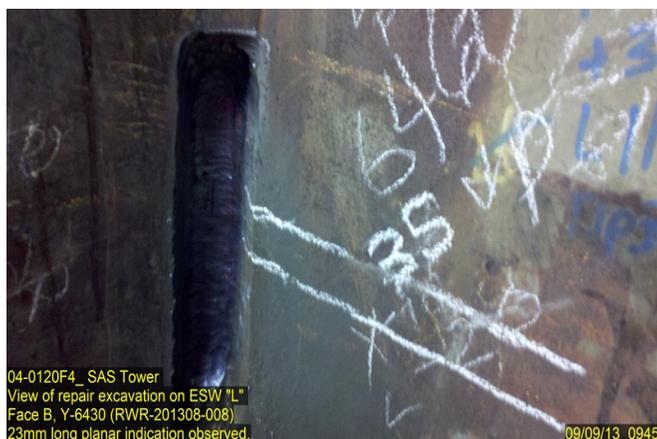
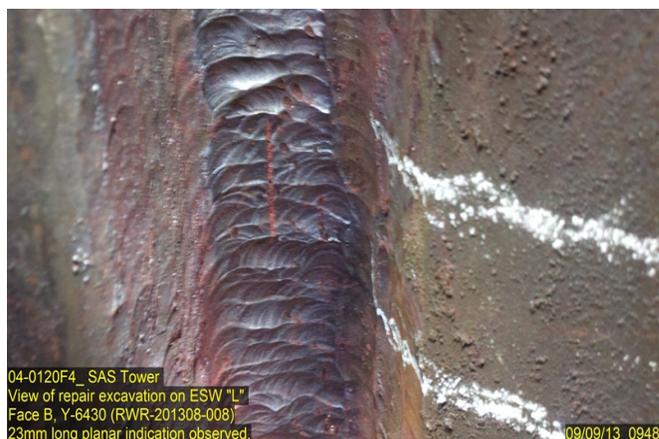
ESW S-042, Location "L"-Face B:

The QA Inspector observed ABF welder Wai Kit Lai (WID-2953) performing excavation of ESW "L" Face B @ Y-6430mm to verify indications observed during Ultrasonic Testing pulse/echo & pitch/catch. Mr. Lai was performing the excavation using an air carbon arc gouging and a grinder. Mr. Lai was instructed by ABF QC Inspector Jesse Cayabyab to notify him when indications are visible to allow QC/QA time to inspect the excavation. Location of the repair is as follows:

Weld excavated at 27mm dp- 18mm long planar indication observed @ 6460mm.

Weld excavated at 35mm dp- 23mm long planar indication observed @ 6460mm.

Weld excavated at 45mm dp- No indications observed.

Excavation Length (Y=6300mm~6570mm) L-270mm, W= 60mm, D= 45mm.

After grinding to bright metal the ABF QC Inspector Jesse Cayabyab performed MT testing of the excavation. The QC Inspector stated the excavation appears to be free of discontinuities and he would complete ABF daily inspection report and magnetic particle testing report to detail the findings. Mr. Cayabyab also stated that since the indication observed appeared to be a significant planar indication the repair will be performed at both faces of the ESW weld at this Y location to remove the original ESW weld. The QA Inspector also performed MT inspection of the final excavation. After excavation Mr. Lai was observed setting up to perform SMAW repair welding on this date. See TL-6028 for additional details on items inspected on this date.
