**DEPARTMENT OF TRANSPORTATION**

Contract #: 04-0120F4Cty: SF/ALA Rte: 80 PM: 13.2/13.9File #: 01.28**WELDING INSPECTION REPORT****Resident Engineer:** Casey, William**Address:** 333 Burma Road**City:** Oakland, CA 94607**Report No:** WIR-029996**Date Inspected:** 09-Sep-2013**Project Name:** SAS Superstructure**OSM Arrival Time:** 700**Prime Contractor:** American Bridge/Fluor Enterprises, a JV**OSM Departure Time:** 1730**Contractor:** American Bridge/Fluor Enterprises, a JV**Location:** Job Site

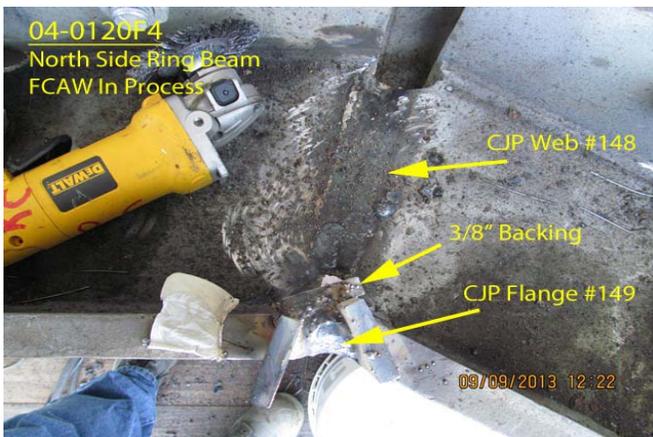
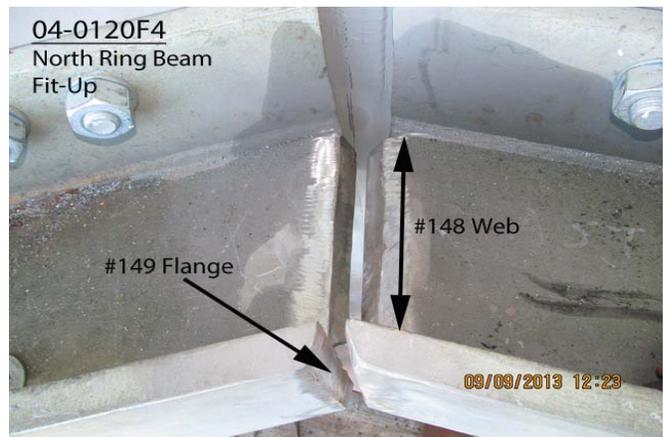
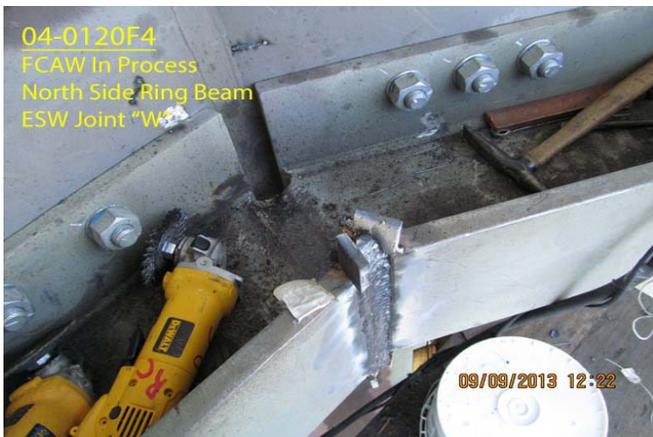
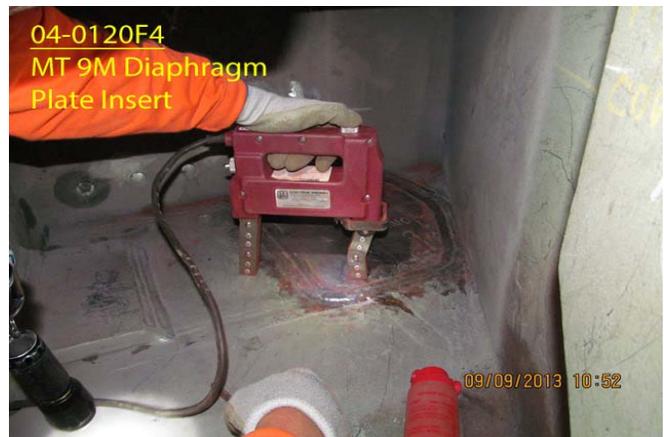
The welding & workmanship observed on this date appeared to be in general compliance with the contract specifications. The following pictures below detail some of the observations made on this date.
