DEPARTMENT OF TRANSPORTATION

Contract #: 04-0120F4Cty: SF/ALA Rte: 80 PM: 13.2/13.9File #: 1.28**WELDING INSPECTION REPORT****Resident Engineer:** Casey, William**Address:** 333 Burma Road**City:** Oakland, CA 94607**Report No:** WIR-029998**Date Inspected:** 12-Aug-2013**Project Name:** SAS Superstructure**OSM Arrival Time:** 600**Prime Contractor:** American Bridge/Fluor Enterprises, a JV**OSM Departure Time:** 1500**Contractor:** American Bridge/Fluor Enterprises, a JV**Location:** Richmond, CA**CWI Name:****CWI Present:**

Bridge No: 34-0006**Component:****Summary of Items Observed:**

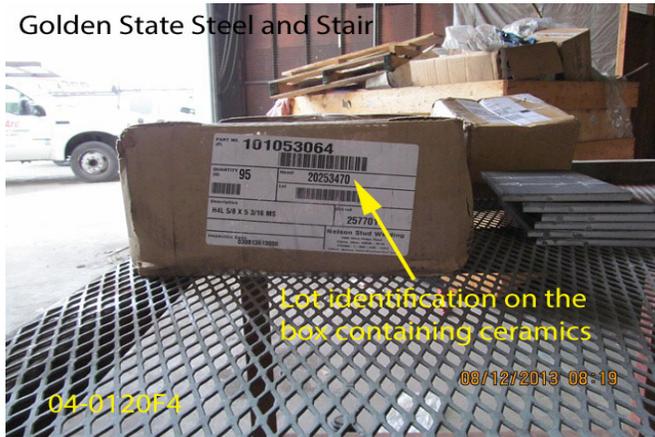
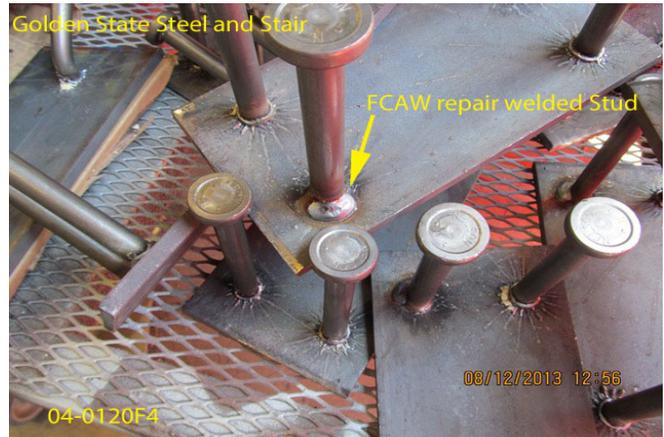
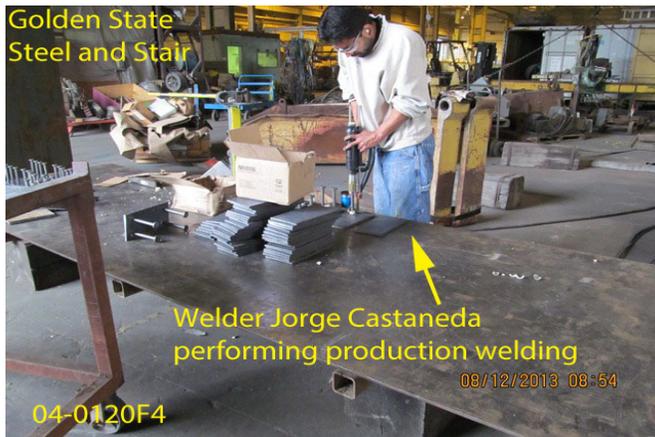
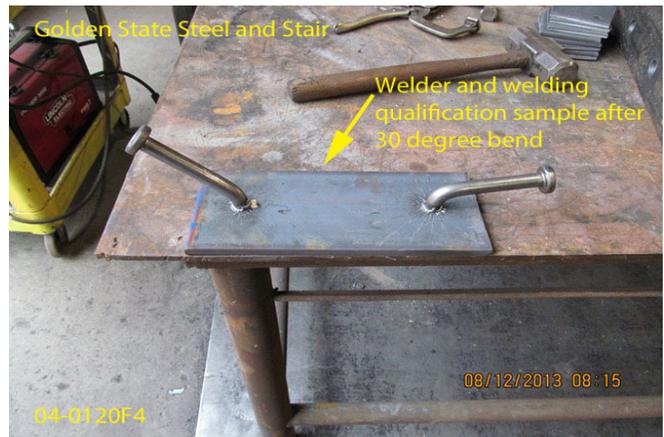
of loose flash and small pieces of ceramic, it was determined that 1 piece was cut short of the required length. This piece was segregated and not utilized for the lot. This QA witnessed the cut of an additional piece, center punching for location and the subsequent stud welding.

During final review, it was determined that 16 of the welded studs did not exhibit the required 100% flash. These studs were FCAW weld repaired in accordance with a AWS D1.1 prequalified procedure. Each of the 16 were then 15 degree bent to determine complete fusion. None were found to be unfused.
