DEPARTMENT OF TRANSPORTATION

Quality Assurance and Source Inspection

Contract #: 04-0120F4Cty: SF/ALA Rte: 80 PM: 13.2/13.9File #: 99.28**WELDING INSPECTION REPORT****Resident Engineer:** Casey, William**Address:** 333 Burma Road**City:** Oakland, CA 94607**Report No:** WIR-030002**Date Inspected:** 13-Sep-2013**Project Name:** SAS Superstructure**OSM Arrival Time:** 630**Prime Contractor:** American Bridge/Fluor Enterprises, a JV**OSM Departure Time:** 1530**Contractor:** American Bridge/Fluor Enterprises, a JV**Location:** Oakland, CA**CWI Name:** Tony Sherwood**CWI Present:** Yes No**Inspected CWI report:** Yes No N/A**Rod Oven in Use:** Yes No N/A**Electrode to specification:** Yes No N/A**Weld Procedures Followed:** Yes No N/A**Qualified Welders:** Yes No N/A**Verified Joint Fit-up:** Yes No N/A**Approved Drawings:** Yes No N/A**Approved WPS:** Yes No N/A**Delayed / Cancelled:** Yes No N/A**Bridge No:** 34-0006**Component:** Tower Skirt Ring Beam**Summary of Items Observed:**

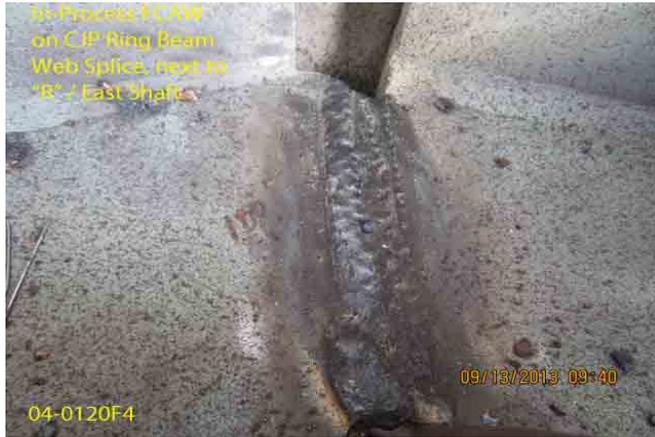
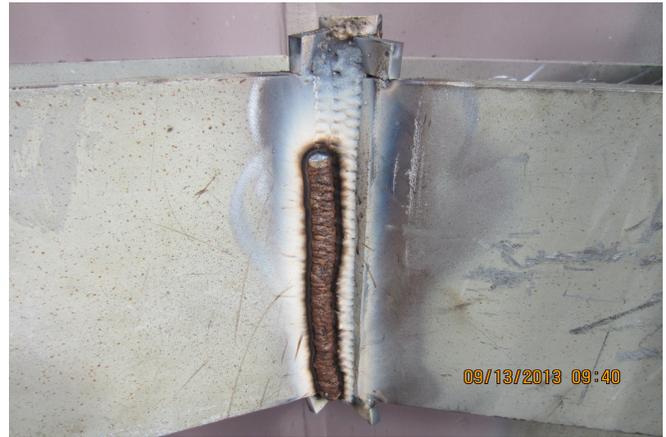
Quality Assurance Inspector (QA) James Doe was at the American Bridge/Flour (ABF) job site at Yerba Buena Island between the times noted above in order to monitor Smith Emery Quality Control (QC) functions and the in process work being performed by ABF personnel. The following items were observed: Nine (9) meter level Tower Skirt Ring Beam, East Side. ABF welding personnel Rick Clayborn was observed performing in process fit up for Complete Joint Penetration (CJP) welds at one location for web & flange of the ring beam on the East side of the tower. The two locations are at Electroslag weld (ESW) "R". The weld numbers per ABF drawing are identified as #146 (web) & #147 (flange). Welder was observed using 3/8" backing for back side (side B) of the root opening which will later be removed for back gouging. Weld joint configuration is identified as a skewed double bevel CJP weld. Fit up at both locations was inspected by both QC Inspector Tony Sherwood and QAI. Fit up was accepted by the QC Inspector and QA inspector agreed. The welder, Rick Clayborn was later observed at ESW "R" utilizing the Flux Cored Arc Welding (FCAW-S) process in the vertical (3G) & flat (1G) position with Lincoln Innershield NR-232, E71T-8, 1.8mm diameter wire electrode to weld ring beam 1" flange and web plates. The welding parameters were verified by QC Inspector Tony Sherwood with a Fluke 337 current clamp meter per ABF Welding Procedure Specification (WPS) ABF-WPS-D15-2030-3, revision 1 & ABF-WPS-D15-2030-1, revision 1 throughout the shift. QC inspector relayed to this QA inspector that the welding parameters for the vertical CJP welds taken at 11:30 was 260 amps and 20.4 volts and was in compliance with the WPS noted above. The welder was using a hand held propylene torch to maintain preheat/interpass temperature at or above 150° Fahrenheit. Welder was observed using proper interpass cleaning methods with a slag hammer, wire wheel and light grinding. At the end of this QA inspectors shift the welding was still in process for ring beam CJP # 146 & 147. The welding & workmanship observed on this date appeared to be in general compliance with the contract specifications. The following pictures below detail some of the observations made on this date.
