DEPARTMENT OF TRANSPORTATION

Contract #: 04-0120F4Cty: SF/ALA Rte: 80 PM: 13.2/13.9File #: 01.28**WELDING INSPECTION REPORT****Resident Engineer:** Casey, William**Address:** 333 Burma Road**City:** Oakland, CA 94607**Report No:** WIR-030031**Date Inspected:** 14-Sep-2013**Project Name:** SAS Superstructure**OSM Arrival Time:** 700**Prime Contractor:** American Bridge/Fluor Enterprises, a JV**OSM Departure Time:** 1530**Contractor:** American Bridge/Fluor Enterprises, a JV**Location:** Job Site

Tower Ring Beam CJP @ ESW S & R

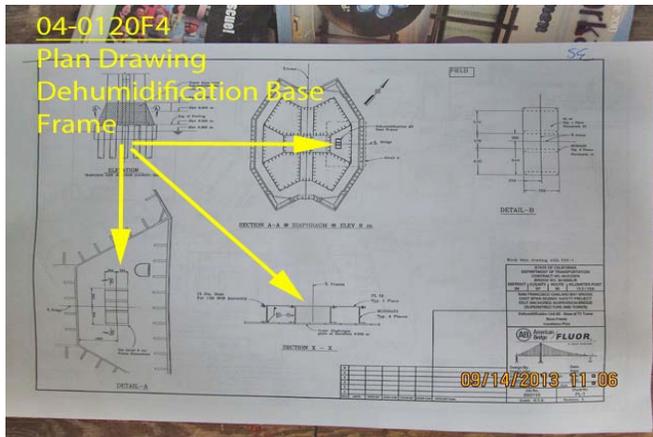
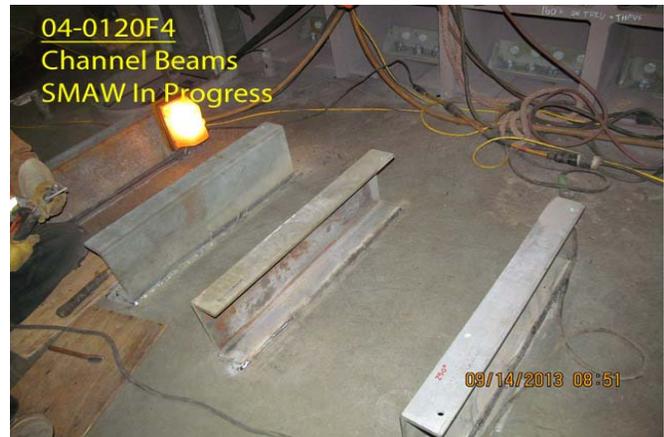
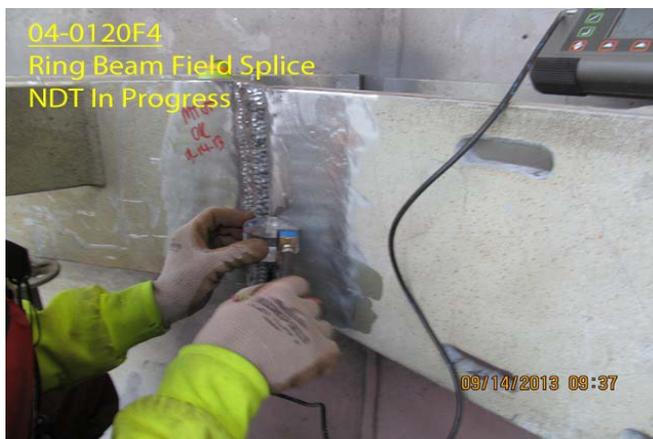
The welding & workmanship observed on this date appeared to be in general compliance with the contract specifications. The following pictures detail the work in progress.
