DEPARTMENT OF TRANSPORTATION

Quality Assurance and Source Inspection

Contract #: 04-0120F4Cty: SF/ALA Rte: 80 PM: 13.2/13.9File #: 1.28**WELDING INSPECTION REPORT****Resident Engineer:** Casey, William**Address:** 333 Burma Road**City:** Oakland, CA 94607**Report No:** WIR-030033**Date Inspected:** 17-Sep-2013**Project Name:** SAS Superstructure**OSM Arrival Time:** 700**Prime Contractor:** American Bridge/Fluor Enterprises, a JV**OSM Departure Time:** 1530**Contractor:** American Bridge/Fluor Enterprises, a JV**Location:** Job Site**CWI Name:** Salvador Merino**CWI Present:** Yes No**Inspected CWI report:** Yes No N/A**Rod Oven in Use:** Yes No N/A**Electrode to specification:** Yes No N/A**Weld Procedures Followed:** Yes No N/A**Qualified Welders:** Yes No N/A**Verified Joint Fit-up:** Yes No N/A**Approved Drawings:** Yes No N/A**Approved WPS:** Yes No N/A**Delayed / Cancelled:** Yes No N/A**Bridge No:** 34-0006**Component:** SAS Upper Saddle**Summary of Items Observed:**

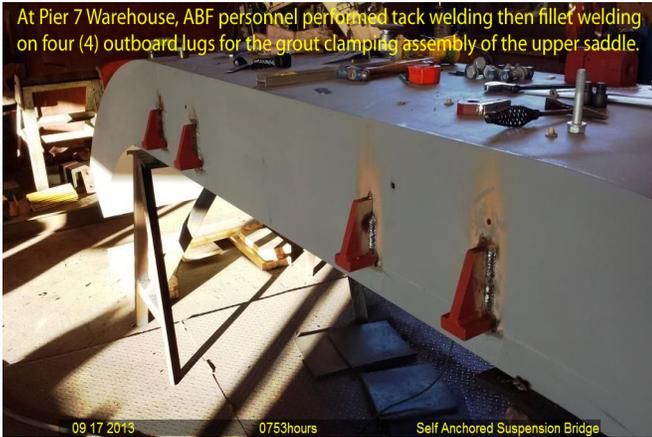
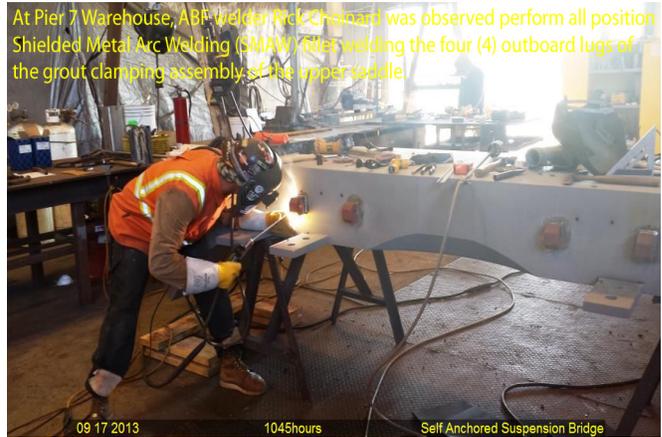
At Pier 7 Warehouse Oakland, CA this QA randomly observed ABF welders Richard Garcia and Rick Choinard continuing to perform Shielded Metal Arc Welding (SMAW) fillet welding between the outboard lugs marked x361-08a2 and inboard lugs marked x361-08pb3 to 3/4" thick upper saddle S10B. The welders were using 3/32" diameter E7018H4R electrode during tack welding and switched to 1/8" diameter E7018H4R during the fillet welding implementing Caltrans approved ABF-WPS-D15-F1200A. The fillet welding of the splice lugs to the upper saddle is being done per Contract Change Order CCO #327 with reference ABF shop drawing #X361-08 Revision A. Prior tack and fillet welding, the welders were noted grinding off the paint then tack welded all eight (8) lugs. After tacking the lugs, the welders preheated the plates using propylene gas torch then performed the fillet welding. ABF personnel have tack/fillet welded four (4) outboard lugs to one side of the upper saddle and four (4) inboard lugs to the other side of the upper saddle. During the shift, ABF QC Salvador Merino was noted on site monitoring the workmanship and parameters of the welders. All eight (8) lugs were completely fillet (3/8") welded during the shift and ABF QC Salvador Merino also performed the visual/dimensional inspection on welded lugs. This QA also performed visual/dimensional verification on completely welded fillet lugs and deemed in compliance to the project requirements.

perform Magnetic Particle Testing (MT). ABF QC Salvador Merino performed the MT on the fillet welds as soon as the welds cooled down and found no relevant indications noted during the test. This QA performed the MT verification and noted same result.
