Quality Assurance and Source Inspection

Contract #: 04-0120F4Cty: SF/ALA Rte: 80 PM: 13.2/13.9File #: 01.28**WELDING INSPECTION REPORT****Resident Engineer:** Casey, William**Address:** 333 Burma Road**City:** Oakland, CA 94607**Report No:** WIR-030036**Date Inspected:** 10-Sep-2013**Project Name:** SAS Superstructure**OSM Arrival Time:** 700**Prime Contractor:** American Bridge/Fluor Enterprises, a JV**OSM Departure Time:** 1730**Contractor:** American Bridge/Fluor Enterprises, a JV**Location:** Job Site

Ring Beam North Side

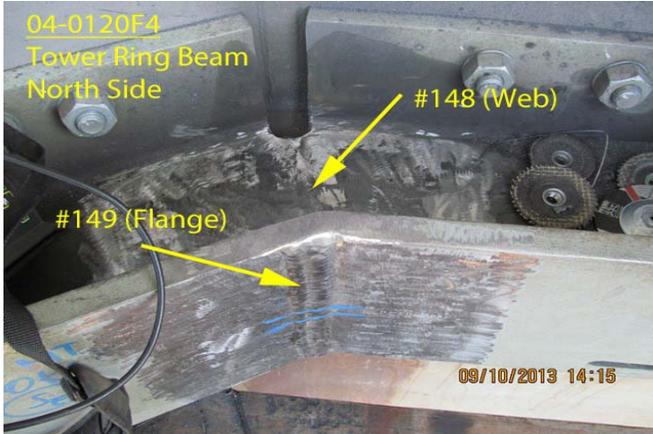
meter per ABF Welding Procedure Specification (WPS) ABF-WPS-D15-2030-3. After welding was completed and cooled to ambient temperature, the QAI along with QC Inspector Bernie Docena performed final visual inspection, Magnetic Particle Testing (MT) examination and Ultrasonic Testing (UT) for welds #148 & 149 (web & flange) on the north tower side ring beam. No relevant indications were observed during inspection and welds were accepted by QC.

The welding & workmanship observed on this date appeared to be in general compliance with the contract specifications. The following picture below details completed welds on north ring beam after final inspection.
