DEPARTMENT OF TRANSPORTATION

Contract #: 04-0120F4Cty: SF/ALA Rte: 80 PM: 13.2/13.9File #: 1.28**WELDING INSPECTION REPORT****Resident Engineer:** Casey, William**Address:** 333 Burma Road**City:** Oakland, CA 94607**Report No:** WIR-030037**Date Inspected:** 10-Sep-2013**Project Name:** SAS Superstructure**OSM Arrival Time:** 700**Prime Contractor:** American Bridge/Fluor Enterprises, a JV**OSM Departure Time:** 1730**Contractor:** American Bridge/Fluor Enterprises, a JV**Location:** Job Site**CWI Name:** Bernie Docena, Jesse Cayabyab**CWI Present:** Yes No**Inspected CWI report:** Yes No N/A**Rod Oven in Use:** Yes No N/A**Electrode to specification:** Yes No N/A**Weld Procedures Followed:** Yes No N/A**Qualified Welders:** Yes No N/A**Verified Joint Fit-up:** Yes No N/A**Approved Drawings:** Yes No N/A**Approved WPS:** Yes No N/A**Delayed / Cancelled:** Yes No N/A**Bridge No:** 34-0006**Component:** SAS Tower**Summary of Items Observed:**

ESW Repair Welding

ESW S-042, Location "L"-Face B:

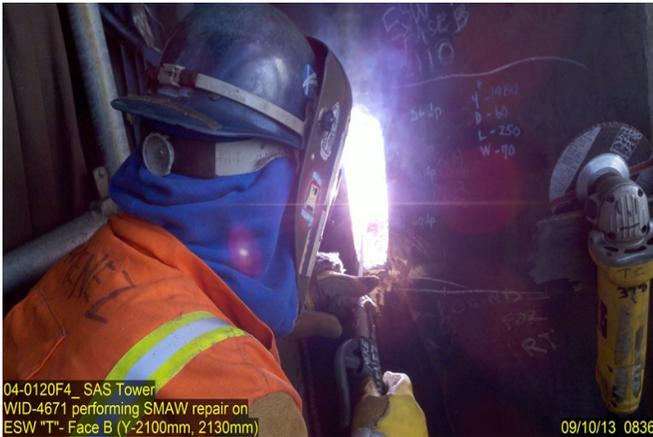
The QA Inspector observed ABF welder Mike Jimenez (WID-4671) performing Shield Metal Arc Welding (SMAW) on the repair excavation on Electroslag Weld (ESW) "T" at Face B. The locations and repair information

are listed in Request for Weld Repair (RWR) 201308-004 from Ultrasonic Testing indications designated for repair. The repair locations were noted as:

Original Y's= 2100mm,2130mm

Excavation Y=1980mm~2230mm

Prior to welding, Mr. Jimenez was observed preheating the weld to over 350° Fahrenheit using the Miller ProHeat 35 with heat induction blankets and a propylene torch. The welder was using 4.0mm diameter electrode (E7018-1 HR4) per ABF Welding Procedure Specification (WPS) ABF-WPS-D15-1000-Repair Rev.3. The welding process in use was the Shielded Metal Arc Welding process (SMAW). ABF QC Inspector Bernie Docena performed welding parameters verifications at random intervals throughout the shift. The welding observed appeared to be in compliance with the WPS noted above.
