Contract #: 04-0120F4Cty: SF/ALA Rte: 80 PM: 13.2/13.9File #: 1.28**WELDING INSPECTION REPORT****Resident Engineer:** Casey, William**Address:** 333 Burma Road**City:** Oakland, CA 94607**Report No:** WIR-030038**Date Inspected:** 11-Sep-2013**Project Name:** SAS Superstructure**OSM Arrival Time:** 700**Prime Contractor:** American Bridge/Fluor Enterprises, a JV**OSM Departure Time:** 1730**Contractor:** American Bridge/Fluor Enterprises, a JV**Location:** Job Site**CWI Name:** Bernie Docena**CWI Present:** Yes No**Inspected CWI report:** Yes No N/A**Rod Oven in Use:** Yes No N/A**Electrode to specification:** Yes No N/A**Weld Procedures Followed:** Yes No N/A**Qualified Welders:** Yes No N/A**Verified Joint Fit-up:** Yes No N/A**Approved Drawings:** Yes No N/A**Approved WPS:** Yes No N/A**Delayed / Cancelled:** Yes No N/A**Bridge No:** 34-0006**Component:** SAS Tower**Summary of Items Observed:**

ESW Repair Welding

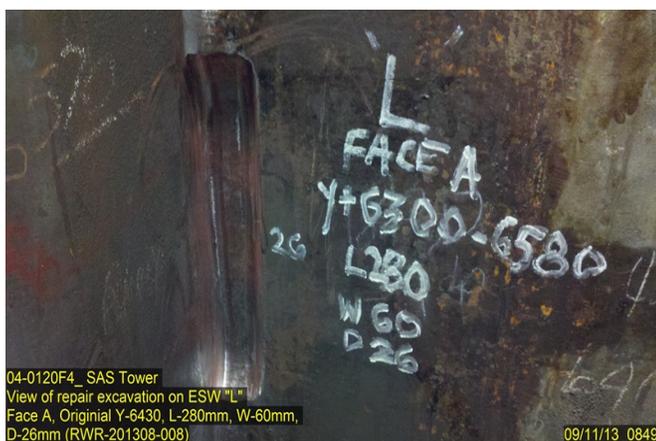
The QA Inspector observed ABF welder Wai Kit Lai (WID-2953) performing excavation of ESW "L" Face A @ Y-6430mm to verify indications observed during Ultrasonic Testing pulse/echo & pitch/catch. The repair information and rejectable indication is described in Request for Weld Repair (RWR) 201308-008. Mr. Lai was performing the excavation using an air carbon arc gouging and a grinder. The repair is being performed on Face A, since a significant planar indication was verified and removed on Face B at this Y location. Mr. Lai was instructed by ABF QC Inspector Bernie Docena to notify him if indications are visible to allow QC/QA time to inspect the excavation. Location of the repair is as follows:

Weld excavated at 26mm dp- No indications observed.

After grinding to bright metal the QC Inspector performed MT testing of the excavation. The QC Inspector stated the excavation appears to be free of discontinuities and he would complete ABF daily inspection report and magnetic particle testing report to detail the findings. See TL-6028 for additional details on items inspected on this date. Mr. Lai was later observed performing Shield Metal Arc Welding (SMAW) on the repair excavation mentioned above. The preheat was being held to over 350° Fahrenheit using the Miller ProHeat 35 with heat induction blankets. The welder was using 4.0mm diameter electrode (E7018-1 HR4) per ABF Welding Procedure Specification (WPS) ABF-WPS-D15-1000-Repair Rev.3. ABF QC Inspector Bernie Docena performed welding parameters verifications at random intervals throughout the shift. The welding observed appeared to be in compliance with the WPS noted above.
