Contract #: 04-0120F4Cty: SF/ALA Rte: 80 PM: 13.2/13.9File #: 1.28**WELDING INSPECTION REPORT**

**Report No:** WIR-030040  
**Date Inspected:** 13-Sep-2013

**Project Name:** SAS Superstructure  
**Prime Contractor:** American Bridge/Fluor Enterprises, a JV  
**Contractor:** American Bridge/Fluor Enterprises, a JV

<b>CWI Name:</b>	Bernie Docena	<b>CWI Present:</b>	Yes	No
<b>Inspected CWI report:</b>	Yes No N/A	<b>Rod Oven in Use:</b>	Yes	No N/A
<b>Electrode to specification:</b>	Yes No N/A	<b>Weld Procedures Followed:</b>	Yes	No N/A
<b>Qualified Welders:</b>	Yes No N/A	<b>Verified Joint Fit-up:</b>	Yes	No N/A
<b>Approved Drawings:</b>	Yes No N/A	<b>Approved WPS:</b>	Yes	No N/A
		<b>Delayed / Cancelled:</b>	Yes	No N/A
<b>Bridge No:</b>	34-0006	<b>Component:</b>	SAS Tower

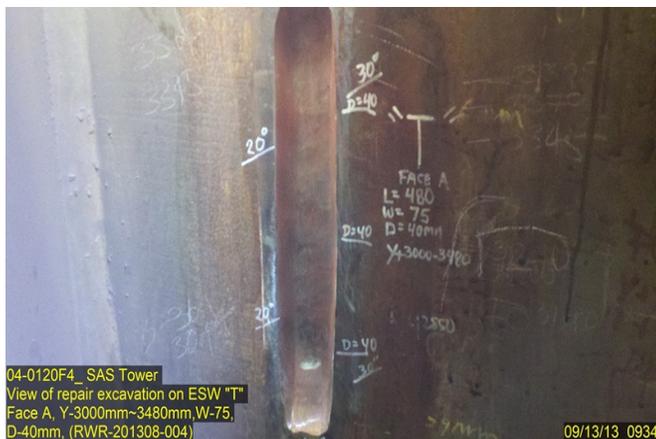
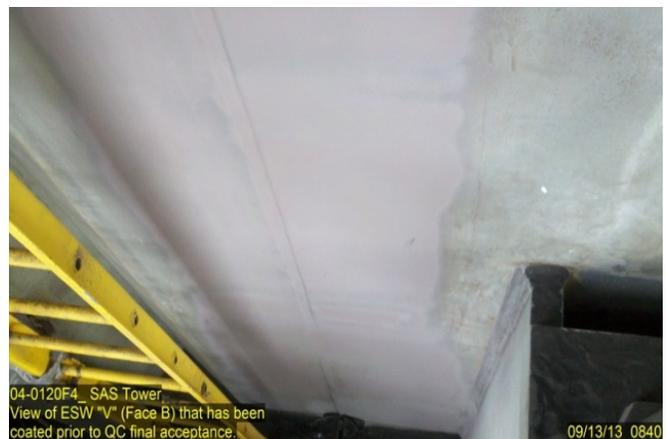
ESW W-043, Location "V"-Face B:

On the date the QA Inspector observed that ABF Painting Subcontractor Certified Coatings had applied inorganic zinc primer to the exterior of Tower Electroslag Weld (ESW) "V"-W-043 prior to the welds being final inspected & accepted by ABF QC. Per the Contract Special Provisions section 8-3.01- "Quality Control (QC) shall be the responsibility of the Contractor. As a minimum, the Contractor shall perform inspection and testing of each weld joint prior to welding, during welding, and after welding as specified in this section and to ensure that materials and workmanship conform to the requirements of the contract documents." Information regarding the Incident Report was forwarded to Lead Inspector Ken Riley for distribution. See TL-15 Quality Assurance Incident Report for additional details on items observed in non-compliance on this date.
