Contract #: 04-0120F4Cty: SF/ALA Rte: 80 PM: 13.2/13.9File #: 1.28**WELDING INSPECTION REPORT**

Report No: WIR-030060
Date Inspected: 18-Sep-2013

Project Name: SAS Superstructure
Prime Contractor: American Bridge/Fluor Enterprises, a JV
Contractor: American Bridge/Fluor Enterprises, a JV

CWI Name:				CWI Present:	Yes	No	
Inspected CWI report:	Yes	No	N/A	Rod Oven in Use:	Yes	No	N/A
Electrode to specification:	Yes	No	N/A	Weld Procedures Followed:	Yes	No	N/A
Qualified Welders:	Yes	No	N/A	Verified Joint Fit-up:	Yes	No	N/A
Approved Drawings:	Yes	No	N/A	Approved WPS:	Yes	No	N/A
				Delayed / Cancelled:	Yes	No	N/A
Bridge No:	34-0006			Component:	SAS Tower Head

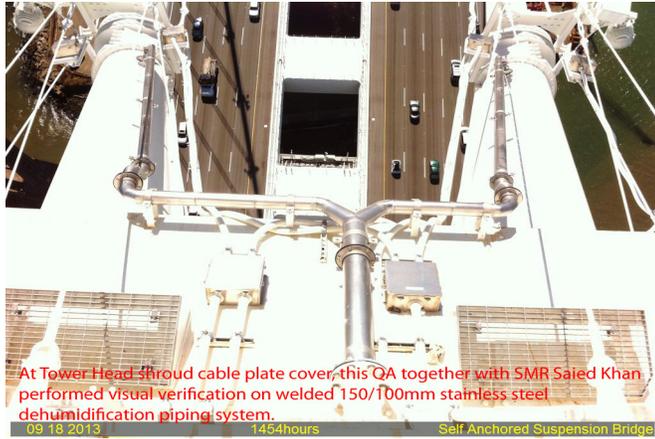
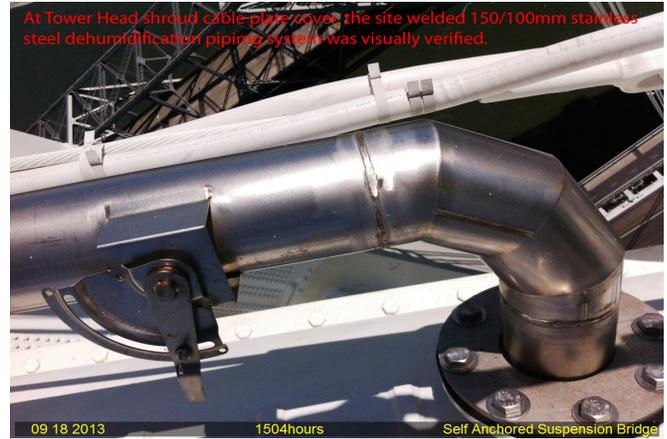
During the visual verification, the 150mm diameter stainless steel started from a 150mm diameter carbon steel pipe outlet from cable saddle bolted flange to flange connection and then branched out to a 150/100mm Y-reducer that led to a 100mm diameter line on each shroud cable cover. In between the 100mm diameter stainless steel line, there was also a stainless steel flexihose that was fillet welded to a flange on both ends that were flange connected to the 100mm diameter line.

This QA together with SMR Saied Khan went on each of the stainless steel ducting at the west side north and south cable and east side north and south cable. This QA has noted that the east and west sides ducting system was having typical stainless steel dehumidification ducting that were welded at the job site. The welded butt joints were visually verified and deemed in conformance to the job requirements.
