**DEPARTMENT OF TRANSPORTATION**

Contract #: 04-0120F4Cty: SF/ALA Rte: 80 PM: 13.2/13.9File #: 1.28**WELDING INSPECTION REPORT****Resident Engineer:** Casey, William**Address:** 333 Burma Road**City:** Oakland, CA 94607**Report No:** WIR-030064**Date Inspected:** 23-Sep-2013**Project Name:** SAS Superstructure**OSM Arrival Time:** 700**Prime Contractor:** American Bridge/Fluor Enterprises, a JV**OSM Departure Time:** 1730**Contractor:** American Bridge/Fluor Enterprises, a JV**Location:** Job Site**CWI Name:** Scott Kortum**CWI Present:** Yes No**Inspected CWI report:** Yes No N/A**Rod Oven in Use:** Yes No N/A**Electrode to specification:** Yes No N/A**Weld Procedures Followed:** Yes No N/A**Qualified Welders:** Yes No N/A**Verified Joint Fit-up:** Yes No N/A**Approved Drawings:** Yes No N/A**Approved WPS:** Yes No N/A**Delayed / Cancelled:** Yes No N/A**Bridge No:** 34-0006**Component:** SAS Tower**Summary of Items Observed:**

# WELDING INSPECTION REPORT

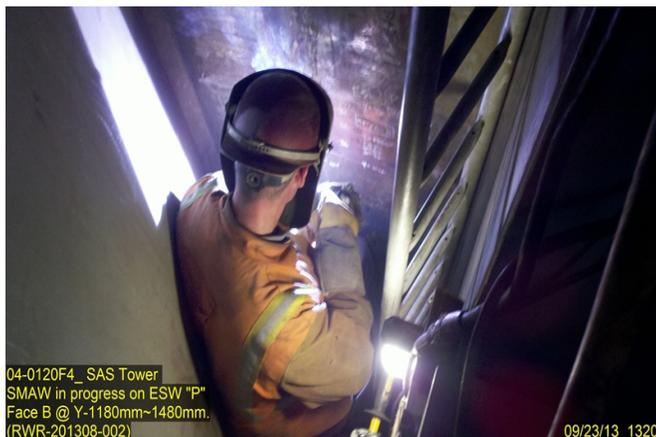
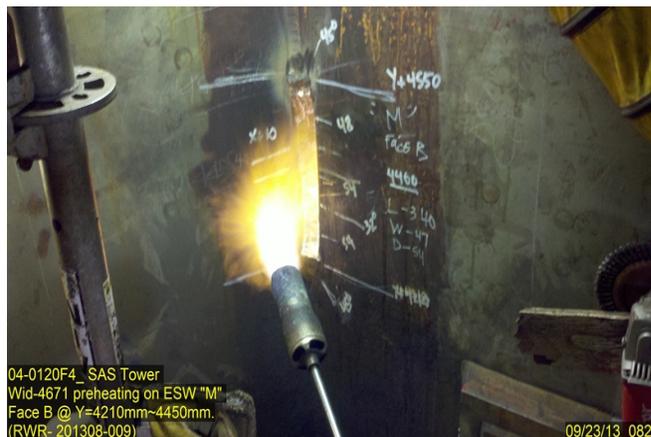
The QA Inspector observed ABF welder Mike Jimenez (WID-4671) performing Shield Metal Arc Welding (SMAW) on the repair excavation of Electroslag Weld (ESW) "M" Face B @ Original Y-4400mm. Location of the repair is as follows:

Repair excavation (Y=-4210mm~4450mm) L=340mm, W-47mm, D-54mm.

Prior to welding, Mr. Jimenez was observed preheating the weld to over 300° Fahrenheit using the Miller ProHeat 35 with heat induction blankets and a propylene torch. Mr. Jimenez used a temperature indicator. The welding electrode in use was 4.0mm diameter electrode (E7018-1 HR4) per ABF Welding Procedure Specification (WPS) ABF-WPS-D15-1000-Repair Rev.3. The welding process in use was the SMAW process. ABF QC Inspector Scott Kortum performed welding parameters verifications at random intervals throughout the shift and informed the QA Inspector that the average welding amps were at -177. The welding observed appeared to be in compliance with the WPS noted above. Welding at this location is approximately 60% complete.
