**DEPARTMENT OF TRANSPORTATION**

Contract #: 04-0120F4Cty: SF/ALA Rte: 80 PM: 13.2/13.9File #: 1.28**WELDING INSPECTION REPORT****Resident Engineer:** Casey, William**Address:** 333 Burma Road**City:** Oakland, CA 94607**Report No:** WIR-030067**Date Inspected:** 20-Sep-2013**Project Name:** SAS Superstructure**OSM Arrival Time:** 700**Prime Contractor:** American Bridge/Fluor Enterprises, a JV**OSM Departure Time:** 1730**Contractor:** American Bridge/Fluor Enterprises, a JV**Location:** Job Site**CWI Name:** Scott Kortum**CWI Present:** Yes No**Inspected CWI report:** Yes No N/A**Rod Oven in Use:** Yes No N/A**Electrode to specification:** Yes No N/A**Weld Procedures Followed:** Yes No N/A**Qualified Welders:** Yes No N/A**Verified Joint Fit-up:** Yes No N/A**Approved Drawings:** Yes No N/A**Approved WPS:** Yes No N/A**Delayed / Cancelled:** Yes No N/A**Bridge No:** 34-0006**Component:** SAS Tower**Summary of Items Observed:**

ESW Repair Welding/Excavation

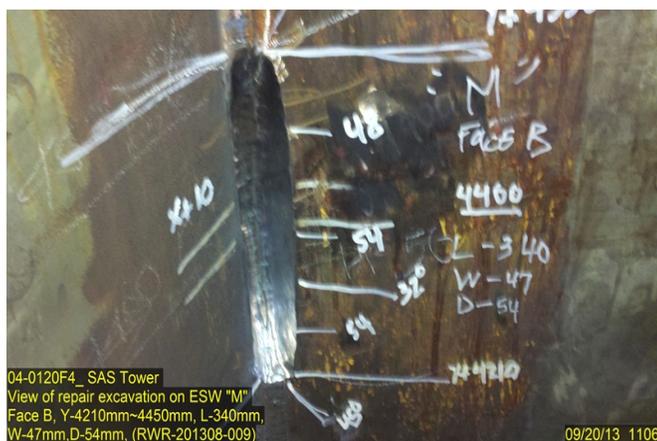
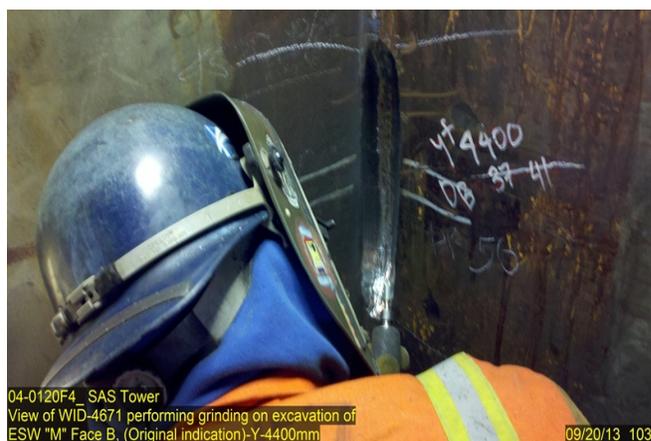
The QA Inspector observed ABF welder Mike Jimenez (WID-4671) performing excavation of ESW "M" at Face B, Y= 4400mm to verify indications observed during Ultrasonic Testing with pulse/echo & pitch/catch. Mr. Jimenez was performing the excavation using an air carbon arc gouging and a grinder. Mr. Jimenez was instructed by ABF QC Inspector Scott Kortum to notify him when indications are visible to allow QC/QA time to inspect the excavation. The repair location was noted as:

Weld excavated at: D=30mm- No indications observed.

Weld excavated at: D=50mm- No indications observed.

Excavation Length: (Y-4210mm~4450mm) L=340mm

After grinding to bright metal the QC Inspector performed Magnetic Particle Testing (MT) of the final excavation. The QC Inspector stated the excavation appears to be free of discontinuities and he would complete ABF daily inspection report and magnetic particle testing report to detail the findings. ABF Field Engineer Eric Blue informed the QA Inspector that he had given approval to commence the repair welding at this location. The QA Inspector also performed an MT verification of the final excavation. See TL-6028 for additional details on items inspected on this date. Mr. Jimenez was later observed setting up the Miller ProHeat 35 induction blankets at the repair location in preparation for SMAW of the repair excavation.
