DEPARTMENT OF TRANSPORTATION

Office of Structural Materials

Contract #: 04-0120F4Cty: SF/ALA Rte: 80 PM: 13.2/13.9File #: 99.28**WELDING INSPECTION REPORT****Resident Engineer:** Casey, William**Address:** 333 Burma Road**City:** Oakland, CA 94607**Report No:** WIR-030069**Date Inspected:** 18-Sep-2013**Project Name:** SAS Superstructure**OSM Arrival Time:** 700**Prime Contractor:** American Bridge/Fluor Enterprises, a JV**OSM Departure Time:** 1730**Contractor:** American Bridge/Fluor Enterprises, a JV**Location:** Job Site

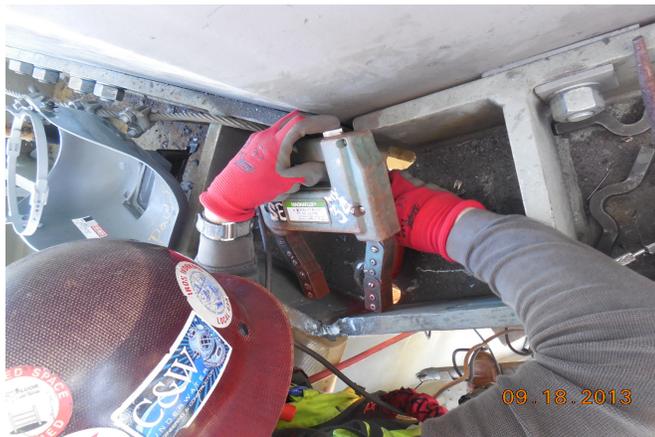
The welding procedure specification (WPS) #ABF-WPS-D15-2030-3 for flux core arc welding (FCAW) was available for reference on site by QC Inspectors. QC Inspector verified electrical welding parameters at the start of shift and randomly until the end of shift. The weld backing was removed by air arc and the weld was back gouged to sound material. QC inspected the back gouged weld areas with MT and VT. The back gouged web was welded with shielded metal arc weld (SMAW) procedure ABF-WPS-D15-1110B. Weld crowns were ground to a smooth contour. Upon cooling to ambient temperature QC Inspector performed VT, MT and UT on web and flange, all test results are in general compliance.

QC MT of ring beam back gouged root areas.

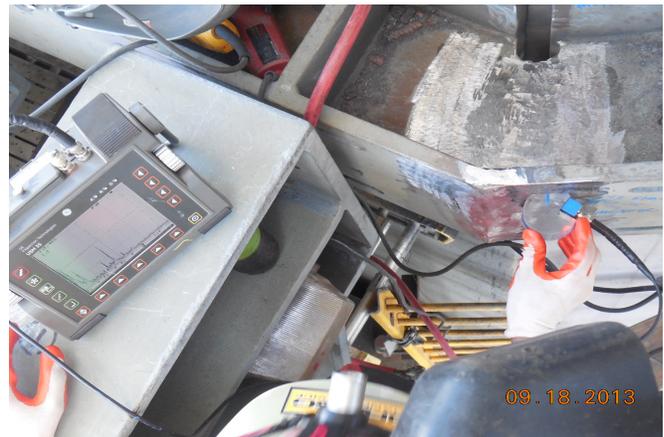
QC UT of ring beam web and flange ground flush.
