DEPARTMENT OF TRANSPORTATION

Contract #: 04-0120F4Cty: SF/ALA Rte: 80 PM: 13.2/13.9File #: 99.28**WELDING INSPECTION REPORT**

Report No: WIR-030076
Date Inspected: 26-Sep-2013

Project Name: SAS Superstructure **OSM Arrival Time:** 700
Prime Contractor: American Bridge/Fluor Enterprises, a JV **OSM Departure Time:** 1530
Contractor: Steward Machine Co. **Location:** Birmingham, AL

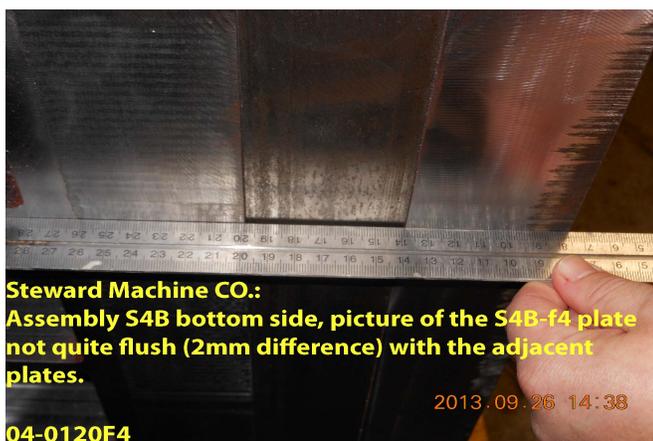
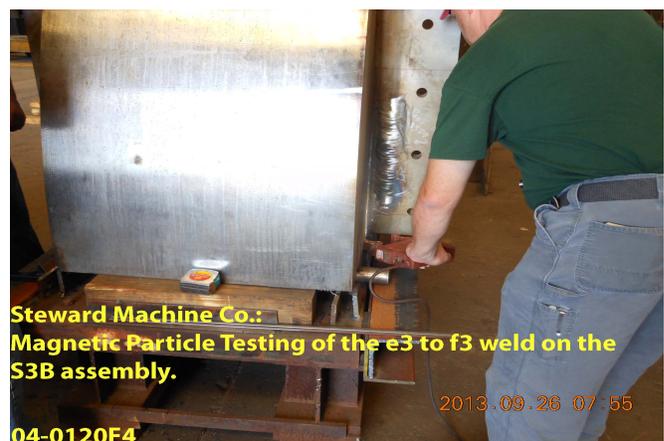
While performing the Magnetic Particle Test on the S4B assembly the QA Inspector noted that welds for the strap to the e3 plate were not ground flush. The QAI asked the QCI if the welds were to be ground flush at a later time and was informed by the QCI that the welds will not be ground flush due to inaccessibility posed by the S3 round

bars in the way. The QAI informed the QCI that an NCR will be submitted for the welds not ground flush as per drawings.

The QAI also noted that the f3 plate was not flush with the adjacent e3 and g3 plates of assembly S4B. The plate was recessed below the adjacent plates by 2mm. The QAI informed the QCI of the issue and was informed by QCI that he was aware of the issues and that an NCMR was being submitted for the assembly.
