DEPARTMENT OF TRANSPORTATION

Contract #: 04-0120F4Cty: SF/ALA Rte: 80 PM: 13.2/13.9File #: 1.28**WELDING INSPECTION REPORT****Resident Engineer:** Casey, William**Address:** 333 Burma Road**City:** Oakland, CA 94607**Report No:** WIR-030082**Date Inspected:** 02-Oct-2013**Project Name:** SAS Superstructure**OSM Arrival Time:** 700**Prime Contractor:** American Bridge/Fluor Enterprises, a JV**OSM Departure Time:** 1730**Contractor:** American Bridge/Fluor Enterprises, a JV**Location:** Job Site**CWI Name:** Bernie Docena, Jesse Cayabyab**CWI Present:** Yes No**Inspected CWI report:** Yes No N/A**Rod Oven in Use:** Yes No N/A**Electrode to specification:** Yes No N/A**Weld Procedures Followed:** Yes No N/A**Qualified Welders:** Yes No N/A**Verified Joint Fit-up:** Yes No N/A**Approved Drawings:** Yes No N/A**Approved WPS:** Yes No N/A**Delayed / Cancelled:** Yes No N/A**Bridge No:** 34-0006**Component:** SAS Tower**Summary of Items Observed:**

ESW Repair Welding

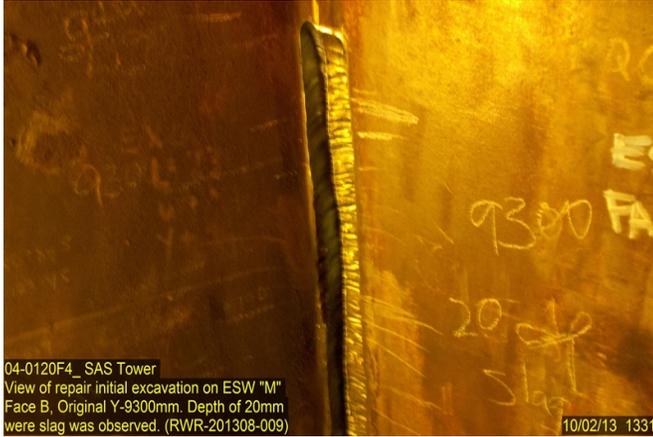
The QA Inspector later observed ABF welder Mike Jimenez (WID-4671) performing excavation of ESW "M" at Face B, Y= 9300mm to verify indications observed during Ultrasonic Testing with pulse/echo & pitch/catch. Mr. Jimenez was performing the excavation using an air carbon arc gouging and a grinder. Mr. Jimenez was instructed by ABF QC Inspector Jesse Cayabyab to notify him when indications are visible to allow QC/QA time to inspect the excavation.

Weld excavated at: D=20mm- Slag observed.

Weld excavated at: D=25mm- Slag observed.

Weld excavated at: D=32 mm- Slag observed.

Current excavation length is 8790mm~9480mm.
