Contract #: 04-0120F4Cty: SF/ALA Rte: 80 PM: 13.2/13.9File #: 1.28**WELDING INSPECTION REPORT**

Report No: WIR-030083
Date Inspected: 01-Oct-2013

Project Name: SAS Superstructure **OSM Arrival Time:** 700
Prime Contractor: American Bridge/Fluor Enterprises, a JV **OSM Departure Time:** 1730
Contractor: American Bridge/Fluor Enterprises, a JV **Location:** Job Site

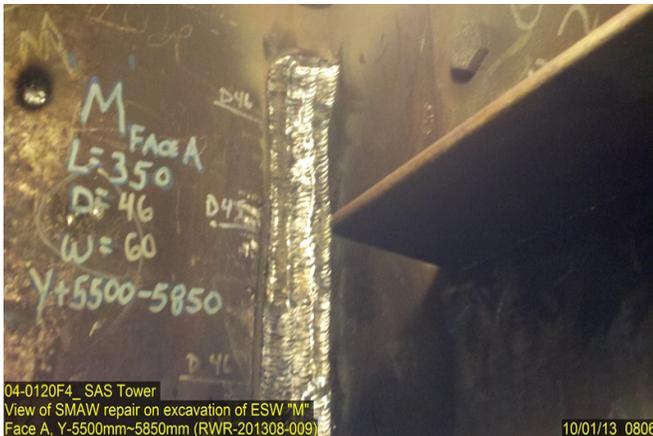
ESW W-042, Location "M"-Face A:

The QA Inspector observed ABF welder Mike Jimenez (WID-4671) performing Shield Metal Arc Welding (SMAW) on the repair excavation of Electroslag Weld Electroslag Weld (ESW) "M" Face A @ Original Y's-5670mm, 5700mm & 5720mm. Location of this repair is as follows: Excavation length (Y-5500mm~5850mm) L-350mm, W-60mm, D-46mm

Prior to welding, Mr. Jimenez was observed preheating the weld to over 300° Fahrenheit using the Miller ProHeat 35 with heat induction blankets and a propylene torch. The welder was using 4.0mm diameter electrode (E7018-1 HR4) per ABF Welding Procedure Specification (WPS) ABF-WPS-D15-1000-Repair Rev.3. The welding process in use was the SMAW process. ABF QC Inspector Bernie Docena performed welding parameters verifications and checked preheat at random intervals throughout the shift. The QA Inspector also verified the preheat with a 300° F. temperature indicator. Welding was approximately 75% complete at this location on this date.
