DEPARTMENT OF TRANSPORTATION

Contract #: 04-0120F4Cty: SF/ALA Rte: 80 PM: 13.2/13.9File #: 1.28**WELDING INSPECTION REPORT****Resident Engineer:** Casey, William**Address:** 333 Burma Road**City:** Oakland, CA 94607**Report No:** WIR-030084**Date Inspected:** 30-Sep-2013**Project Name:** SAS Superstructure**OSM Arrival Time:** 700**Prime Contractor:** American Bridge/Fluor Enterprises, a JV**OSM Departure Time:** 1730**Contractor:** American Bridge/Fluor Enterprises, a JV**Location:** Job Site**CWI Name:** Bernie Docena, Jesse Cayabyab**CWI Present:** Yes No**Inspected CWI report:** Yes No N/A**Rod Oven in Use:** Yes No N/A**Electrode to specification:** Yes No N/A**Weld Procedures Followed:** Yes No N/A**Qualified Welders:** Yes No N/A**Verified Joint Fit-up:** Yes No N/A**Approved Drawings:** Yes No N/A**Approved WPS:** Yes No N/A**Delayed / Cancelled:** Yes No N/A**Bridge No:** 34-0006**Component:** SAS Tower**Summary of Items Observed:**

ESW Repair Excavation

RWR-201308-009

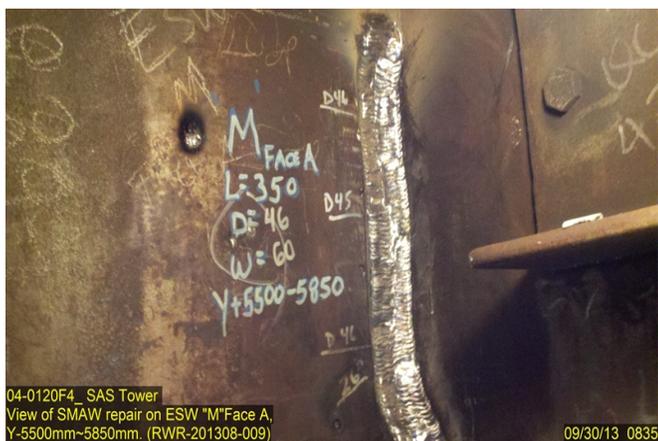
ESW W-042, Location "M"-Face A:

The QA Inspector observed ABF welder Mike Jimenez (WID-4671) performing Shield Metal Arc Welding (SMAW) on the repair excavation of Electroslag Weld Electroslag Weld (ESW) "M" Face A @ Original Y's-5670mm, 5700mm & 5720mm. Location of this repair is as follows:

Excavation length (Y-5500mm~5850mm) L-350mm, W-60mm, D-46mm

Prior to welding, Mr. Jimenez was observed preheating the weld to over 300° Fahrenheit using the Miller ProHeat 35 with heat induction blankets and a propylene torch. The welder was using 4.0mm diameter electrode (E7018-1 HR4) per ABF Welding Procedure Specification (WPS) ABF-WPS-D15-1000-Repair Rev.3. The welding process in use was the SMAW process. ABF QC Inspector Bernie Docena performed welding parameters verifications and checked preheat at random intervals throughout the shift. The QA Inspector also verified the preheat with a 300° F. temperature indicator. The QA Inspector and the QC Inspector also discussed the importance of avoiding arc strikes with the welder. Mr. Jimenez stated that he unintentionally had caused a few arc strikes due to the restricted location of the repair. The QC Inspector also stated that upon completion of all welding at this repair location the arc strikes will be ground out and magnetic particle testing (MT) will be performed in the area of concern.

Welding was approximately 50% complete at this location on this date.
