DEPARTMENT OF TRANSPORTATION

Quality Assurance and Source Inspection

Contract #: 04-0120F4Cty: SF/ALA Rte: 80 PM: 13.2/13.9File #: 78.28**WELDING INSPECTION REPORT****Resident Engineer:** Casey, William**Address:** 333 Burma Road**City:** Oakland, CA 94607**Report No:** WIR-030089**Date Inspected:** 30-Sep-2013**Project Name:** SAS Superstructure**OSM Arrival Time:** 700**Prime Contractor:** American Bridge/Fluor Enterprises, a JV**OSM Departure Time:** 1530**Contractor:** Steward Machine Co.**Location:** Birmingham, AL

CWI Name:	Fred Hudson (Cert. #01061501)	CWI Present:	Yes	No
Inspected CWI report:	Yes No N/A	Rod Oven in Use:	Yes	No N/A
Electrode to specification:	Yes No N/A	Weld Procedures Followed:	Yes	No N/A
Qualified Welders:	Yes No N/A	Verified Joint Fit-up:	Yes	No N/A
Approved Drawings:	Yes No N/A	Approved WPS:	Yes	No N/A
		Delayed / Cancelled:	Yes	No N/A
Bridge No:	34-0006	Component:	E3 Shear Key Anchorages

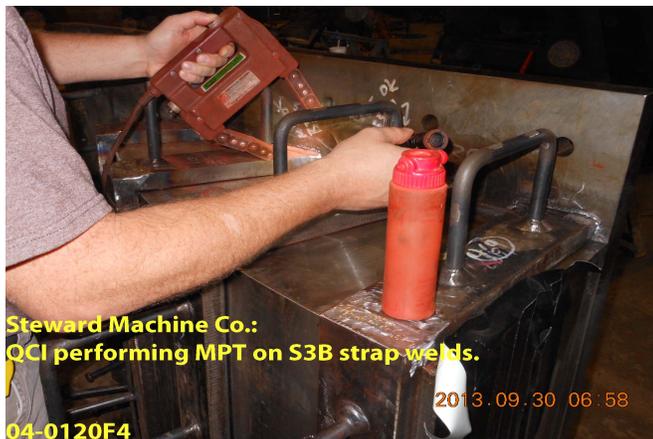
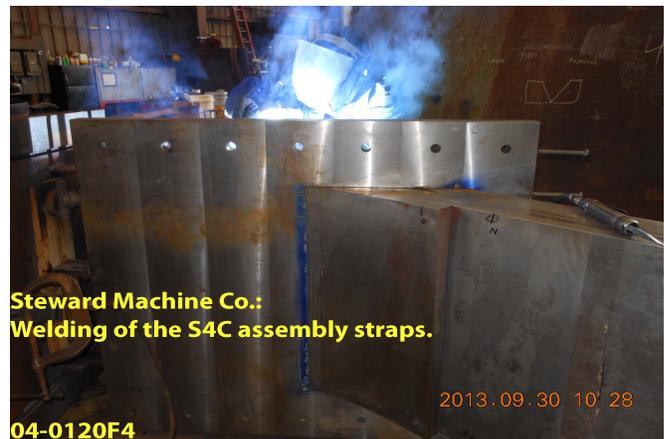
The assembly straps and S3 fillet welds at side A were MT inspected. Sikadur 35LV was reapplied to the bottom side of the assembly to fill a 10mm deep incomplete fill. After the Sikadur 35LV has cured the assembly was prepped for coating.

- Strap PJP Welds and S3 Fillet welds on side A. (MT acceptable. See TL-6028 for MT report)

- Final MT for the e4 to f4 weld at sides A & B. (MT acceptable. See TL-6028 for MT report)

- Root pass at Sides A & B straps. (MT acceptable. See TL-6028 for MT report)

While performing VT and MT of assembly S3B the QAI noted the bottom side gap was not completely filled to the top with the Sikadur 35LV. The QAI inquired of the QCI if he was aware of the issue and was informed he was and that the matter will corrected before painting of the assembly.
