Contract #: 04-0120F4Cty: SF/ALA Rte: 80 PM: 13.2/13.9File #: 1.28**WELDING INSPECTION REPORT**

Report No: WIR-030110
Date Inspected: 03-Oct-2013

Project Name: SAS Superstructure **OSM Arrival Time:** 700
Prime Contractor: American Bridge/Fluor Enterprises, a JV **OSM Departure Time:** 1730
Contractor: American Bridge/Fluor Enterprises, a JV **Location:** Job Site

Ultrasonic Testing of Electroslag Welds (ESW) Repair

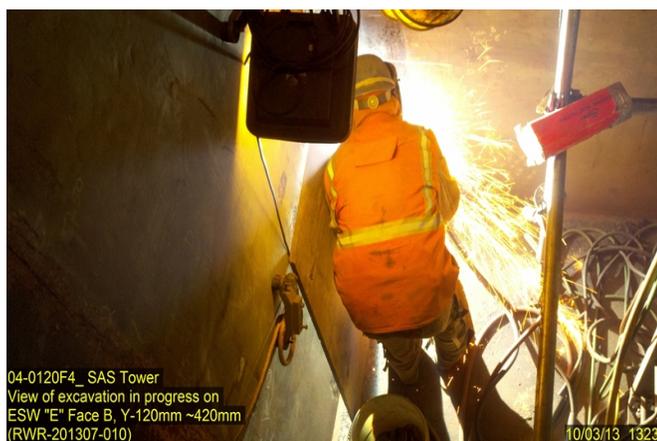
ESW N-045, Location "E"-Face B:

The QA Inspector observed that ABF welders Rick Clayborn (WID-2773) and Kit Lai (WID-2953) have commenced excavation of Electroslag Weld (ESW) "E" at Face B. The weld is being excavated full length of Face B due to multiple indications remaining from previous unsuccessful weld repair attempts. The work is described in Request for Weld Repair (RWR) 201308-009 and has been approved in ABF Request for Information (RFI) 003388R00. The excavation locations were preheated to 350° Fahrenheit prior to the work being performed with the Miller Proheat 35 induction system with dual heating blankets at Face a & Face C. per RWR-201307-010, the specified preheat of 107°C. / 350°F. would be applied at the start of excavation and held continuously for the entire length of the excavation until welding is complete. Mr. Clayborn and Mr. Lai were performing the excavation using an air carbon arc gouging and grinders at "Y" locations 120mm ~420mm & 9550mm~9850mm. Depth of the excavations observed was approximately 10mm by 40mm wide. On this date initial excavation work continued until the end of the shift. The QA Inspector was informed by ABF QC Inspector Bernie Docena that proheat will maintain the preheat continuously throughout the night until work excavation work continues on 10-04-13.
