Contract #: 04-0120F4Cty: SF/ALA Rte: 80 PM: 13.2/13.9File #: 99.28**WELDING INSPECTION REPORT**

Report No: WIR-030111
Date Inspected: 03-Oct-2013

Project Name: SAS Superstructure **OSM Arrival Time:** 700
Prime Contractor: American Bridge/Fluor Enterprises, a JV **OSM Departure Time:** 1730
Contractor: American Bridge/Fluor Enterprises, a JV **Location:** Job Site

CWI Name:	Tony Sherwood, Bernie Docena			CWI Present:	Yes	No	
Inspected CWI report:	Yes	No	N/A	Rod Oven in Use:	Yes	No	N/A
Electrode to specification:	Yes	No	N/A	Weld Procedures Followed:	Yes	No	N/A
Qualified Welders:	Yes	No	N/A	Verified Joint Fit-up:	Yes	No	N/A
Approved Drawings:	Yes	No	N/A	Approved WPS:	Yes	No	N/A
				Delayed / Cancelled:	Yes	No	N/A
Bridge No:	34-0006			Component:	SAS Tower

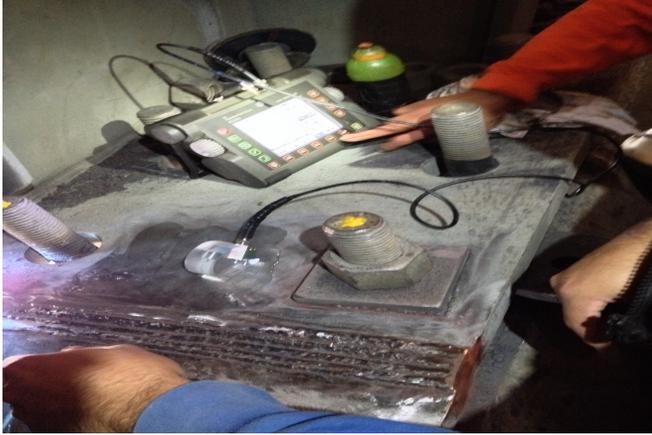
At skirt plate #2 vertical weld seam #156 W. Shaft the weld reinforcing was ground flush by ABF personnel. At weld #156 W. Shaft, QAI observed QCI performed VT as required and MT of 25% of weld face. Inspection at 1400 hour. QCI deemed test results acceptable. QAI observed at skirt base plate #001, ABF personnel removed the weld run-off tabs and ground the ends of weld flush with the tips of base plate, using carbon air-arc and grinding wheel. The weld crown (1.5mm) at base plate #001 remains in the as welded condition. Weld spatter was removed from face A to facilitate non-destructive testing (NDT). QA Inspector observed QCI Tony Sherwood perform 100% VT and MT of weld #001 including the weld ends, inspection at 1500 hour. QC deemed test results acceptable. QA Inspector observed QCI Bernie Docena, perform UT inspection on 25% of CJP weld #001, QC deemed results acceptable. Inspection at 1600 hour. After observing QCI perform the specified visual and non-destructive testing noted above, QA Inspector performed verification VT, MT and UT on approximately 10% of QC inspected areas. QA test results are in general compliance with project specifications. Reference QA NDT reports for more details.

QC 25% UT of base plate CJP weld #001.

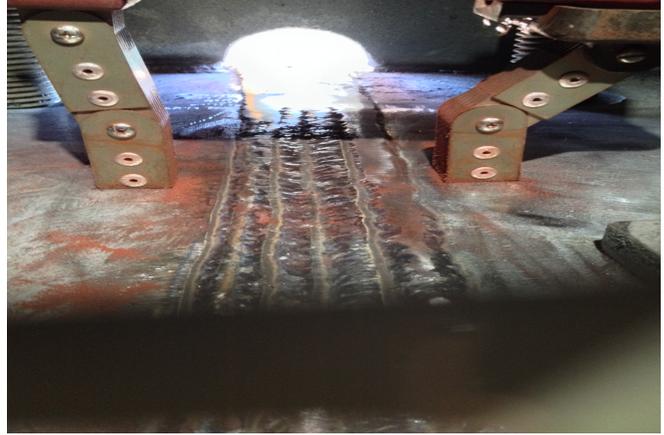
QC MT full length of CJP base plate weld #001.
