A Report on the Corrosion of Prestressing Steel During Fabrication and Curing of Post-Tensioned Concrete

January 1960

State of California
Department of Public Works
Division of Highways
Materials and Research Department

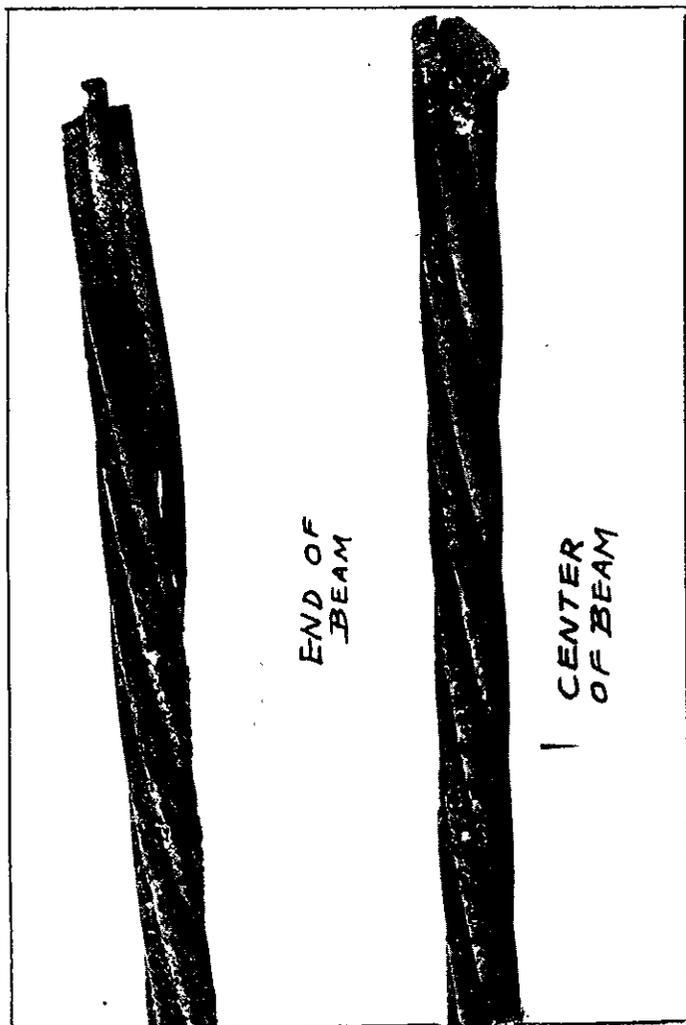
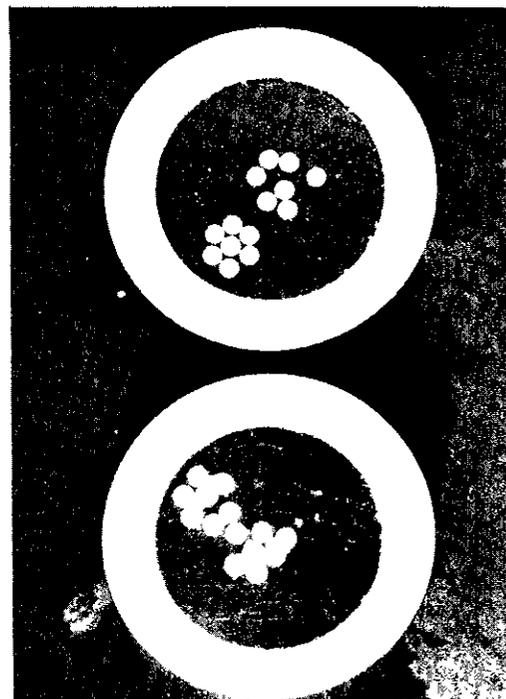
3/8" 7 Wire Strand

The above left specimen shows heavy corrosion. Each strand was corroded mainly on the outer surface with little corrosion on the inside. The picture on the right shows the mounting used to hold the specimen for microscopic inspection. Four different cross-sectional cuts were made across the same wire strand specimen.

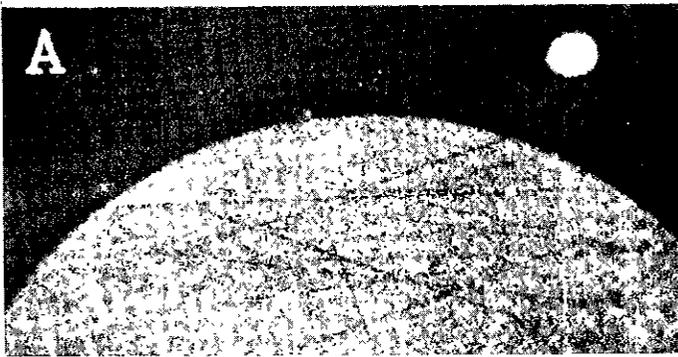
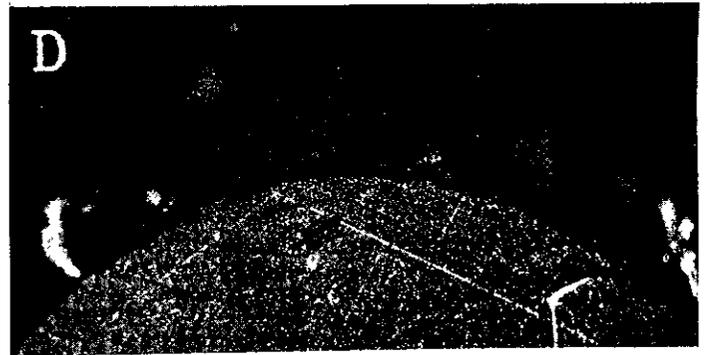
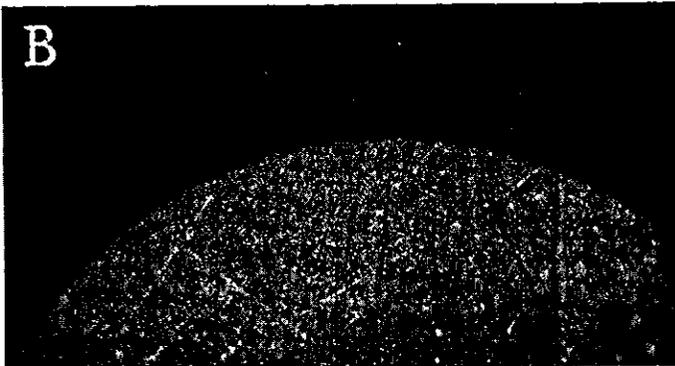
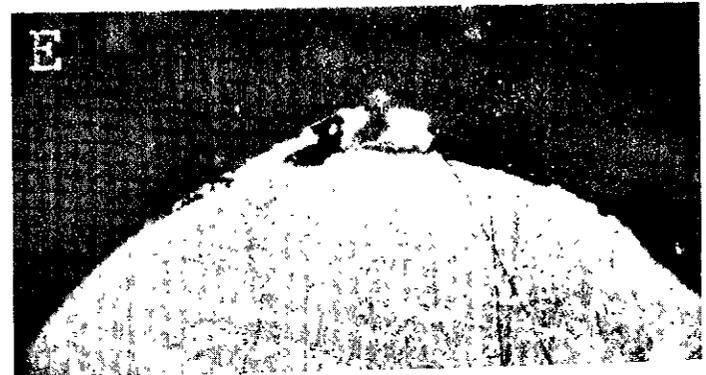
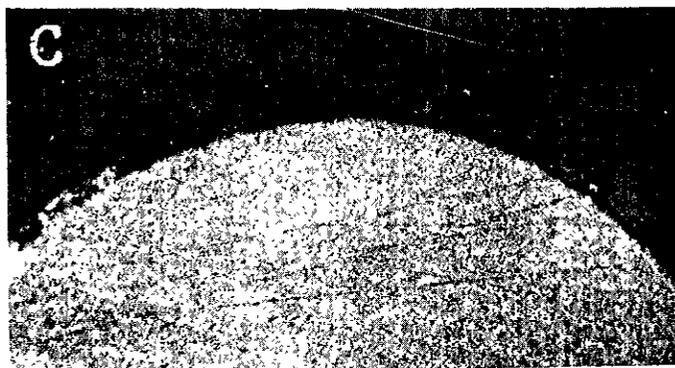
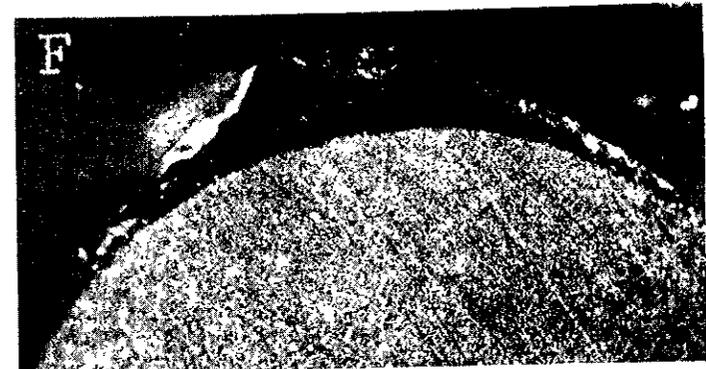
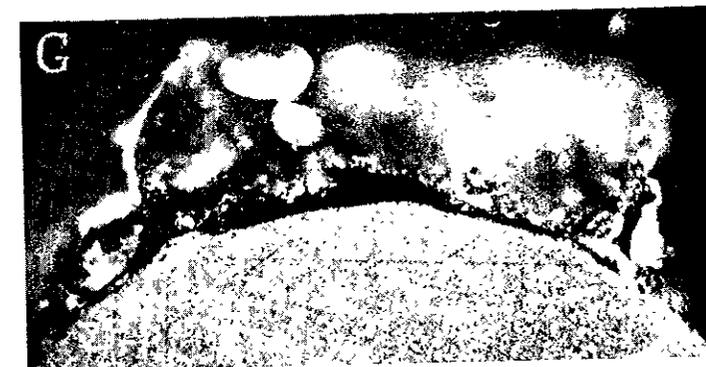
3/8" Wire Strand - 36 Diameters

The above are typical examples of the surface from a cross-sectional view. The white and black layers on the circumference of the wire are oxides. The white spots in the epoxy above the wire are either bubbles or foreign material embedded in the epoxy. Figures A and B exhibit no corrosion. Figure C exhibits mild corrosion. Figures D and E exhibit moderate corrosion. Figures F and G exhibit heavy rusting.

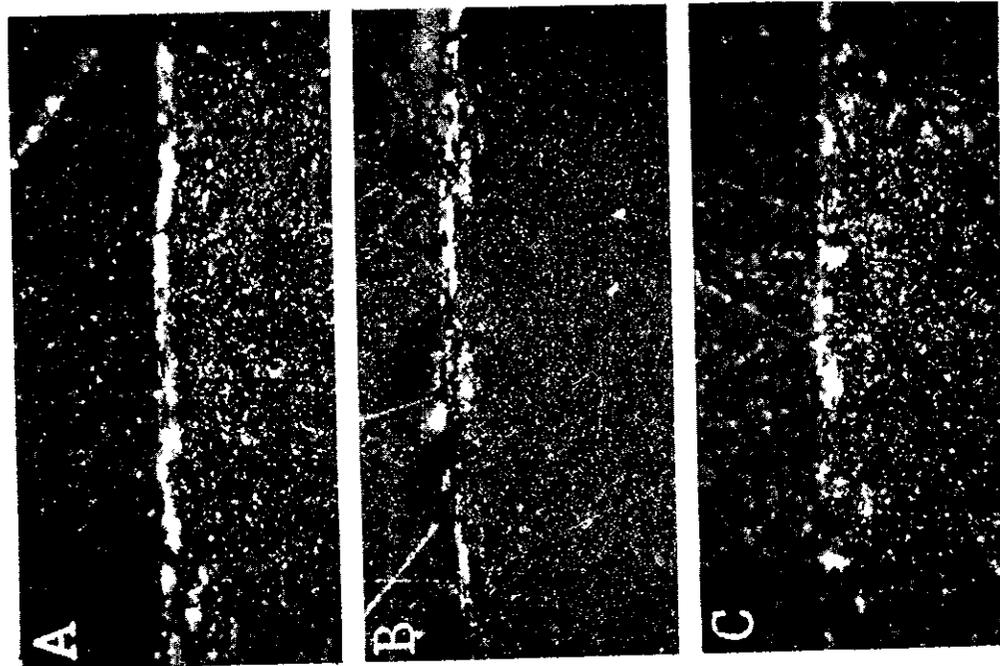
1 1/8" High-Tensile Rod

Above is the specimen in actual size showing corrosion on its surface. In general the rusting is heavy and uniformly distributed with the exception of concentrations as exhibited in the lower middle of the bar.

To the left are cross-section photographs of the above bar at approximately 110 diameters. The bright white band across the middle is oxide and the occasional black patches below the band are black oxides. Above the band is the base metal. The shiny white spots in the epoxy and in the base metal are embedded impurities and not iron oxide.

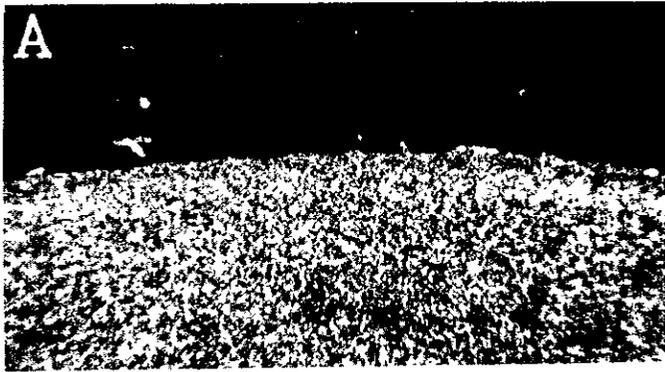
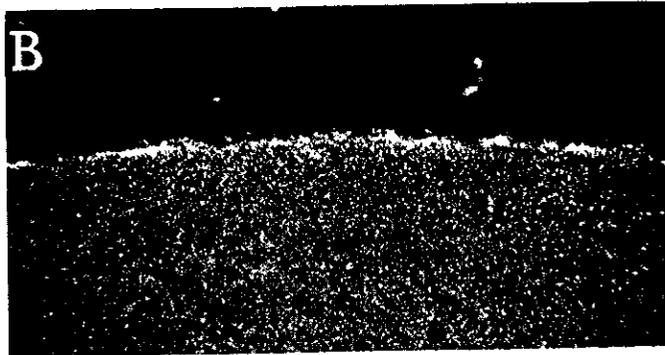
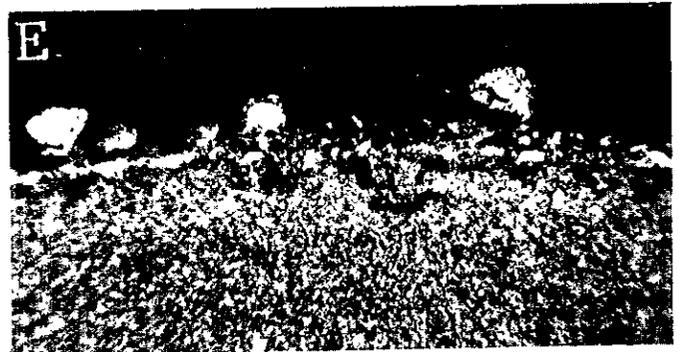
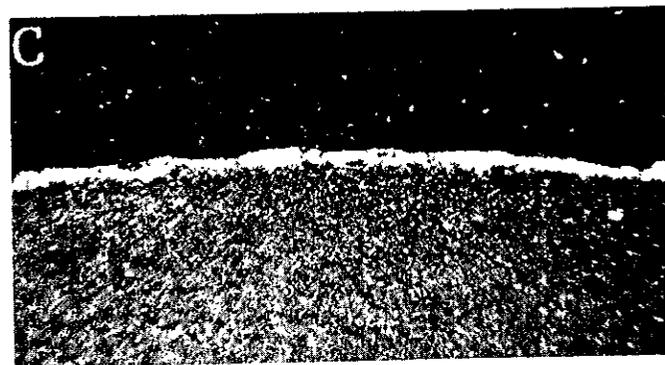
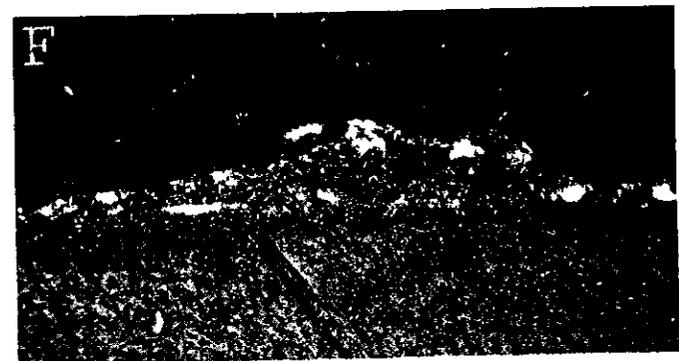
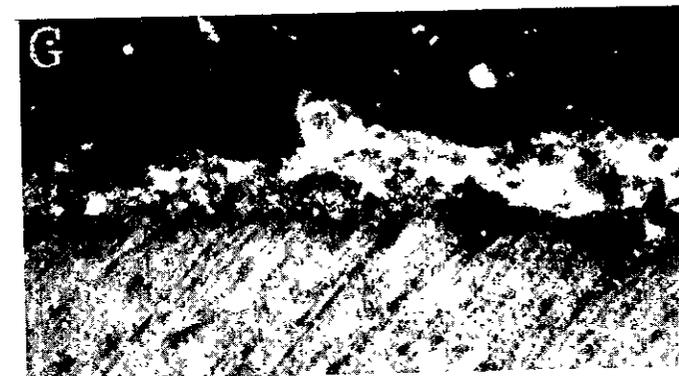
0.276" Wire at 130 Diameters

Figures A, B, and C - Exhibit negligible, light, and mild corrosion respectively. Figures D, E, F, and G - Exhibit heavy corrosion.

The above are typical examples of the surface from a cross sectional view. The black region in the top portion of each picture is the epoxy plastic which surrounds the wires. The bright specks in the plastic are either bubbles or foreign material which was lodged in during the grinding and lapping process. The oxides are plainly seen between the plastic and the base metal. They show up white, dark gray, or black depending on the type of oxide.

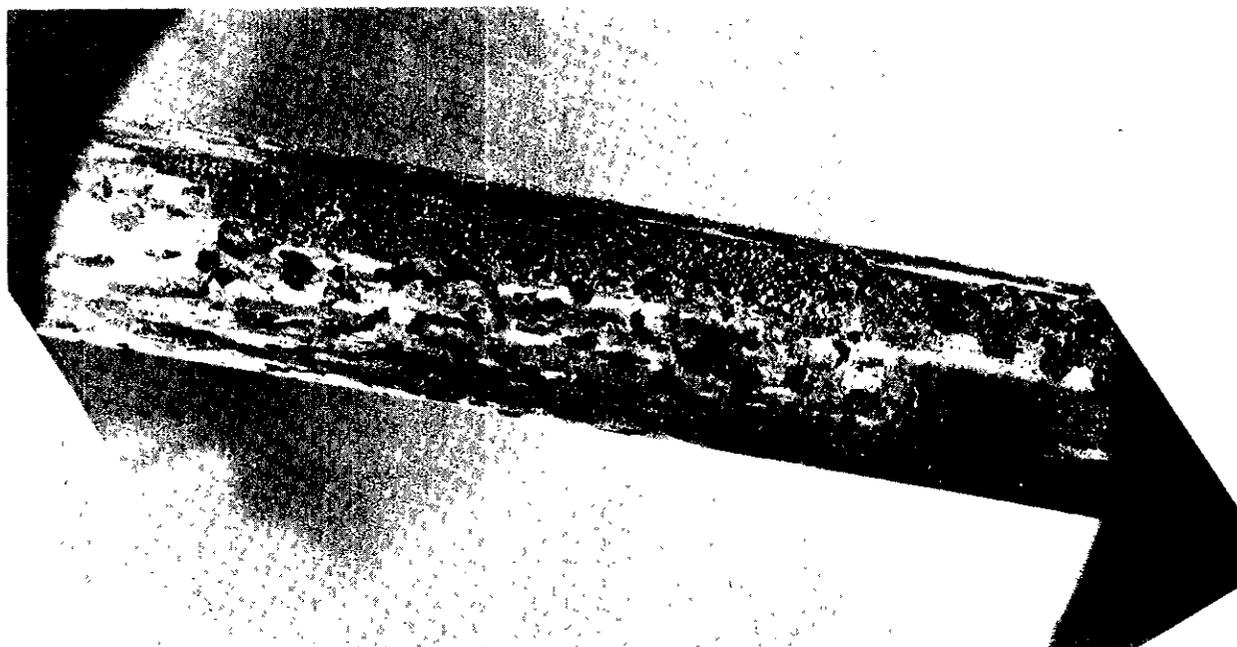
Wire #11, Exhibit VI-A, shows a specimen that was taken from a group of wires exposed to live steam for 18 hours in an investigation at Ryerson Steel Company in January 1959.

Wire #10, Exhibit VI-B, is a 0.250" diameter wire extracted from the Paso Robles Overcrossing approximately 3 years ago. These girders were cast in place and water cured for 21 days. The wire had not been in the structure for more than 30 days total and was removed 21 days after the concrete was cast but before being stressed. It therefore appears that most of the corrosion should be considered as occurring during the water cure.

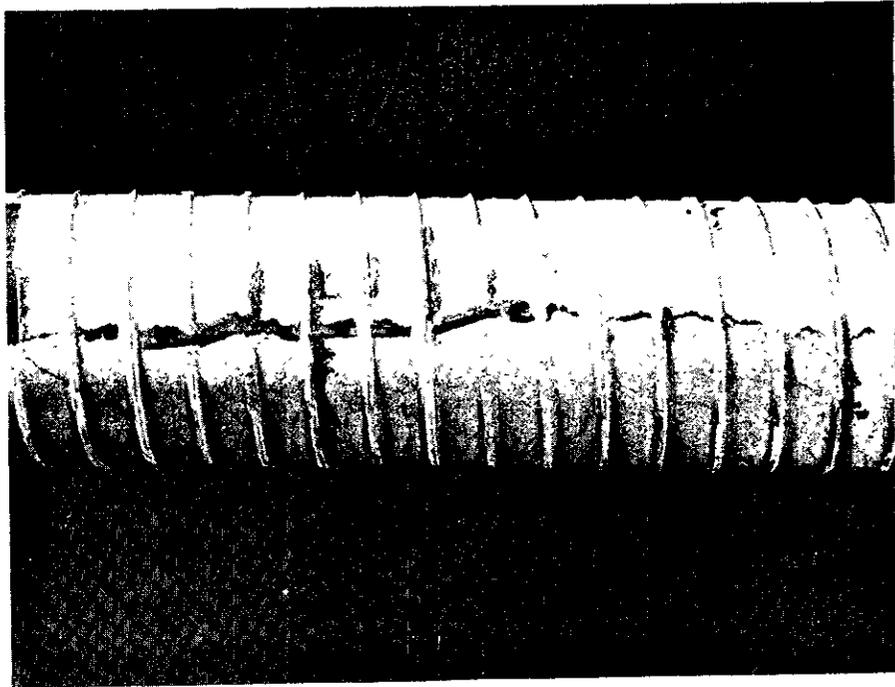
Exhibit VII-A and B are photographs of 1 1/8" diameter post-tensioned, post grouted stressing steel removed from a bridge girder that had been in service for approximately 5 years. The grouting tube has been removed, exposing the incomplete grout fill in the tube. A small amount of rusting has occurred and shows as a dark contrast in the grout.
