## Appendix H Project Photographs (Existing and Proposed)

### Photos of Existing Conditions

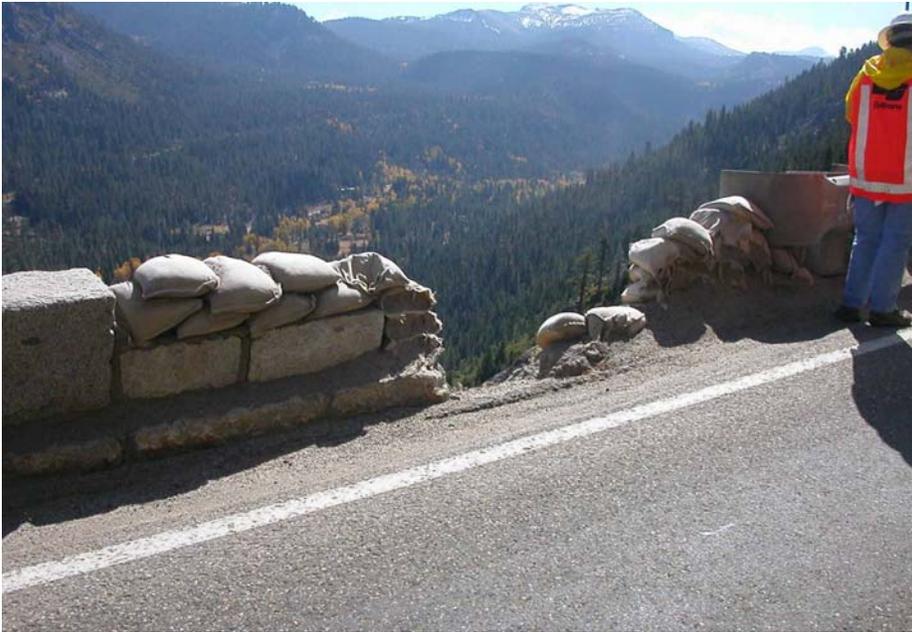
**Photo 9. Meyers Grade Sidehill, damage at south end, view southeast (DSCN1885).**

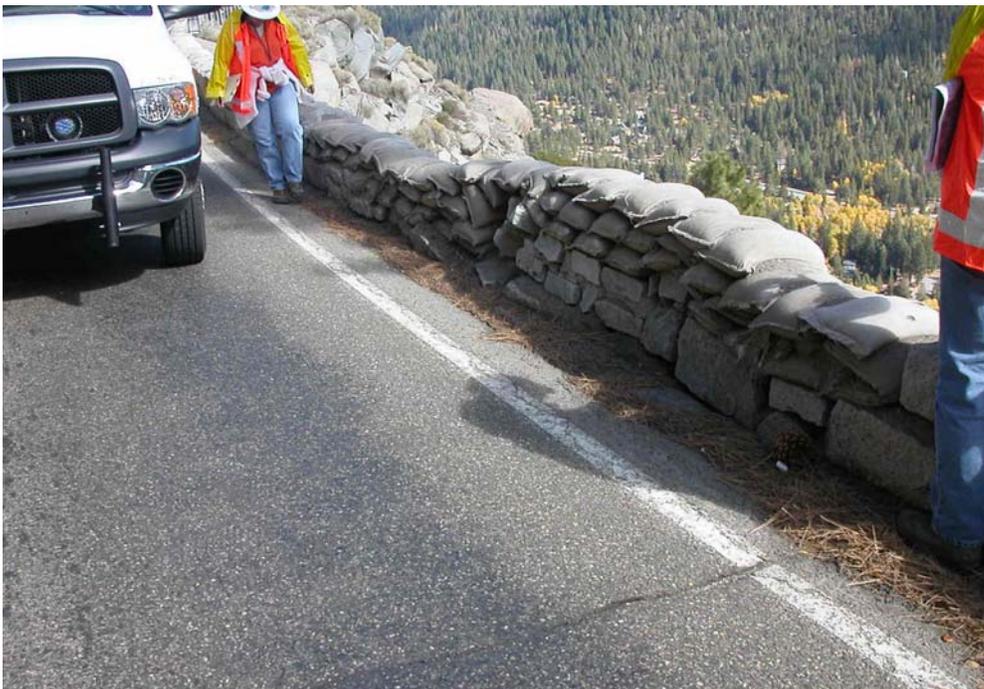
**Photo 12. Lauren's Lookout Sidehill, damage at midpoint, view northeast (DSCN1888).**
