# **INFORMATION HANDOUT**

**For Contract No. 03-1F2604**

**DISTRICT PRELIMINARY GEOTECHNICAL REPORT, JUNE 20, 2013**

File: 03-SIE-89-PM 0.8 & 1.45  
03-1F260, 0312000004  
Wildlife Under Crossings

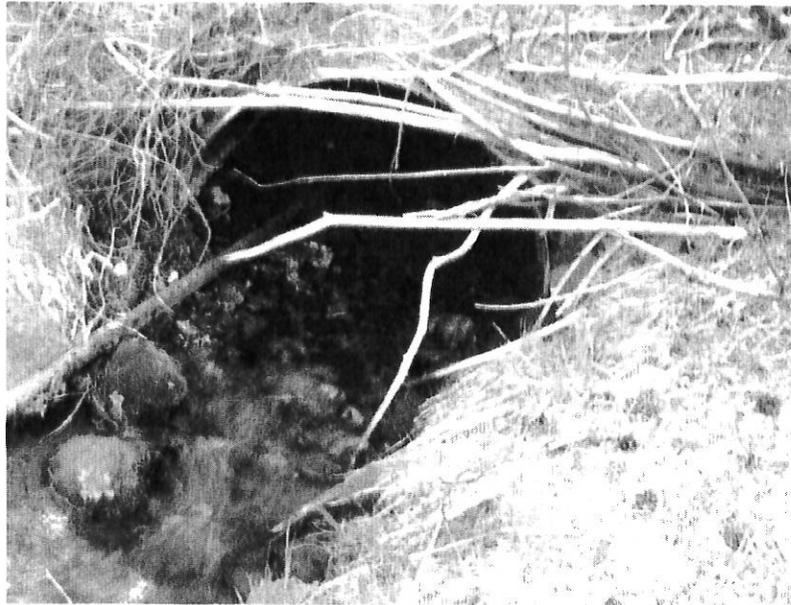
One perennial creek and one intermittent creek, tributaries of the Little Truckee River, cross under the project interval through the culverts previously mentioned in section Man-Made and Natural Features of Engineering and Construction Significance. The general direction of both creeks is west to east. The creek that crosses the roadway at PM 1.45 (see Photograph No. 1 at the end of this report) originates at a spring located outside of the project and is considered perennial.

Photo 1.- Perennial creek flowing out of culvert at PM 1.45

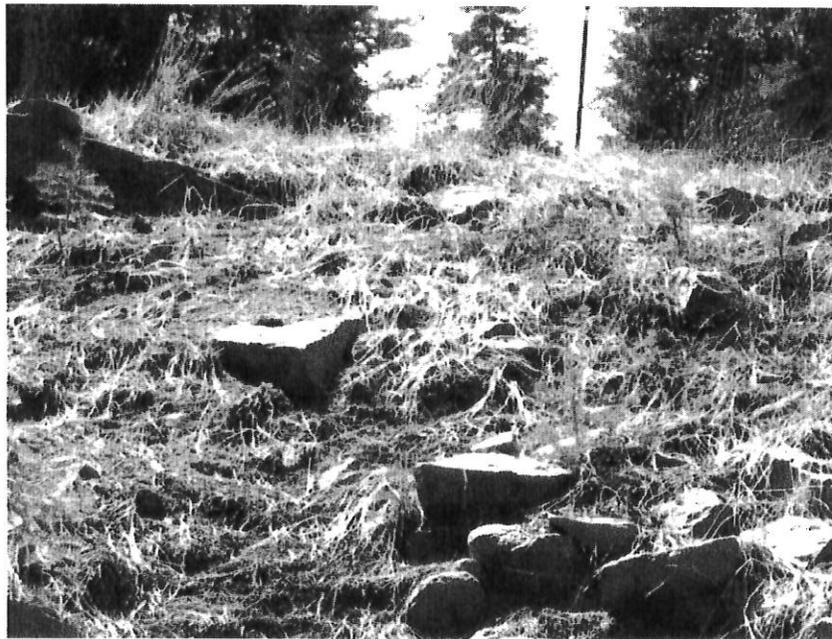
Based on our visual inspection of the soil and rock conditions on the surface of the existing slope, the fill at both locations appears to contain silty sand mixed with cobbles and boulders. The existing fill material is estimated to consist of the following geotechnical engineering properties: unit weight ( $\gamma$ ) of 125 lbs/ft<sup>3</sup>, cohesion ( $c$ ) of 250 lbs/ft<sup>2</sup>, and internal friction angle ( $\phi^\circ$ ) of 33°. The boulders on the surface of the existing slope are flat and elongated with an average length and width of 4 feet and average thickness of 1 foot. These boulders and cobbles are generally volcanic (mostly andesite) and are considered to be very hard (See Photograph No. 2 at the end of this report).

Photo 2.- Slope fill boulders at PM 0.85
