FOR CONTRACT NO.: 08-0P3504

INFORMATION HANDOUT

MATERIALS ENGINEERING FIELD INVESTIGATION WORKSHEET

Description of Work Cold in Place Recycle

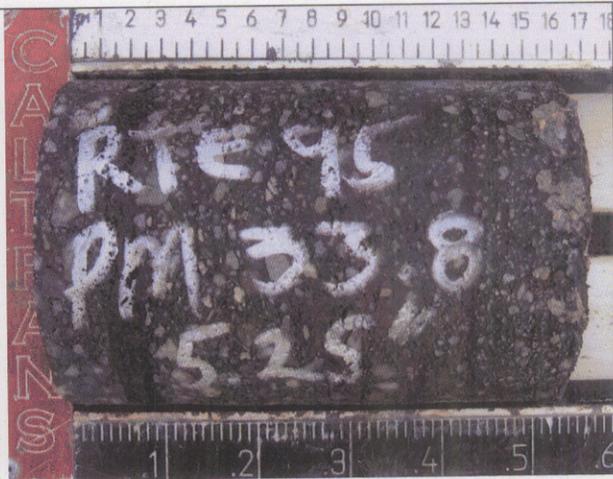
Rte 95 PM 33.8 Core = 0.525'

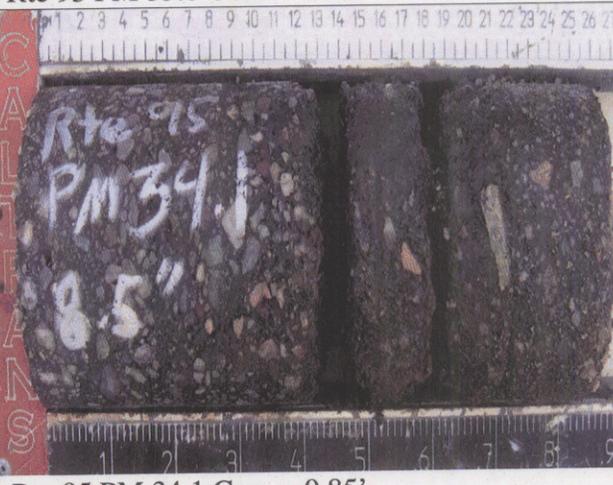
Rte 95 PM 34.1 Core = 0.85'

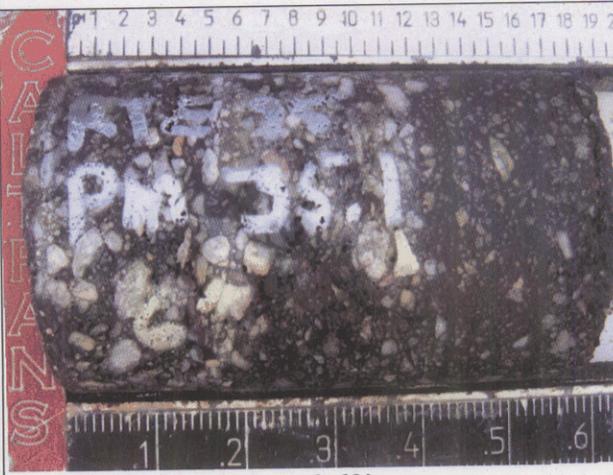
Rte 95 PM 35.1 Core = 0.60'

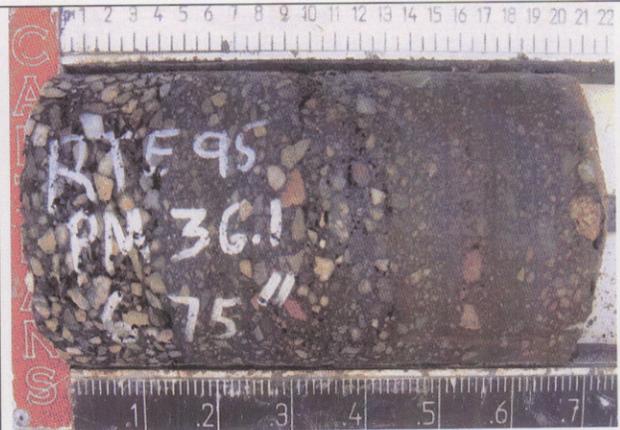
Rte 95 PM 36.1 Core = 0.675'

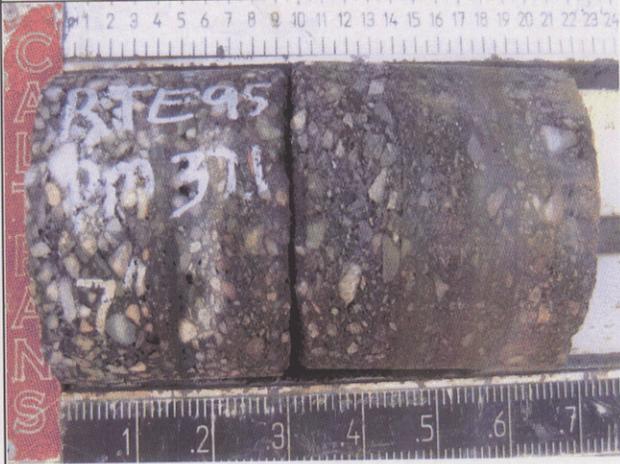
Rte 95 PM 37.1 Core = 0.70'

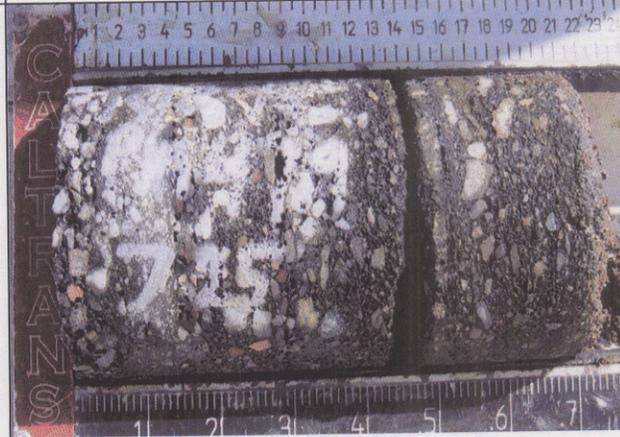
Rte 95 PM 47.9 Core = 0.725'

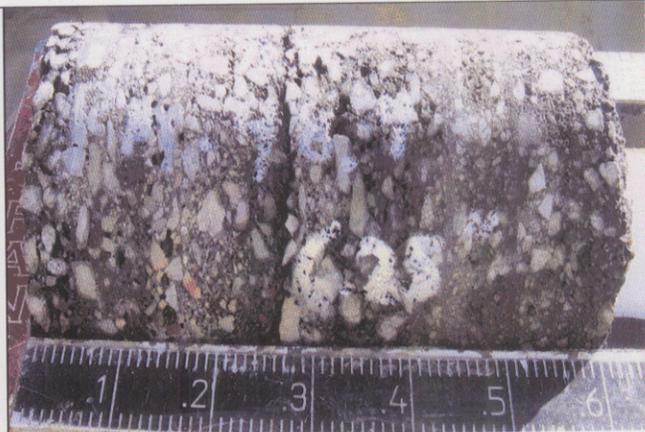
Rte 95 PM 48.9 Core = 0.625'

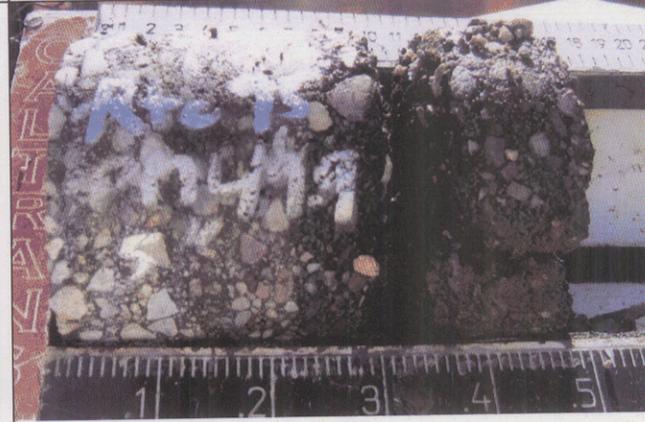
Rte 95 PM 49.9 Core = 0.50'

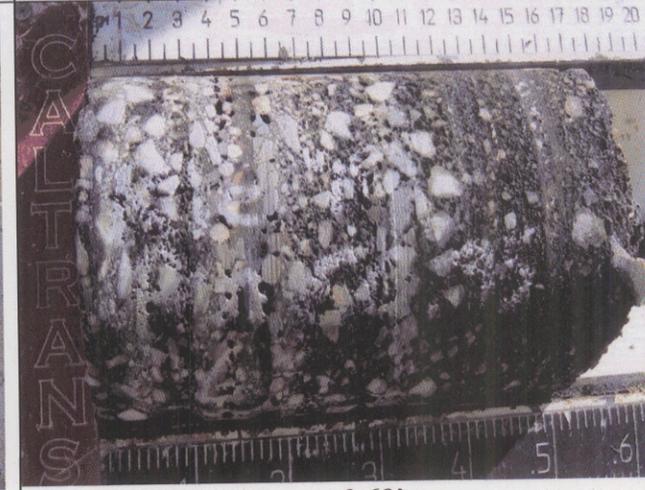
Rte 95 PM 50.95 Core = 0.60'

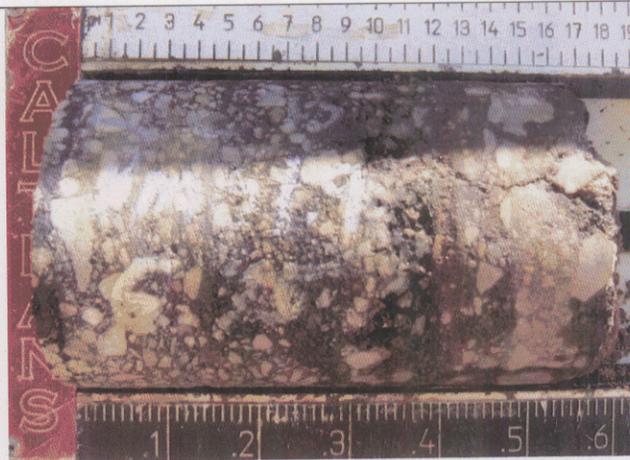
Rte 95 PM 51.9 Core = 0.575'

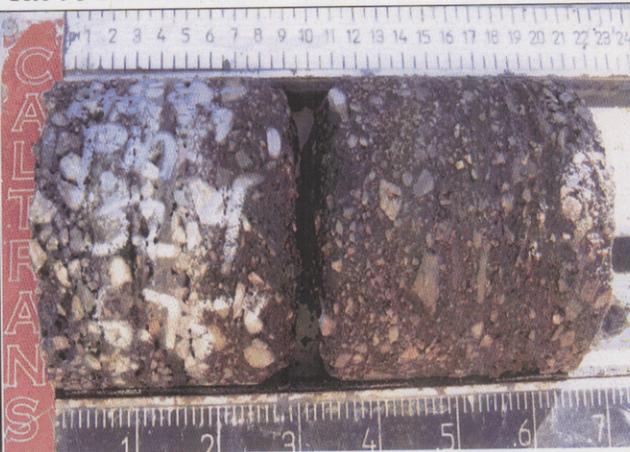
Rte 95 PM 52.9 Core = 0.675'

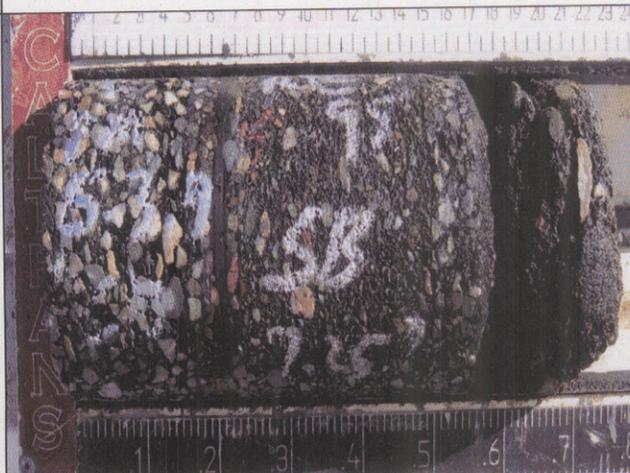
Rte 95 PM 53.9 Core = 0.725'

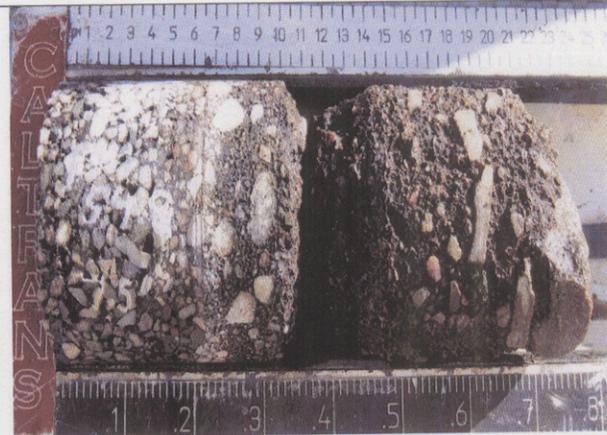
Rte 95 PM 54.8 Core = 0.75'

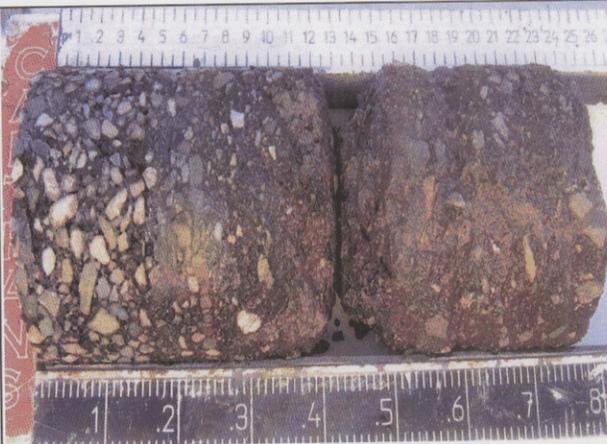
Rte 95 PM 55.9 Core = 0.775'
