File: 10-TUO-49
KP 37.2/37.8 (PM 23.1/23.5)
10-0J1501
Curve Improvement

Subject: Geotechnical Design Report

**10-TUO-49-KP 37.2/37.8
 GEOTECHNICAL DESIGN REPORT**

Subject: Route 49 Curve Improvements

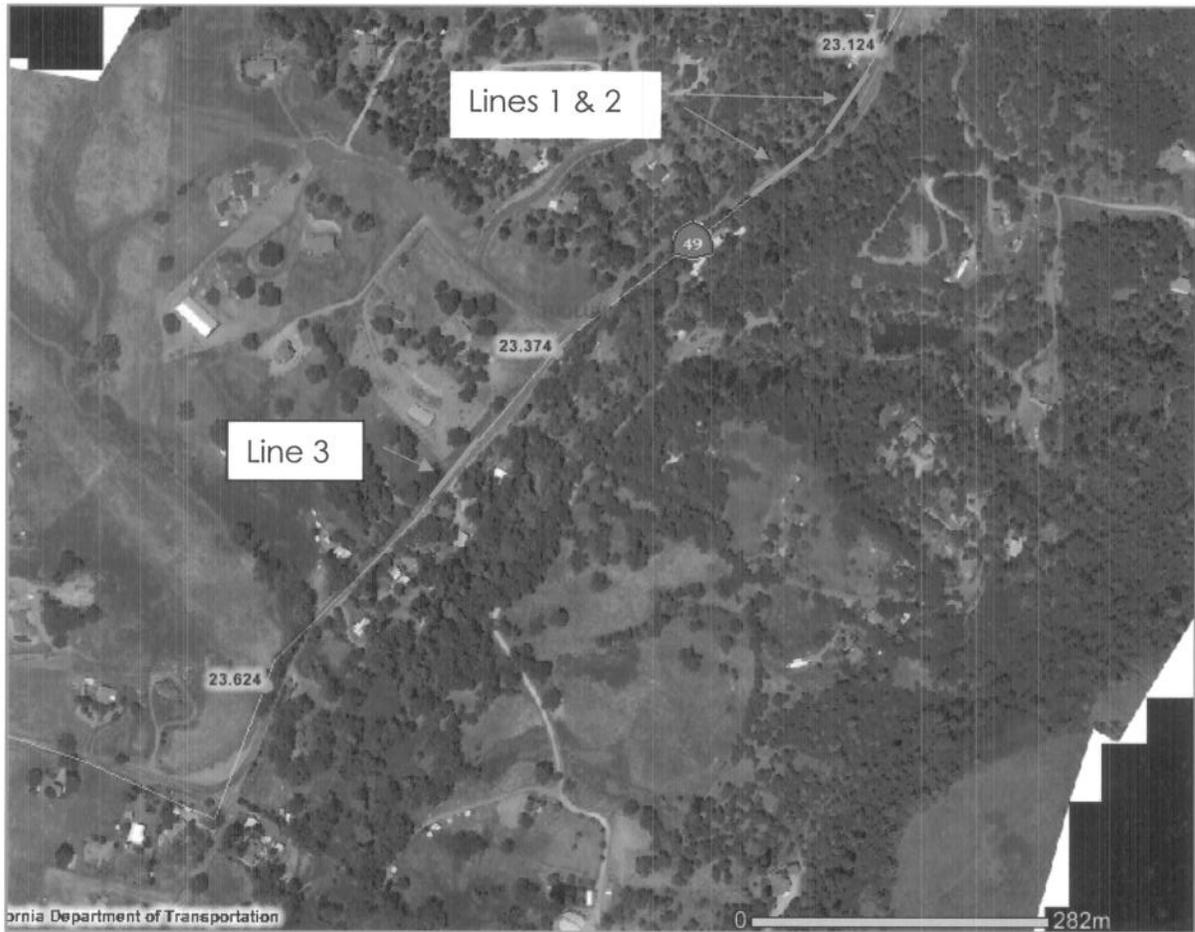
Figure 1. Photo showing the approximate locations of the seismic lines.

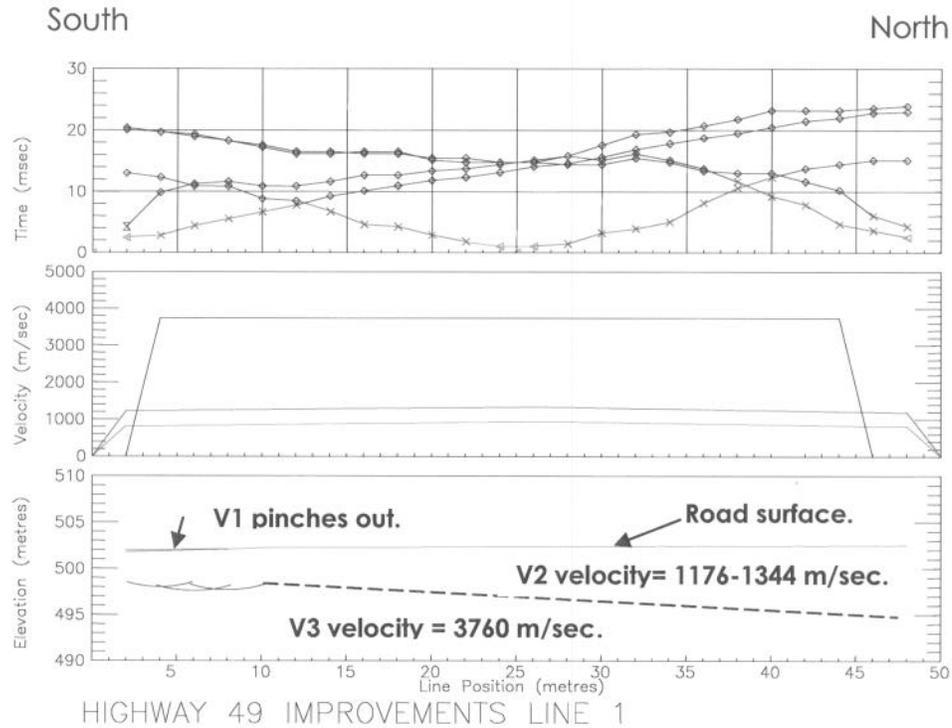
Seismic Line 1 (figure 2) and Line 2 (figure 3) were laid out where rock was exposed in the existing cut. Ripping should be expected to be moderately difficult from the surface (see Figure 2) and become non-rippable as shallow as approximately 3 meters from existing ground surface.

Figure 2. Travel-time curve, velocity model and depth section for Line 1. Layer 1 pinches out meaning the AC sits directly on V2 material. V1 appears to have been removed during original construction. V2 may contain zones requiring light blasting or special equipment for removal. V3 is not rippable. If construction remains above elevation 498.5+/- blasting should not be required, but special equipment may be needed.

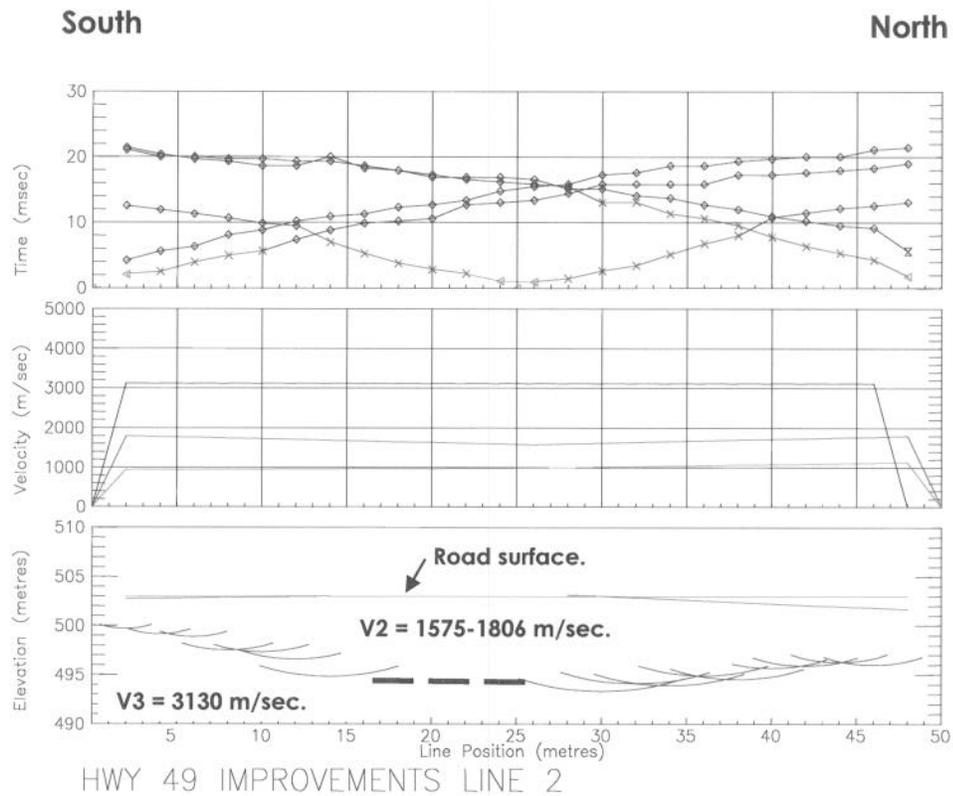
Figure 3. Travel-time curve, velocity model and depth section for Line 2. V1 pinches out, meaning the AC& structural section (if any exists) sits directly on V2 material. This may be due to V1 material being removed during original construction. V2 will be difficult to rip and may require special equipment for removal. V3 is not rippable. Construction above elevation 500 meters should not require blasting but may need special equipment for some hard zones.

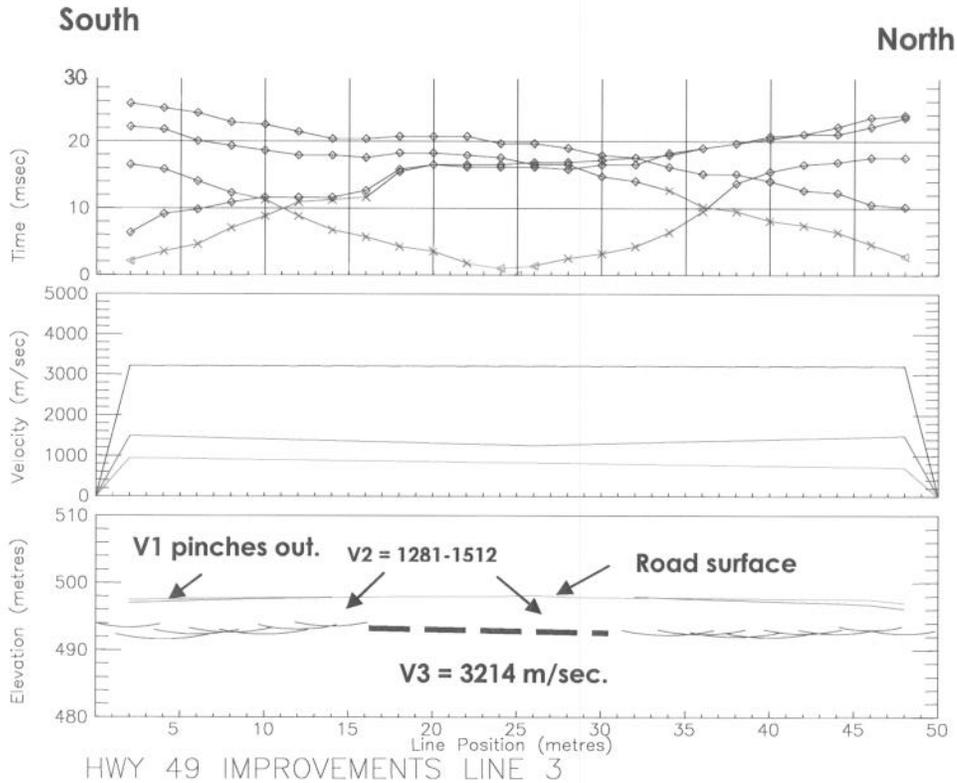
Seismic line 3 (figure 4) is along a vertical curve on Highway 49 just north of Poppy Hills Road. Similar conditions exist at this site as Line 1. Based on seismic data, low-velocity surficial material pinches out across the profile and the road is constructed directly on higher-velocity material along the southern half of the line. That material will be difficult to rip, and any material exposed below that (beginning at approximately 4 meters below surface) will require blasting or other means of mechanical reduction for excavation.

Figure 4. Travel-time curve, velocity model and depth section for Line 3. V1 pinches out most likely due to original construction. AC & structural section (if any exists) sits directly on V2 material and may require special equipment or light blasting depending on depth of designed cut. Any construction below elevation 494 meters is not rippable and zones within V2 may require light blasting or special means of removal.
