DESIGN INFORMATION BULLETIN NO. 83 - 03
CALTRANS SUPPLEMENT TO FHWA CULVERT REPAIR
PRACTICES MANUAL

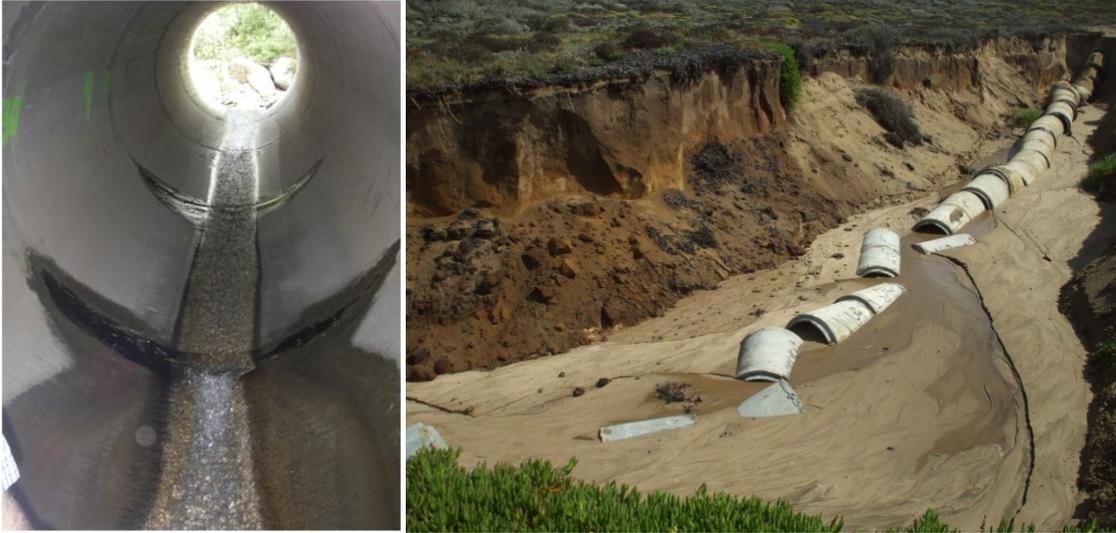
See FHWA Culvert Repair Practices Manual Volume I, pages 3-32, 3-37 and 3-44. Misalignment may indicate the presence of serious problems in the supporting soil. If progressive settlement is present, joint repair should not be performed until a solution to stabilize the surrounding soil has been found. In some cases, reconstruction may be the only option. If so, where there is a need to withstand soil movements or resist disjoining forces, “positive” joints should be specified. Refer to Standard Specifications, Section 61 and Table 854.1 in the HDM.

78 in. RCP with Misalignment

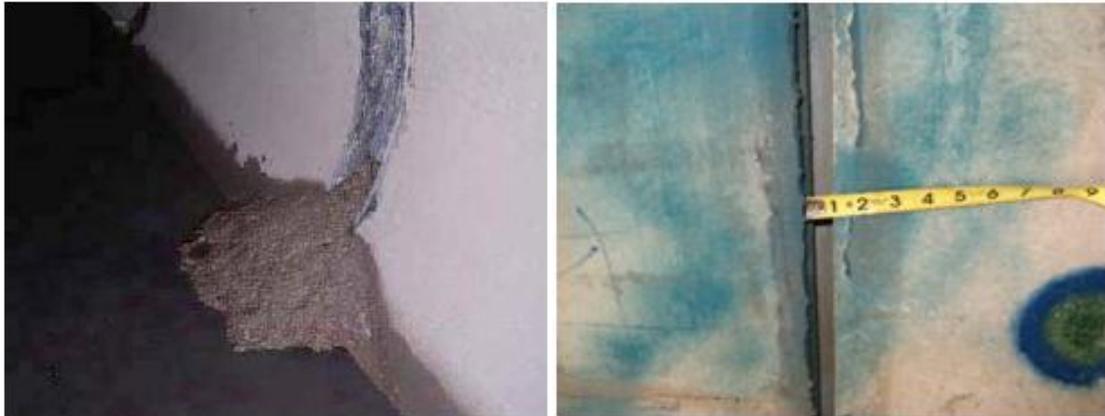
Cracked joints are more than likely not watertight even if gaskets were used. However, if no other problems are evident, such as misalignment, and the cracks are not open or spalling, they may be considered a minor problem to only be noted in inspection. Severe joint cracks are similar in significance to separated joints. Separated joints are often found when severe misalignment is found. In fact either problem may cause or aggravate the other. Embankment slippage may also cause separations to occur. An attempt should be made to determine whether the separations are caused by improper installation, undermining, or uneven settlement of fill. If undermining is determined, an attempt should be made to determine whether the undermining is due to piping, water exfiltration, or infiltration of backfill material. It may also be necessary to test the density of the surrounding soil.

RCP Examples With Joint Separation, Missing Seal and Backfill Loss

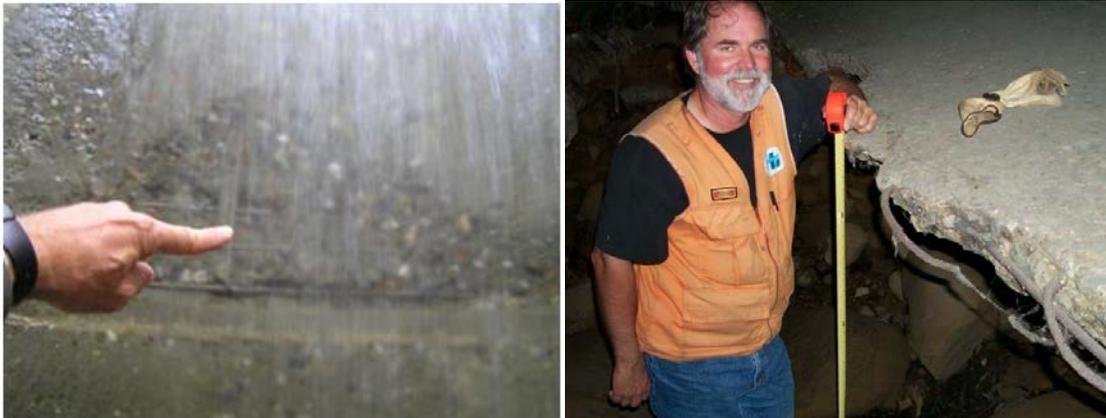
Worn RCP Invert with First Exposure of Reinforcing Steel and Severely Worn RC Arch Invert

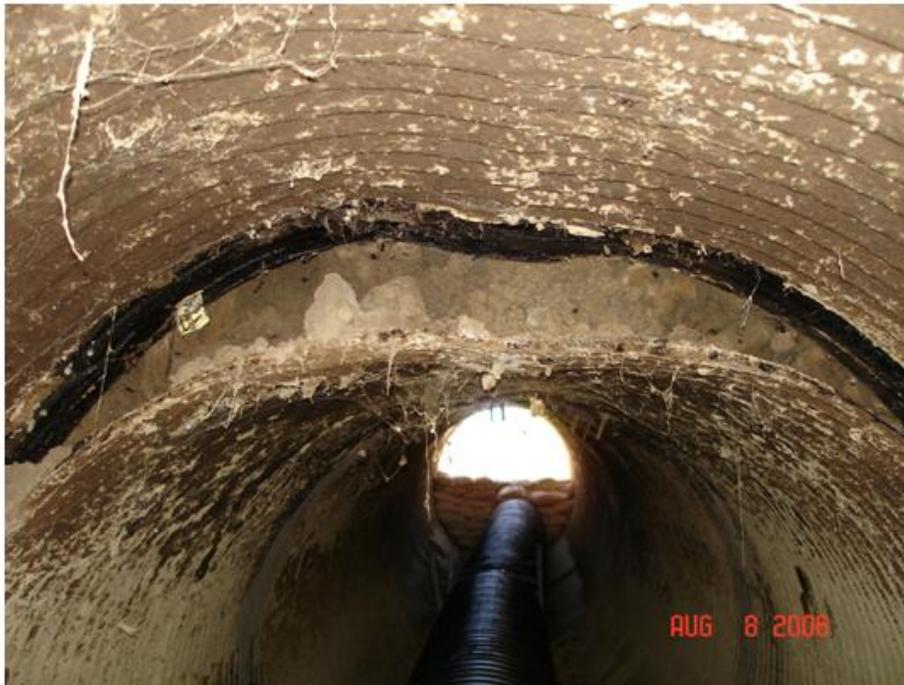
Separated Joint CMP with Physical Separation of Pipe Ends

If abrasion protection is needed, it may be necessary to cover the steel expansion ring with concrete, shotcrete or other authorized material. Section 15-6.05 includes specifications for installing EPDM rubber pipe joint seals onto the interior of an existing pipe or culvert 24 to 108 inches in diameter, creating a circumferential leak resistant seal at the joints.

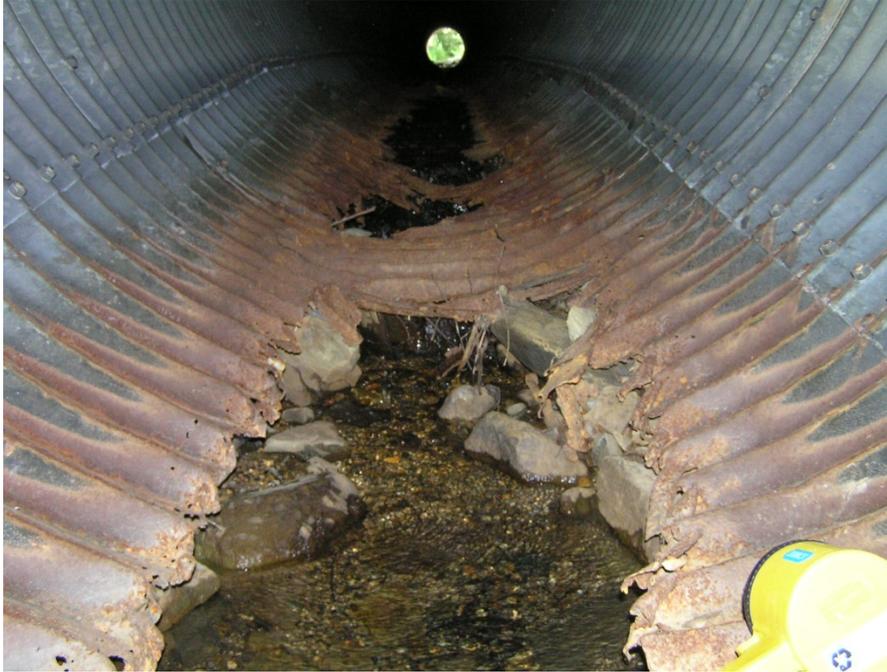
Continuation of this action, if unchecked, will ultimately lead to loss of the invert and the creation of voids under and around the culvert (see pictures below and Appendix G – Example 1).

Corrosion Accelerated by Abrasion Causing Invert Loss and Void Below

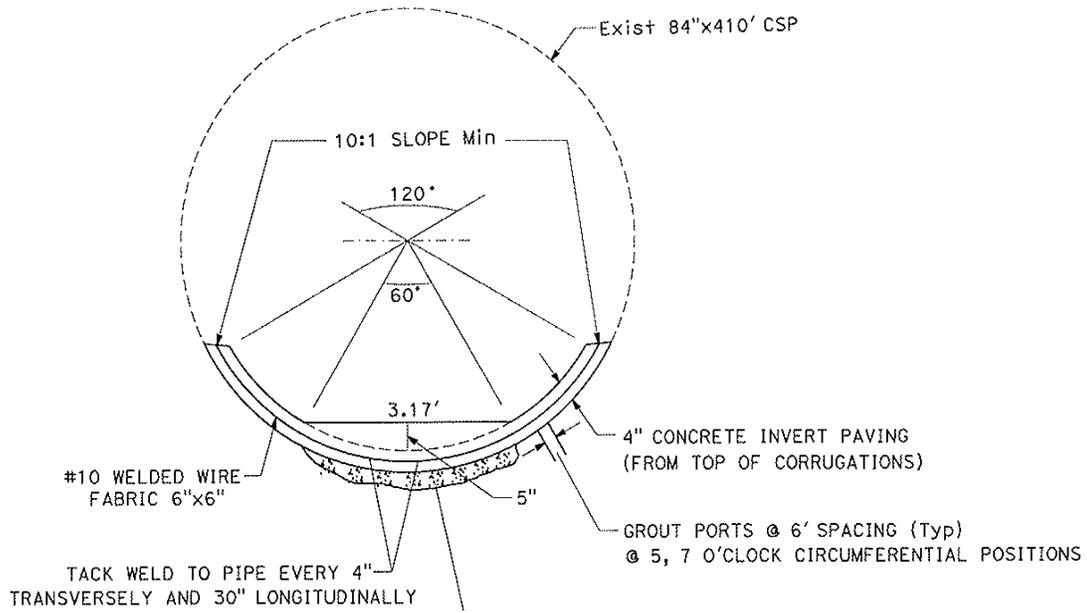
(Above) Example of Insufficient Concrete Invert Paving Design Thickness for Abrasion Level 6

Invert paving sections typically vary from 90 to 180 degrees for the internal angle depending on the extent of the deterioration on both sides of the pipe. In the detail below, the designer opted to provide a flattened invert for additional thickness and to spread the abrasive stream bedload.

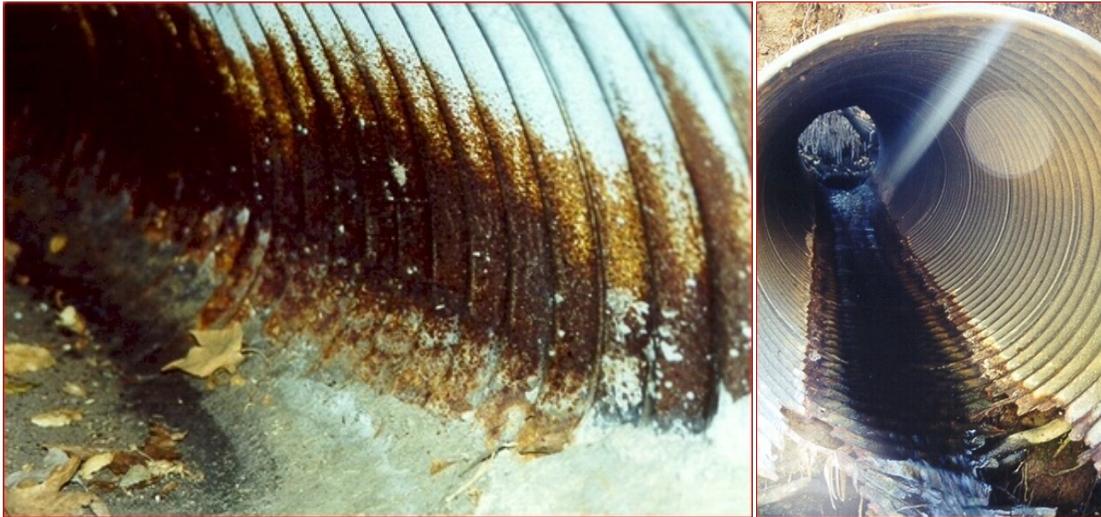
Corroded Steel Pipes

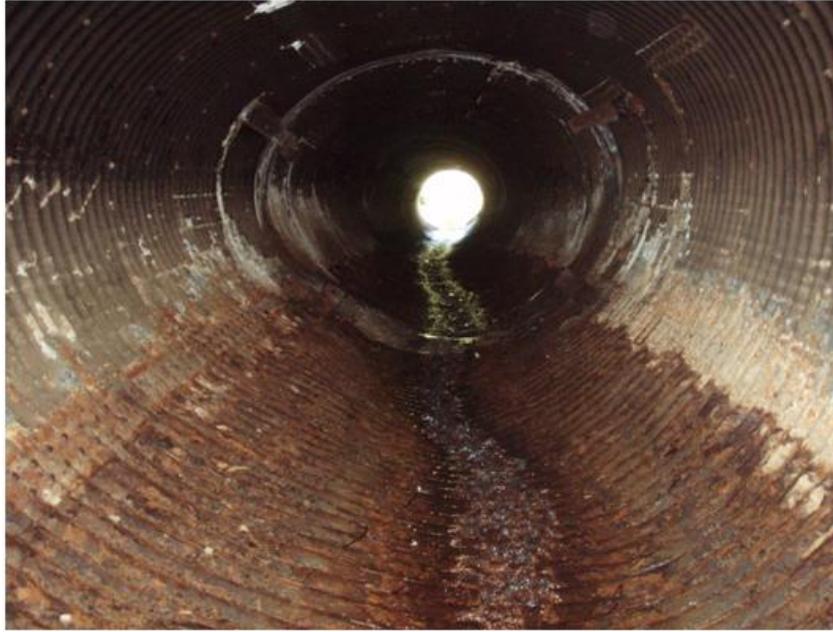
SSPP with Deflection Beyond 10-12%

The same discussions outlined under invert durability and shape distortion for corrugated metal pipe also apply to structural steel plate. There are ordinarily no joints in structural plate culverts, only seams. Distress in circumferential seams is rare and can result from severe differential deflection caused by a foundation or soil failure – usually as a result of invert failure (see photos in Index 5.1.2.2). Depending upon the degree of deflection, it may be possible to rehabilitate the invert, however, contrary to the recommendation under “Joint Defects” on page 6-19 of FHWA Culvert Repair Practices Manual Volume 1, and Appendix B-26 of Volume 2, internal steel expansion ring gasket joint sealing systems are not recommended for circumferential seam repairs. If it is not possible to rehabilitate the invert, and there is severe differential deflection present, replacement is recommended. However, if the host pipe can be adequately stabilized, stopping further distortion, and the soil-pipe interaction re-established, it may be feasible to rehabilitate SSPP with deflections beyond 10-12% using semi rigid pipe such as welded steel (all sizes) or fiber reinforced polymer concrete pipe (available up to 126 in. nominal diameter). See Indices 2.1.1.1.3.1, 5.1.2.2.3.1, 7.1.6.1., and 11.1.1.

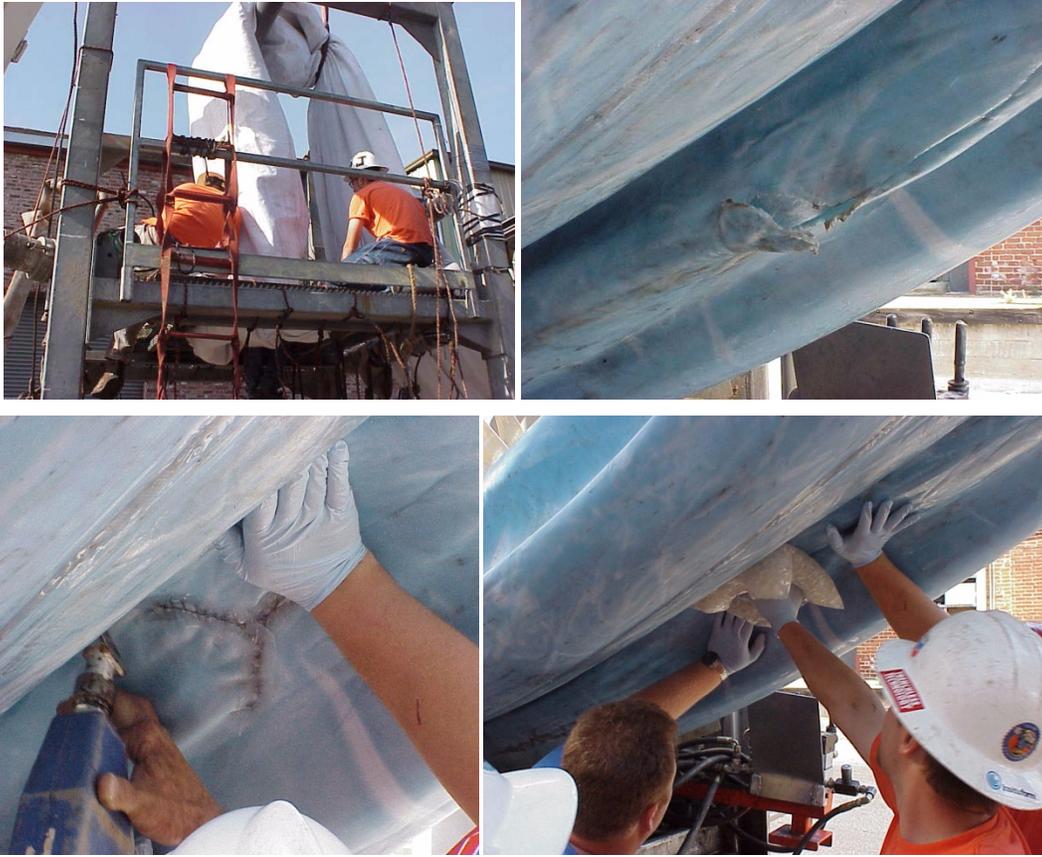
Example of Liner Tear During Installation and Subsequent Repairs

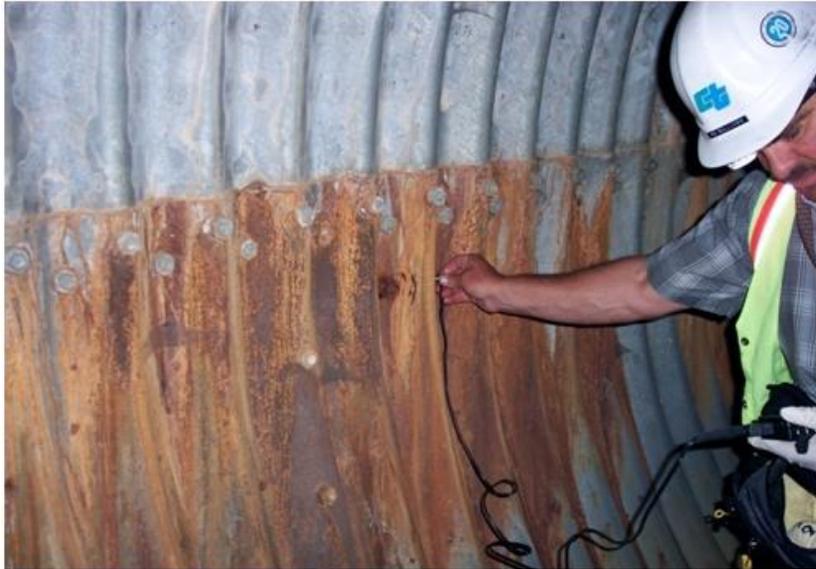
Taking Thickness Measurements. Note Evidence of Leaking Horizontal Seam at Springline

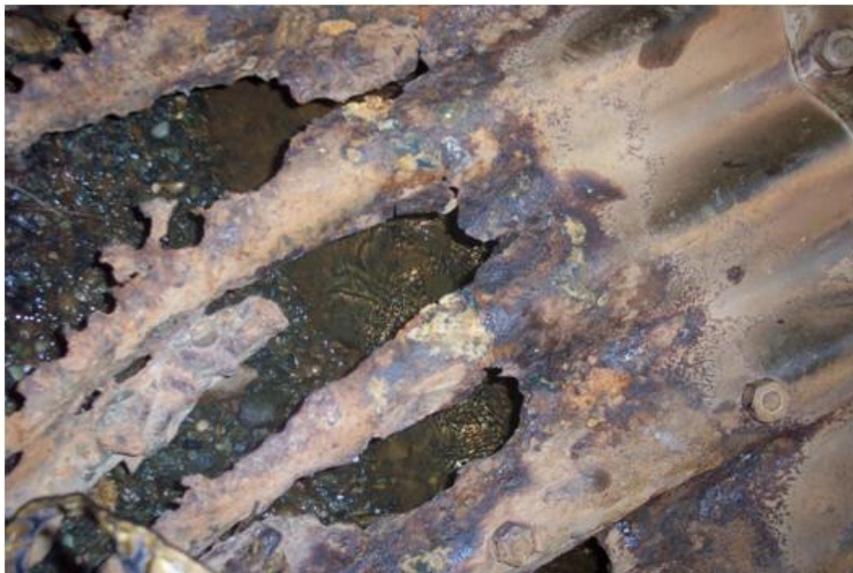
Total Loss of Invert and Existing Nuts Showing Minimal Wear

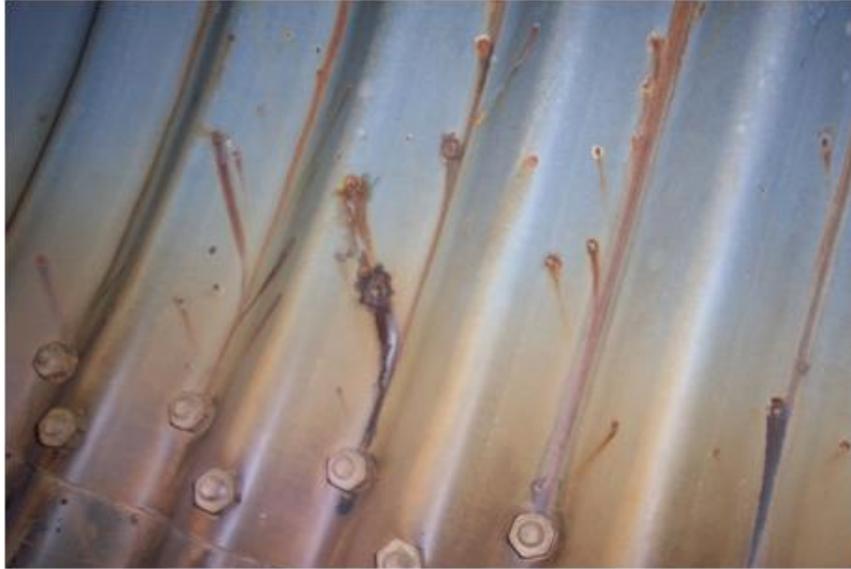
Typical Local Corrosion Cells. Note that the corrosion is coming in from the backside, thus the pipe is in worse condition than it appears. See picture of void found from probing during construction.

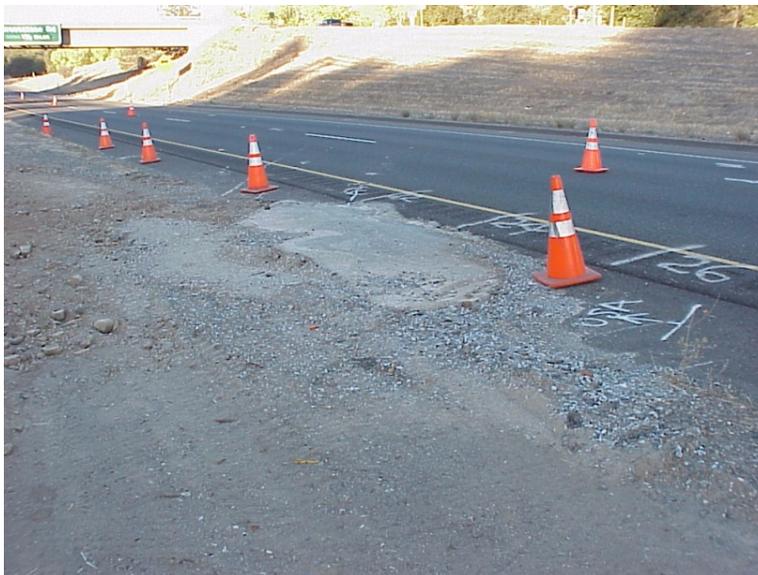
Freshly Placed Slurry where Void Migrated to Surface

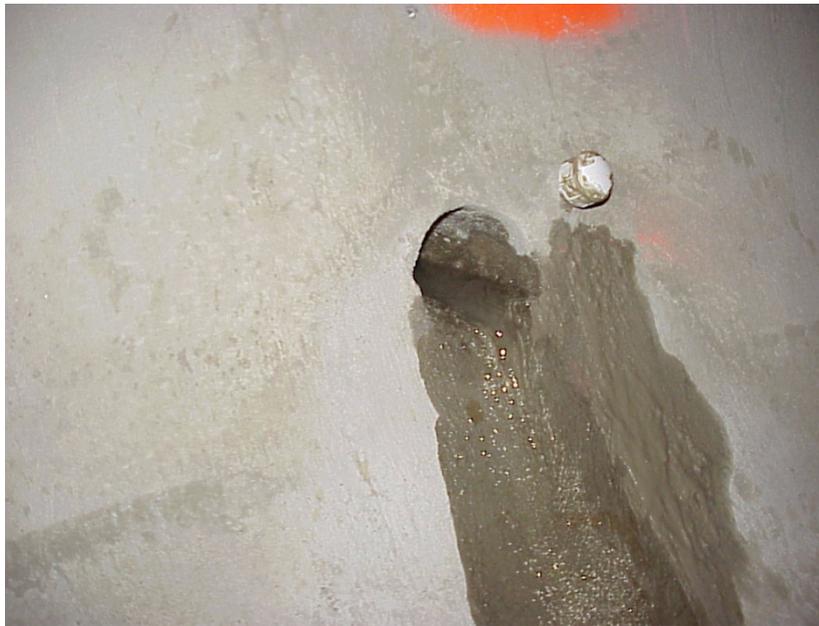
“Cored” Grout Hole in Shotcrete Used to Fill Large Void with 3-Sack Sand Slurry Leaking Groundwater During Contact Grouting. Note capped contact grout port.

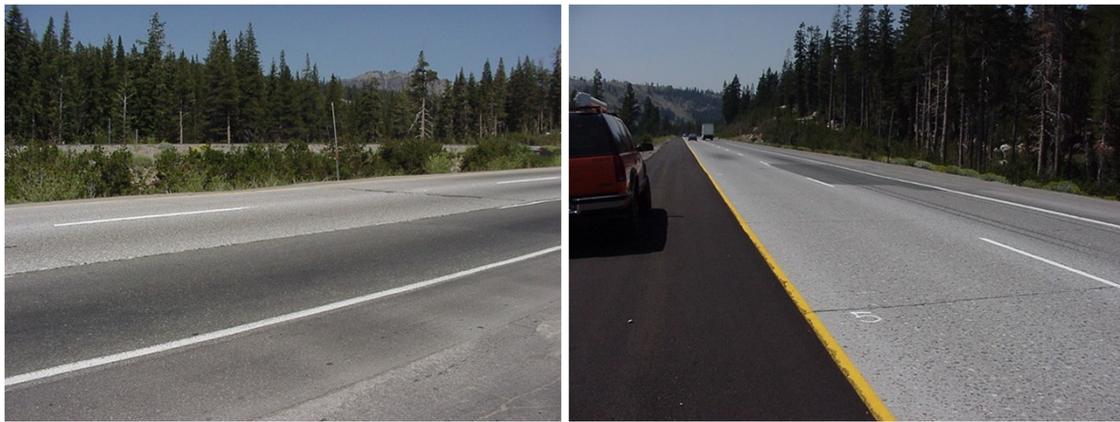
Dip in Number 1 EB Lane. Summer 2002 Dip in entire WB freeway Section. Summer 2002

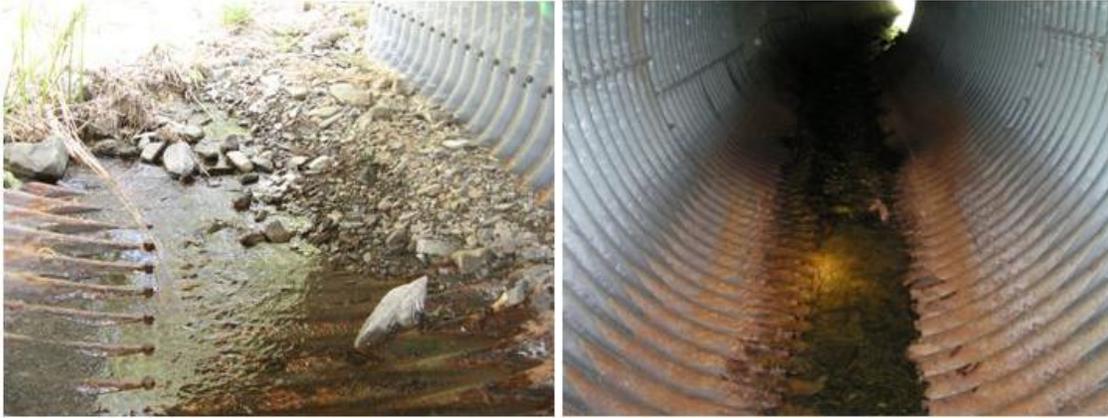
Abrasive Channel Materials and Worn Invert

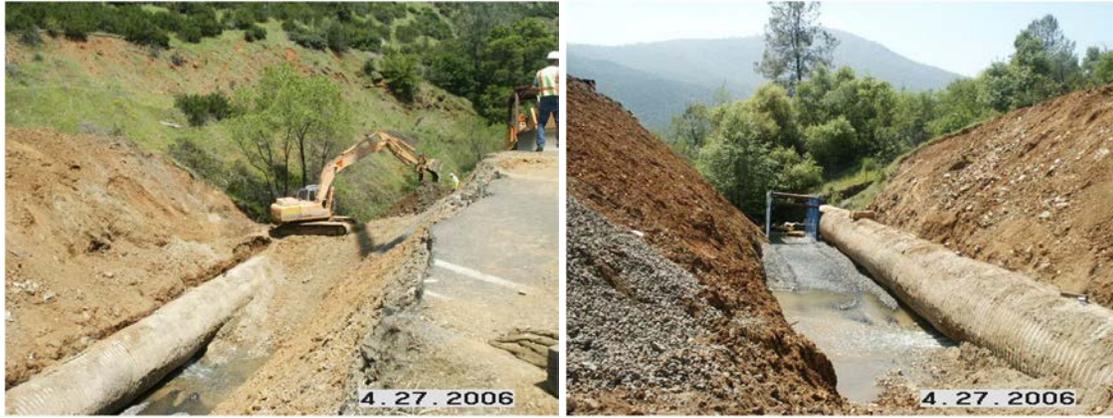
Failed Original 84" - 10-gage SSPP
