PROJECT CHANGE REQUEST

PROJECT (SCOPE) DESCRIPTION: HUM 101 110.6/T113.8 Lagoons Slip and Slide

U.S. Department of Transportation Federal Highway Administration- California Division- Title 23 Damage Assessment Form (DAF)		DAF No. CEP - CT01 - 0 2 6 - 1

Subject: Revised Geotechnical Recommendations

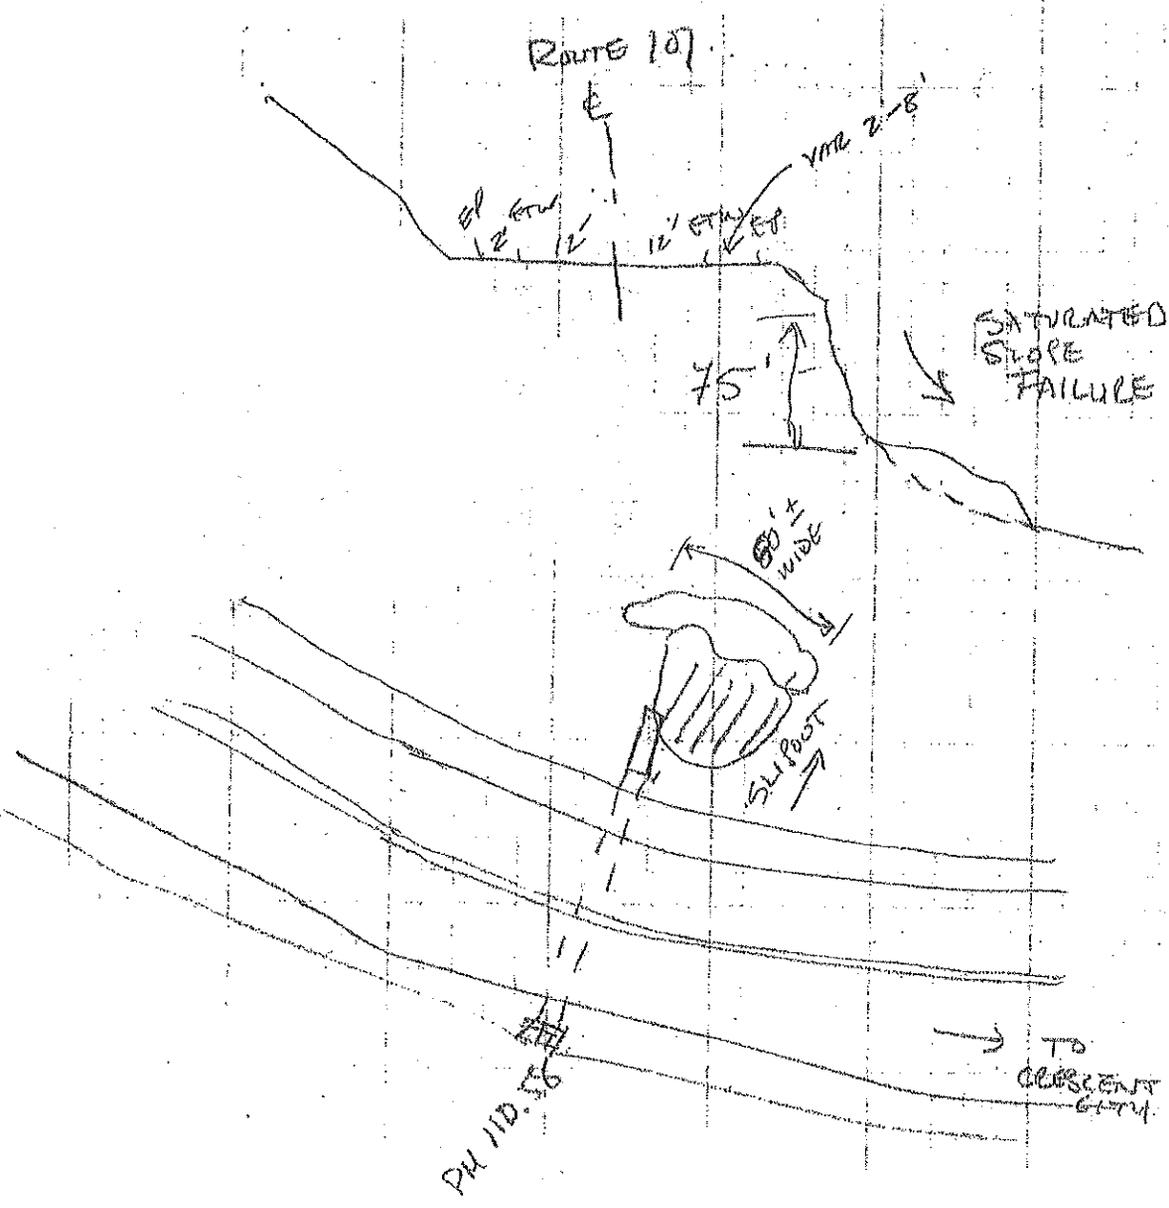
Photo description:
Original Sketch:

Description of Damage:	Slipout and Drainage System Damage

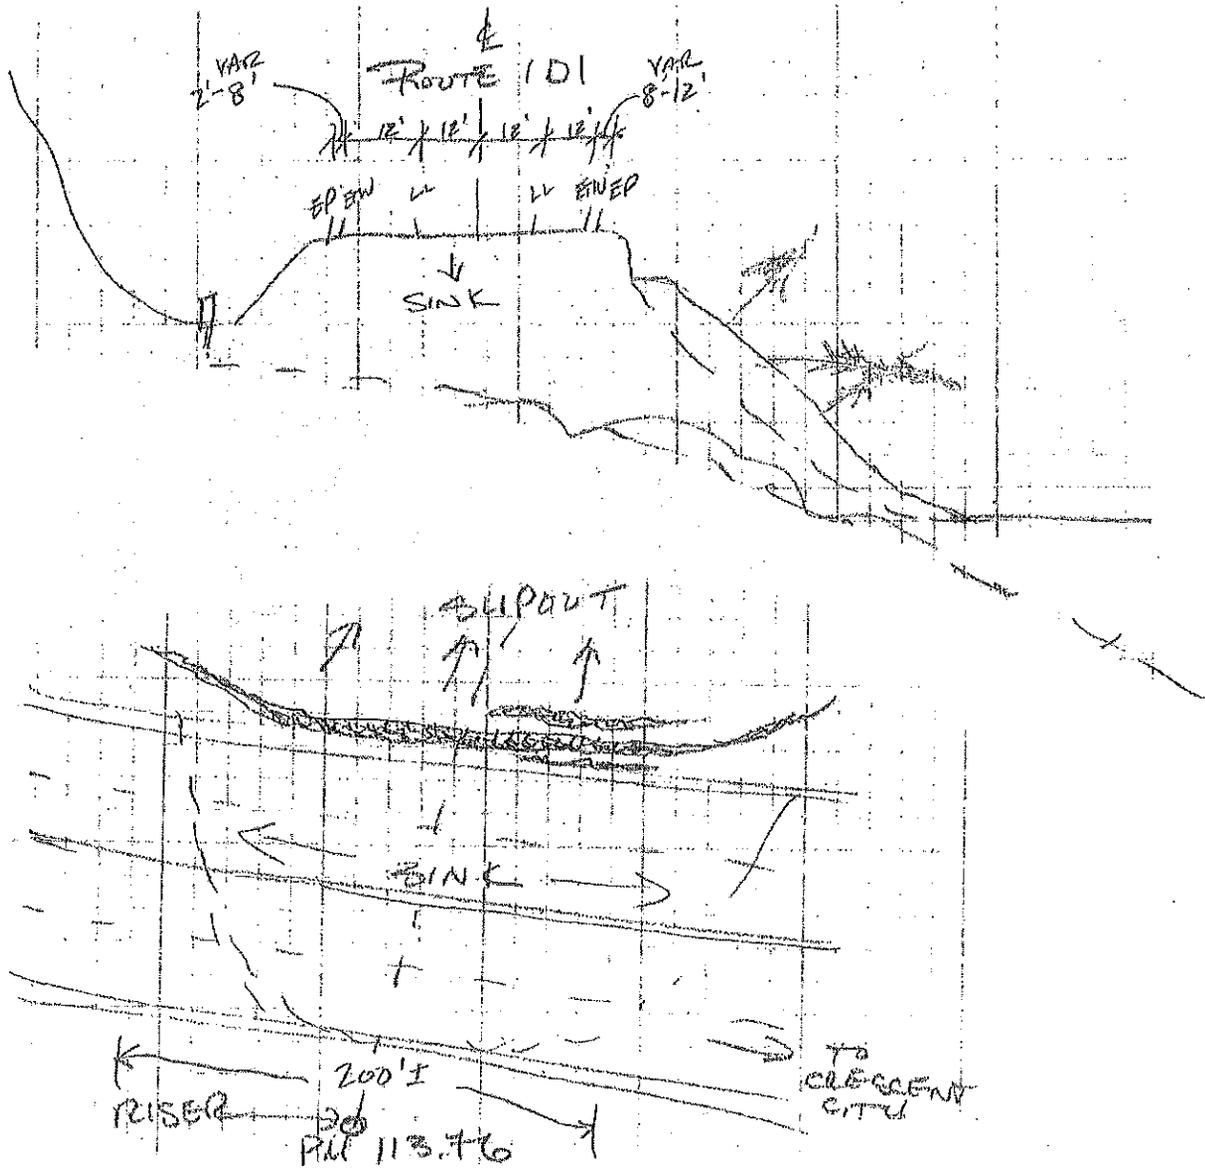
Photo description:
Original Sketch:

Shoulder: Width <u>var 4-10'</u> Type: PCC <input type="checkbox"/> AC <input checked="" type="checkbox"/> Gravel <input type="checkbox"/>		
Description of Damage: <u>Slipout</u>

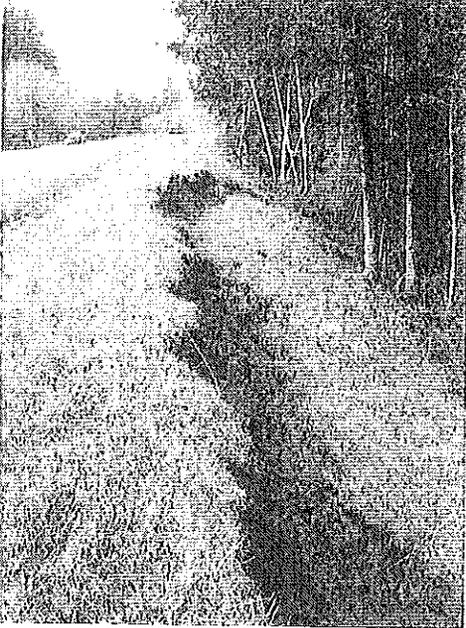
Photo description: Slipout Scarp

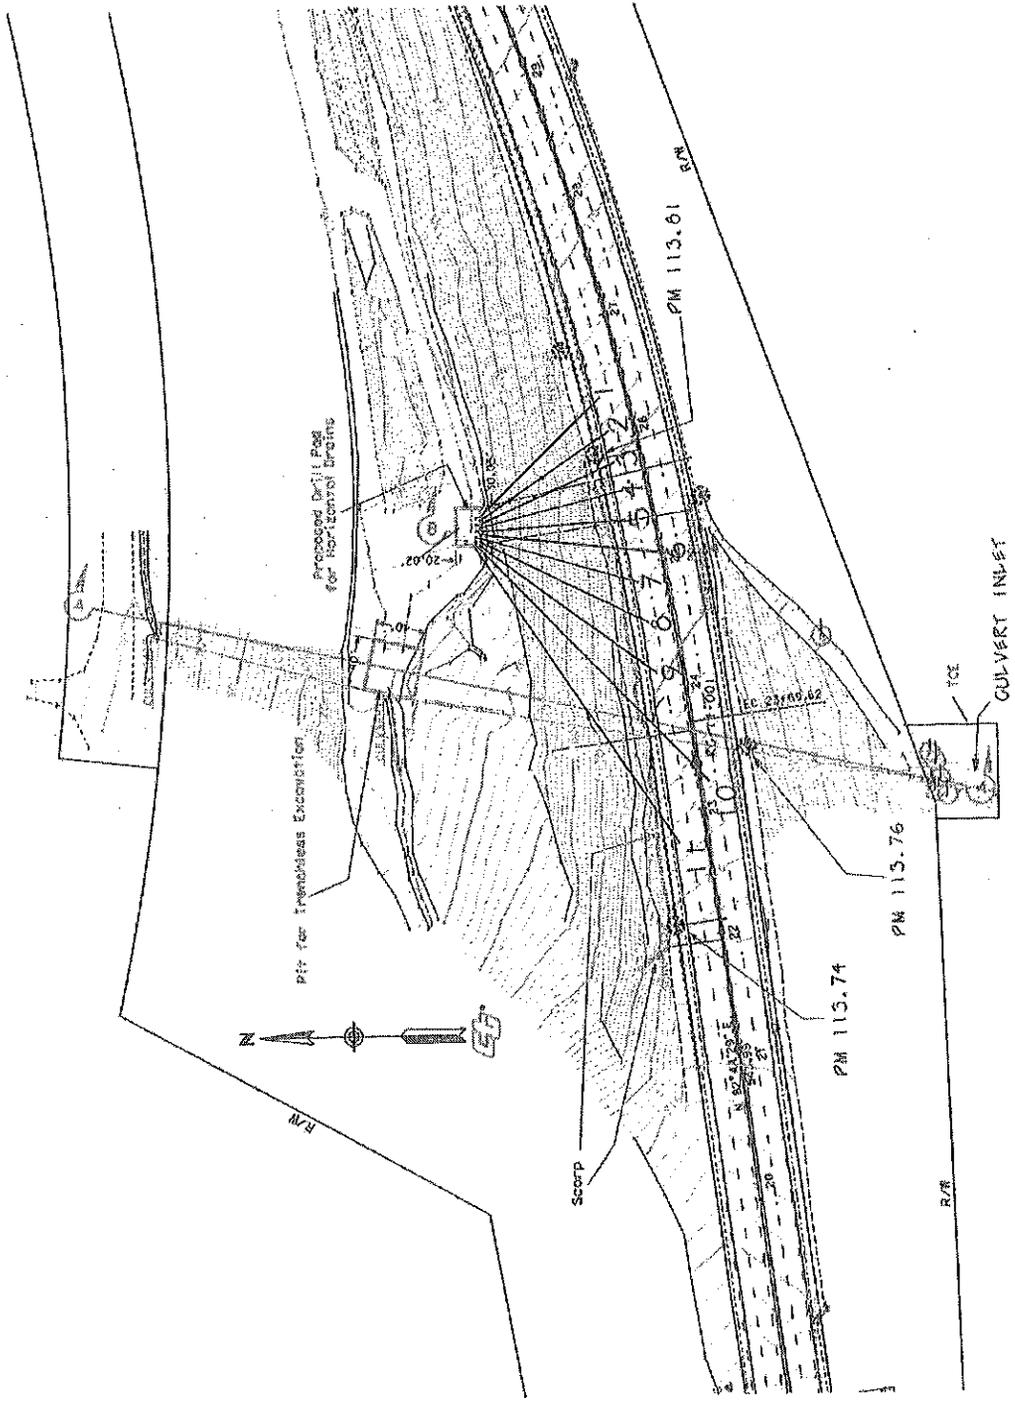
After several intense rainfall events during the winter of 2011, the existing left-side embankment failed along the left shoulder between Station 22+00 and Station 26+00 (Figure 2). The top of the failure begins along the outside edge of the roadway shoulder and terminates downhill at the toe of the embankment.

Figure 2. -- Plan map of U.S. Route 101 at PM 113.76, EA 01-0B420, showing horizontal drains and location of the new culvert.

- 1.) Install horizontal drains prior to the new culvert pipe. The inclination of a horizontal drain drilled at a positive angle of 10° can be expected to drop approximately 2.5° per 100 feet based on instrumental measurements (Cornforth, D.H., 2005). We do not want to risk any damage to a new culvert pipe during drilling for horizontal drains.
- 2.) Install an array of 11 horizontal drains. The approximate location of the array is 120 feet left of the center line, between Station 25+37 and Station
