An Evaluation Of Protective Coatings For Corrugated Metal Pipe

March 1973

Materials and Research Department
California Division of Highways
Sacramento, California 95819

Final Report

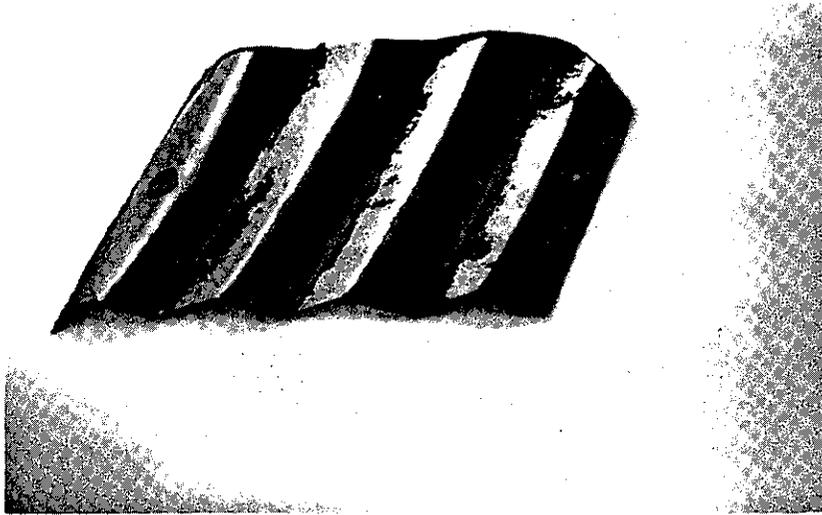
FIGURE 5

Of the specimens tested, the mastic produced by Daubert Chemical Company seemed to abrade the quickest, and in all cases failed before the other specimens. As observed in the asphalt specimens, a kneading action took place. This material seems to require at least 3 days to cure, and like asphalt is quite messy to handle and apply. The material is a mastic, and the volatiles which evaporate when the material is drying may prove dangerous if large amounts of the mastic are applied in a confined area. Spreading the mastic to an adequate, even thickness may prove to be difficult. However, with the use of proper equipment and application techniques, this may not prove to be a serious problem.

INITIAL ABRASION TEST SPECIMEN
Pioneer Culvert Mastic, .025 inch initial coating
thickness with 49,022 revolutions at 3.65 fps,
3/8" x 1/2" coarse aggregate abrasive charge.

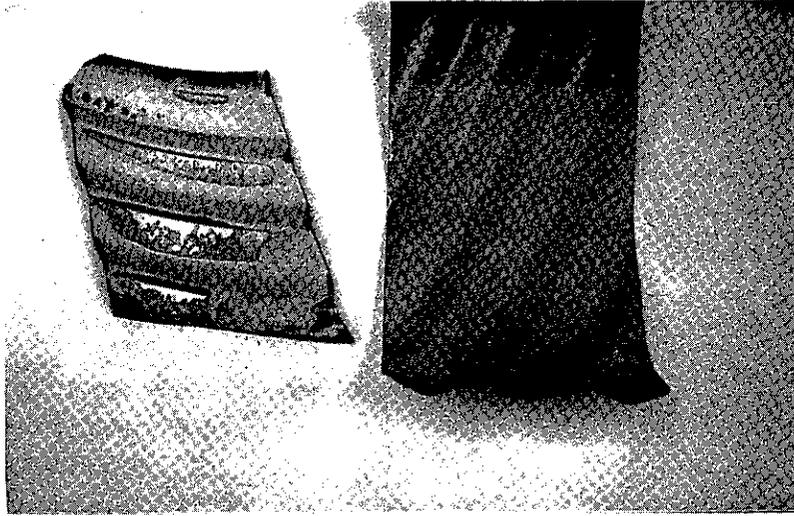
FIGURE 9

Initial abrasion test Copoly-X Terrashield specimen (left) and new Copoly-X Terrashield specimen (right)

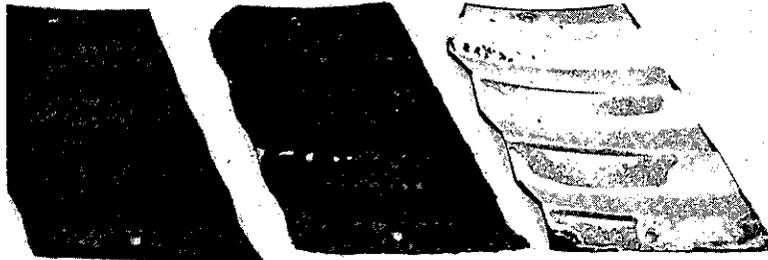
FIGURE 10

INITIAL ABRASION TEST SPECIMENS
.018" Nexon (left), .075" Asphalt (center), and
.018" Copoly-X Terrashield (right) all with
174,312 revolutions at 3.65 fps, 3/8" x 1/2"
coarse aggregate abrasive charge.

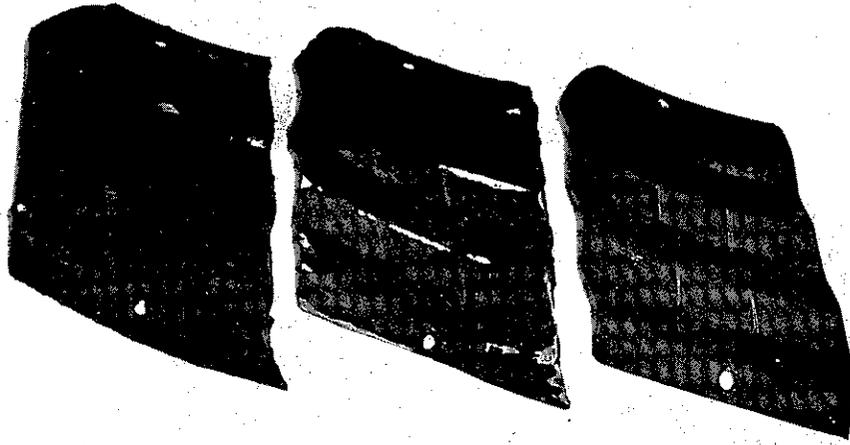
FIGURE 13

ABRASION TEST SPECIMENS

Asphalt (left) and Pioneer Culvert Mastic (center),
and Nexon (right) with 501,100 revolutions at 5 fps,
using minus No. 4 fine aggregate as an abrasive
charge (see Table 4).

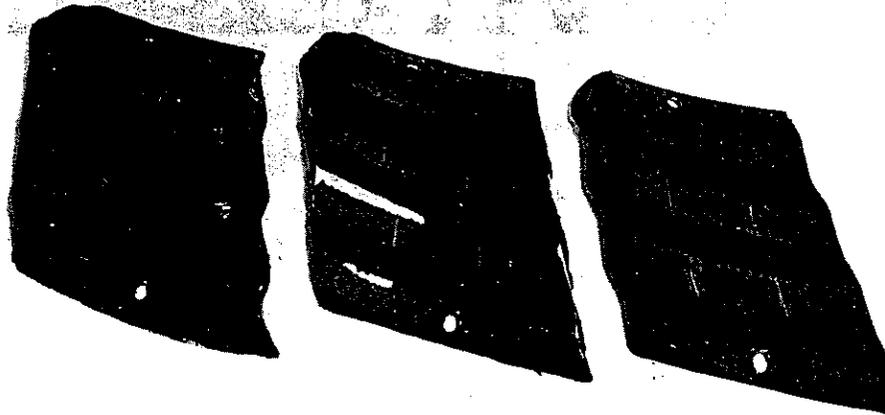
FIGURE 15

ABRASION TEST SPECIMENS

Asphalt (left) and Pioneer Culvert Mastic (center),
and Nexon (right), using minus No. 4 fine aggregate as
an abrasive charge (see Table 5).

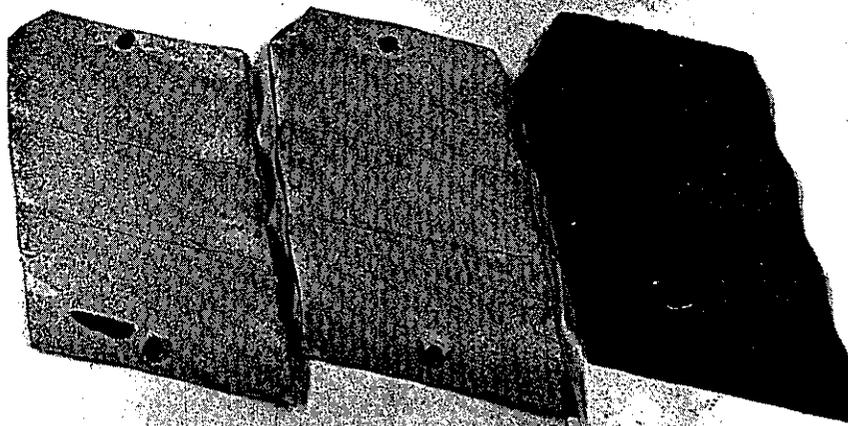
FIGURE 18

Copoly-X Raceway abrasion test specimens, left and center, tested for 121,580 revolutions at 5 fps using $3/8"$ x $1/2"$ coarse aggregate as an abrasive charge. Right specimen - new (see Table 7).

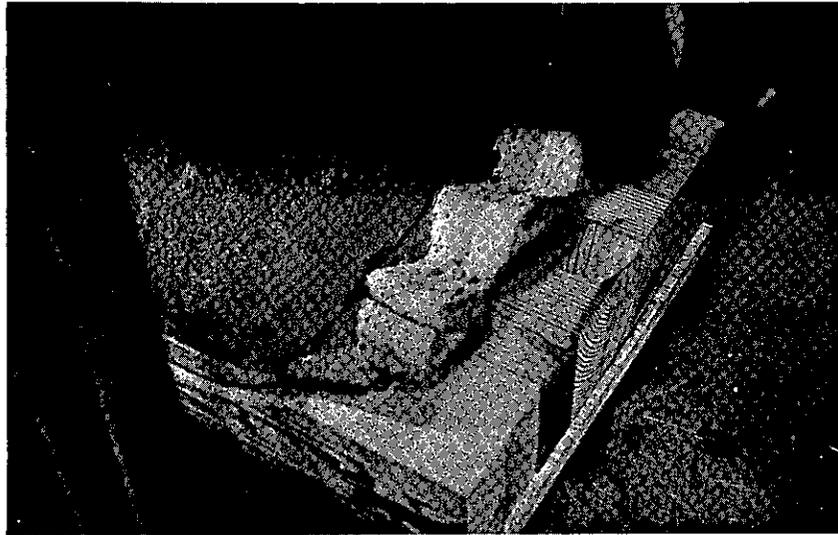
FIGURE 28

The last three samples were coated on the outside with Terrashield and had inverts paved with Raceway. Cracks appeared in the valleys of the corrugations on the outside Terrashield coating and also appeared along the edges of the Raceway coating. Very few cracks appeared in the Raceway coating itself.

View of ring deflection Copoly-X specimen showing crack at Raceway-Terrashield border

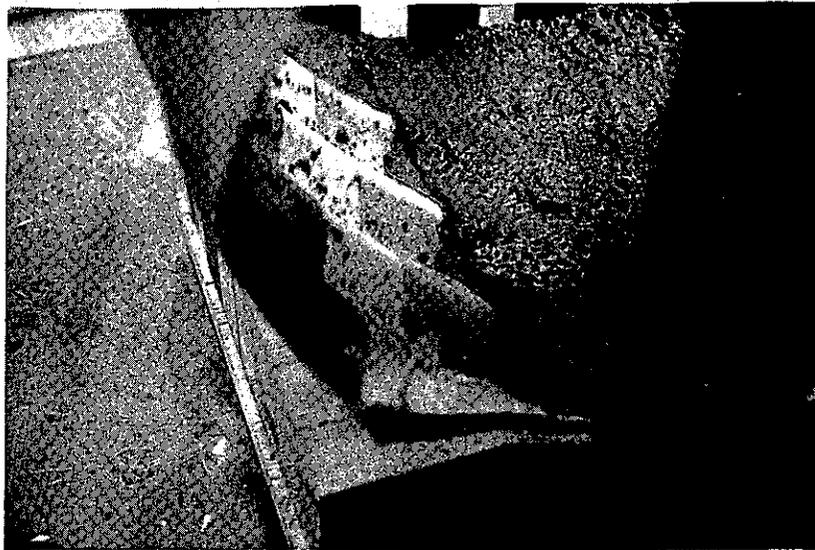
FIGURE 29

The second sample tested was paved in the invert only with Raceway. Before testing, two fine cracks were present along the seam of the Raceway and pipe. When a vertical deflection of .3 inches was reached, these cracks had widened slightly. At .5 inches the width of the cracks had increased to approximately 1/8 of an inch. From a vertical deflection of .5 inches to .9 inches, the crack widths grew to approximately 3/16 of an inch.

Close view of crack along Raceway specimen edge at .9 inches deflection during ring deflection test

Summarizing ring deflection tests, all asphalt, Nexon, and Pioneer Culvert Mastic coatings bent easily, without showing any signs of cracking. Both initial and modified samples of Copoly-X Terrashield and Raceway coatings developed cracks and appeared to be too brittle to be subjected to the wear and abuse received from normal transportation and handling of corrugated metal pipe. The Copoly-X Raceway material may be satisfactory if placed after completion of a pipe installation to preclude cracking.

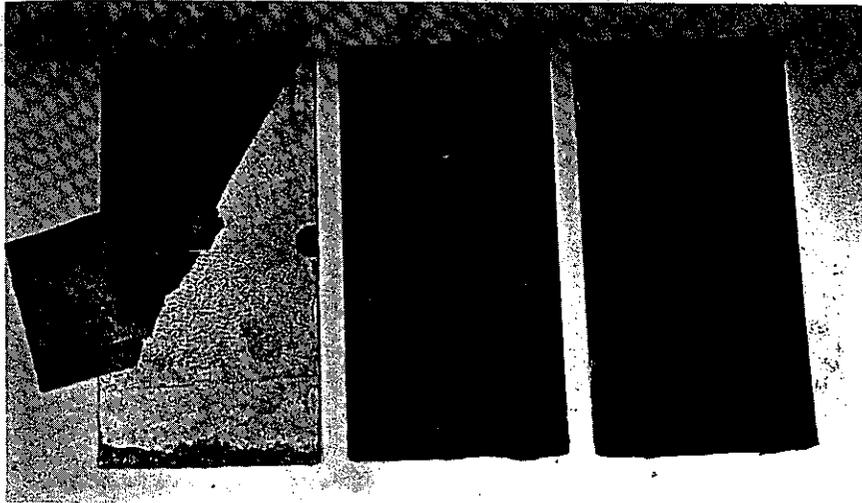
FIGURE 30

Visible evidence of corrosion was limited to a small band about 1/2 inch wide around the periphery of the specimens. Small white streaks, known as white rust or zinc oxide, were observed on the coating surface along the edges, and indicated that underfilm corrosion had taken place. The asphalt bond to the metal plates was poor on all specimens, and the entire coating could be peeled intact from the metal plates. However, a thin film of asphalt remained on the metal surface after the asphalt layer had been peeled which prevented any visible corrosion, other than the band around the edges of the plates, from occurring.

Asphalt corrosion test specimens having
4511 hours in the fog chamber

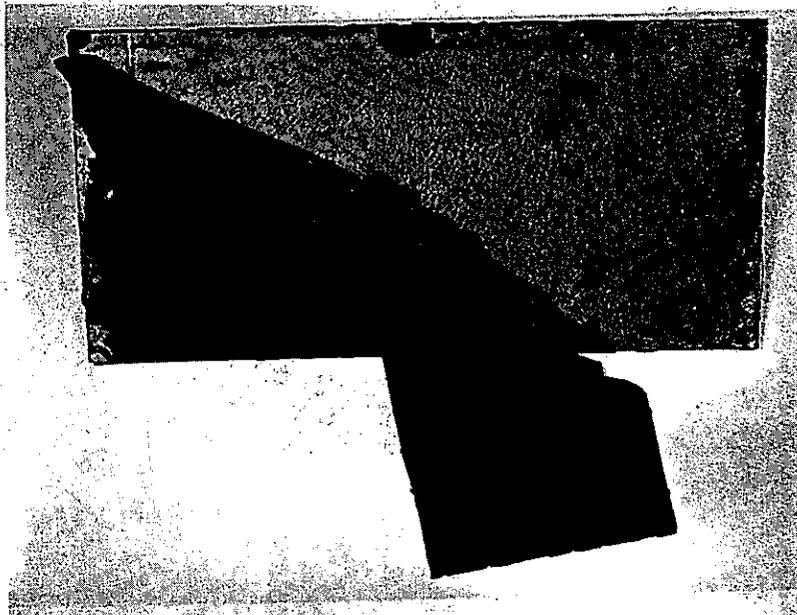
FIGURE 31

Asphalt coated corrosion specimens exhibited a loss of adhesion between the asphalt coating and the flat or corrugated galvanized steel plate, but little visible corrosion was present. Nexon and Pioneer Mastic specimens were noted for their exceptionally good bond qualities and from the tests performed are expected to perform at least as well as asphalt in preventing corrosion. The 1/2 mil paint type coating on the opposite side of Nexon specimens, which had allowed extensive visible corrosion to occur, and the Copoly-X Terrashield coating which had also permitted significant corrosion, are not expected to protect corrugated metal pipe as effectively as asphalt.

Close view of asphalt corrosion test specimen
showing loss of bond

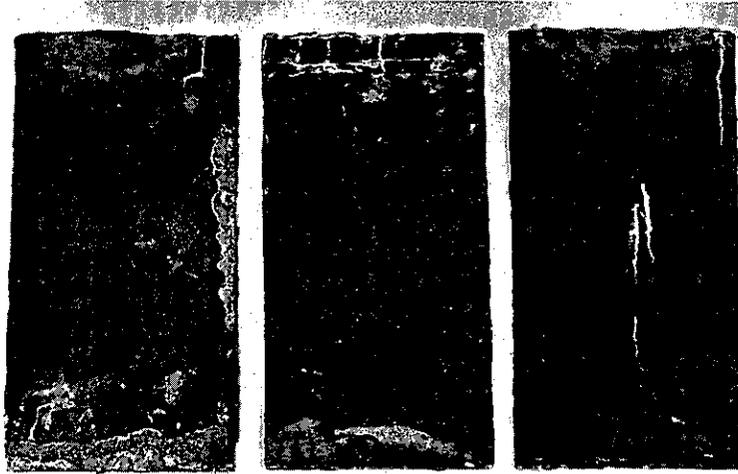
FIGURE 32

Corrosion similar to that observed along edges of asphalt specimens was present on all plates coated with mastic. Bond was poor along the periphery of all mastic specimens due to some underfilm corrosion. With the exception of visible underfilm corrosion and bond loss which was limited to the specimen edges, the Pioneer mastic had excellent bond to the metal, unlike the asphalt coating which easily peeled from metal plates, and provided good protection to the metal against corrosion. Pioneer Culvert Mastic can be expected to perform at least as well as asphalt in preventing corrosion.

Pioneer Culvert Mastic corrosion test specimens
having 4511 hours in the fog chamber

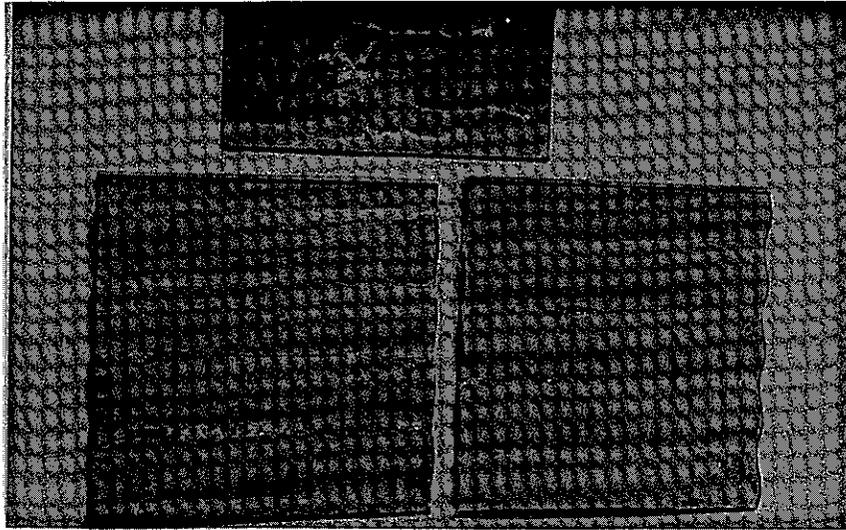
FIGURE 35

Copoly-X Terrashield corrosion test specimens
having 4457 hours in the fog chamber

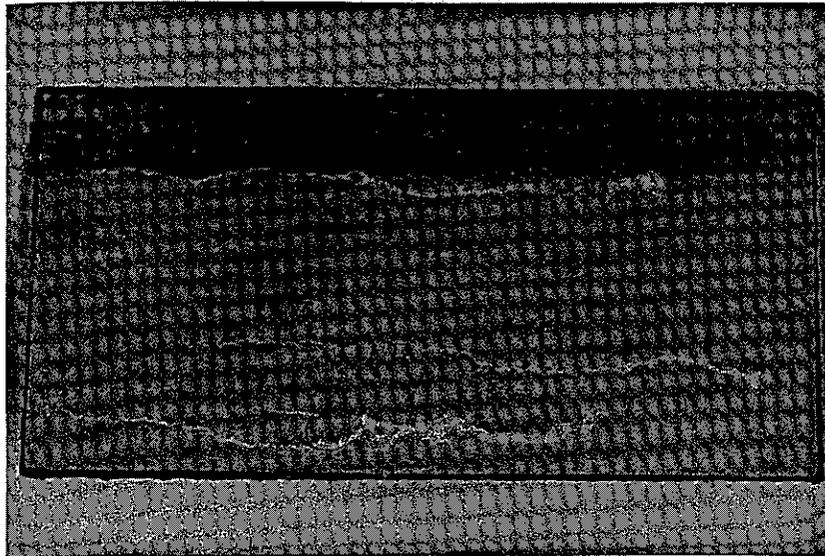
FIGURE 36

Close view of Copoly-X Terrashield specimen
showing extent of blisters

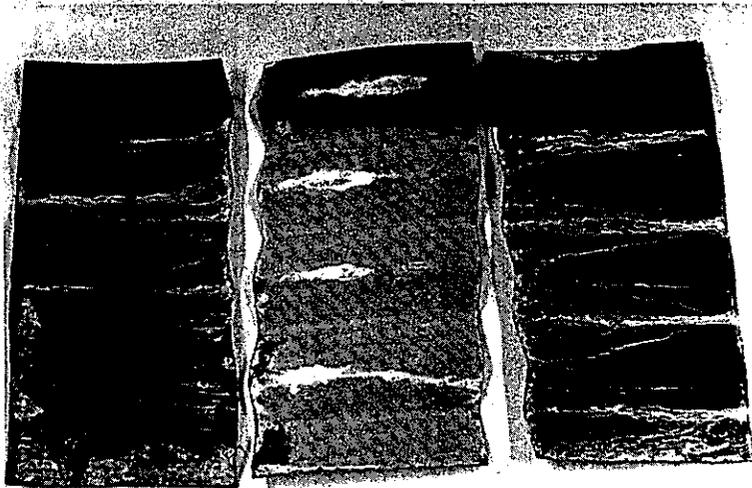
FIGURE 37

Nexon corrosion test specimens having 4511 hours in the fog chamber. Center specimen is turned upside down exposing the yellow epoxy painted surface
