**DEPARTMENT OF TRANSPORTATION**

Contract #: 04-0120F4Cty: SF/ALA Rte: 80 PM: 13.2/13.9File #: 1.28**WELDING INSPECTION REPORT****Resident Engineer:** Siegenthaler, Peter**Address:** 333 Burma Road**City:** Oakland, CA 94607**Report No:** WIR-017243**Date Inspected:** 04-Oct-2010**Project Name:** SAS Superstructure**OSM Arrival Time:** 930**Prime Contractor:** American Bridge/Fluor Enterprises, a JV**OSM Departure Time:** 1800**Contractor:** American Bridge/Fluor Enterprises, a JV**Location:** Jobsite**CWI Name:** See below**CWI Present:** Yes No**Inspected CWI report:** Yes No N/A**Rod Oven in Use:** Yes No N/A**Electrode to specification:** Yes No N/A**Weld Procedures Followed:** Yes No N/A**Qualified Welders:** Yes No N/A**Verified Joint Fit-up:** Yes No N/A**Approved Drawings:** Yes No N/A**Approved WPS:** Yes No N/A**Delayed / Cancelled:** Yes No N/A**Bridge No:** 34-0006**Component:** SAS OBG**Summary of Items Observed:**

## WELDING INSPECTION REPORT

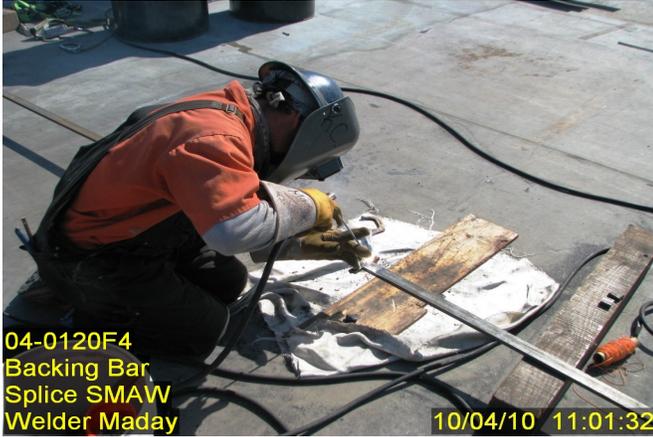
- 1). East Line OBG Splice Welding of Backing Bar for 8E/9E A (SMAW)

The QAI periodically observed AB/F approved welder Mike Maday (ID 3391) performing fit-up and Complete Joint Penetration (CJP) welding per the Shielded Metal Arc Welding (SMAW) process in the 1G (flat) position of backing bar sections for the OBG Field Splice 8E/9E "A". See photo below. QC Inspector John Pagliero was periodically present to monitor the progress and verify that the welding parameters were within the limits established by the approved welding Procedure Specification (WPS) identified as ABF-WPS-D1.5-1030. Work was completed at this location and appeared to be in general compliance with contract documents.

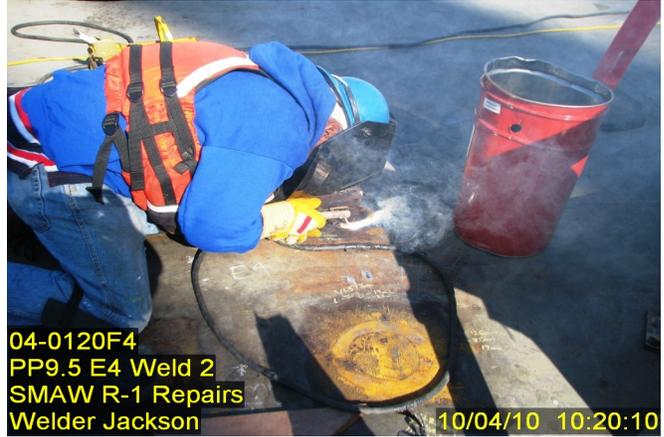
- 2). OBG Field Welding of East Line Lifting Rod Penetration Insert Welds. (R-1 Repair SMAW)

The QAI periodically observed AB/F approved welder Darcel Jackson (ID 9967) performing R-1 repair welding of

the (4) four excavated areas at PP9.5, E4 weld 2 per the Shielded Metal Arc Welding (SMAW) process. See photo below. QC Inspector Steve McConnell was present to monitor the progress and verify that the welding parameters were within the limits established by the approved welding Procedure Specification (WPS) identified as ABF-WPS-D1.5-1001-Repair. The repair welding was completed at this location during the QA Inspectors shift and the work appeared to be in general compliance with contract documents.
