**DEPARTMENT OF TRANSPORTATION**

Contract #: 04-0120F4Cty: SF/ALA Rte: 80 PM: 13.2/13.9File #: 1.28**WELDING INSPECTION REPORT****Resident Engineer:** Siegenthaler, Peter**Address:** 333 Burma Road**City:** Oakland, CA 94607**Report No:** WIR-023442**Date Inspected:** 05-May-2011**Project Name:** SAS Superstructure**OSM Arrival Time:** 700**Prime Contractor:** American Bridge/Fluor Enterprises, a JV**OSM Departure Time:** 1530**Contractor:** American Bridge/Fluor Enterprises, a JV**Location:** Jobsite**CWI Name:** John Pagliero**CWI Present:** Yes No**Inspected CWI report:** Yes No N/A**Rod Oven in Use:** Yes No N/A**Electrode to specification:** Yes No N/A**Weld Procedures Followed:** Yes No N/A**Qualified Welders:** Yes No N/A**Verified Joint Fit-up:** Yes No N/A**Approved Drawings:** Yes No N/A**Approved WPS:** Yes No N/A**Delayed / Cancelled:** Yes No N/A**Bridge No:** 34-0006**Component:** SAS OBG**Summary of Items Observed:**

## WELDING INSPECTION REPORT

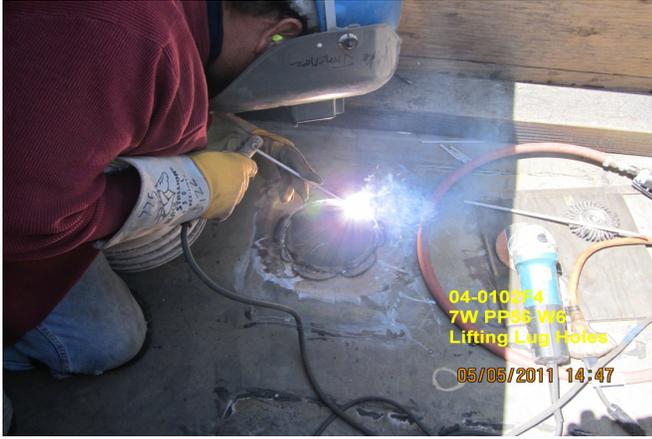
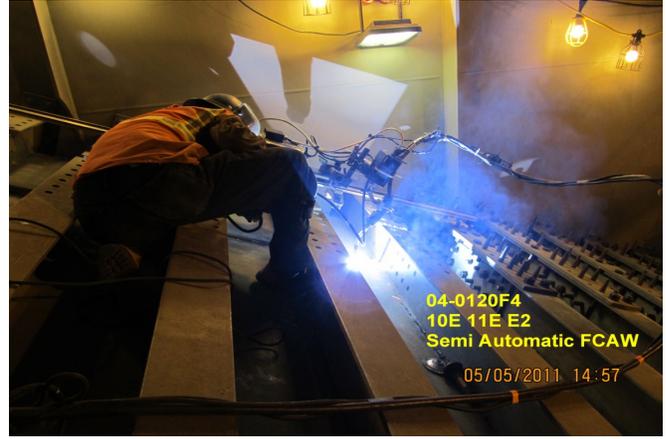
1. 10E 11E E2 (Inside)
2. 9W 10W C (outside)
3. 6W PP64 W3 Lifting Lug Holes 2&4 (Inside) VT Request by QC
4. 7E PP52 E3 Lifting Lug Holes 1&3 (Inside) VT Request by QC
5. 7E PP55 E3 Lifting Lug Holes 2-4 VT, MT and UT
6. 7E PP56 E3 Lifting Lug Holes 1-3 VT, MT and UT
