GEOTECHNICAL DESIGN REPORT

Lee Vining Rockfall Safety Project in Mono County near Lee Vining from 0.4 mile north of
National Forest Visitor Center Road to 0.7 mile north of Picnic Grounds Road

09-Mno-395 PM 52.3/53.7

June 25, 2012

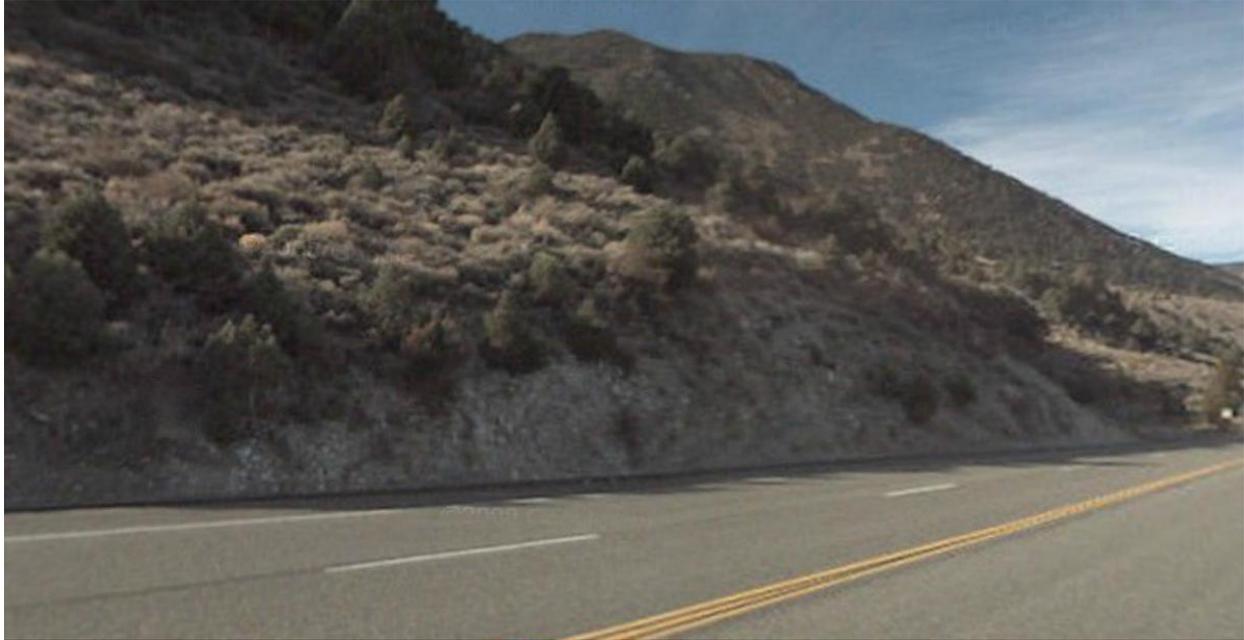
Slope 1 is located at PM 52.39, and begins at Station 114+90 and extends to Station 117+40. The slope lies at an angle of 1:1 (h:v) with a vertical height of about 25-feet to the hinge line. The slope then continues at 1.5: 1 to 2:1 (h:v). The length of the slope is about 250-feet parallel to the roadway. The rocks at this location are typically about 8-inches to 2-feet in diameter.

Figure 2: Photograph looking to the northwest showing Slope 1.

Due to the relatively low generation of rock fall on this slope corresponding to the low RHRS number of 92, as well as a reasonable upslope catchment area, we feel that the proposed 1.5:1 (h:v) cut slopes are constructible. Excavation should be performed according to the 2006 Caltrans Standard Specifications.

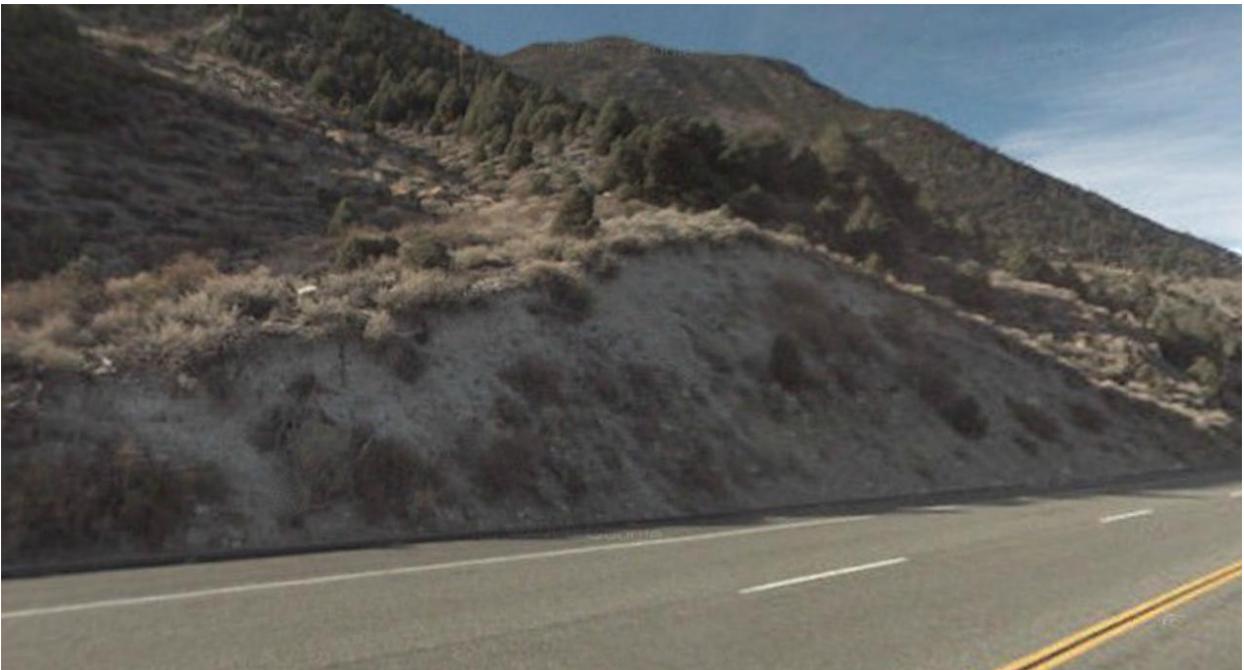
Slope 2 is located at PM 52.50. It begins at Station 120+60 and extends to Station 123+ 10 The slope lies at an angle of 1:1 with a maximum height of 25-feet and a length of about 215-feet along the roadway. The slope then continues at 1.5:1 to 2:1 (h:v) further west. The rocks at this location are typically 6-inches to 1.5-feet in diameter.

Figure 3: Photograph looking to the northwest showing Slope 2.

Due to the presence of an avalanche shoot at the top of the cut slope, it is not recommended to construct a structure at this location. The most feasible alternative for rock fall mitigation would be to grade the slope at a new ratio of 1.5:1 (h:v) or flatter. Excavation should be performed according to the 2006 Cal Ttrans Standard Specifications.

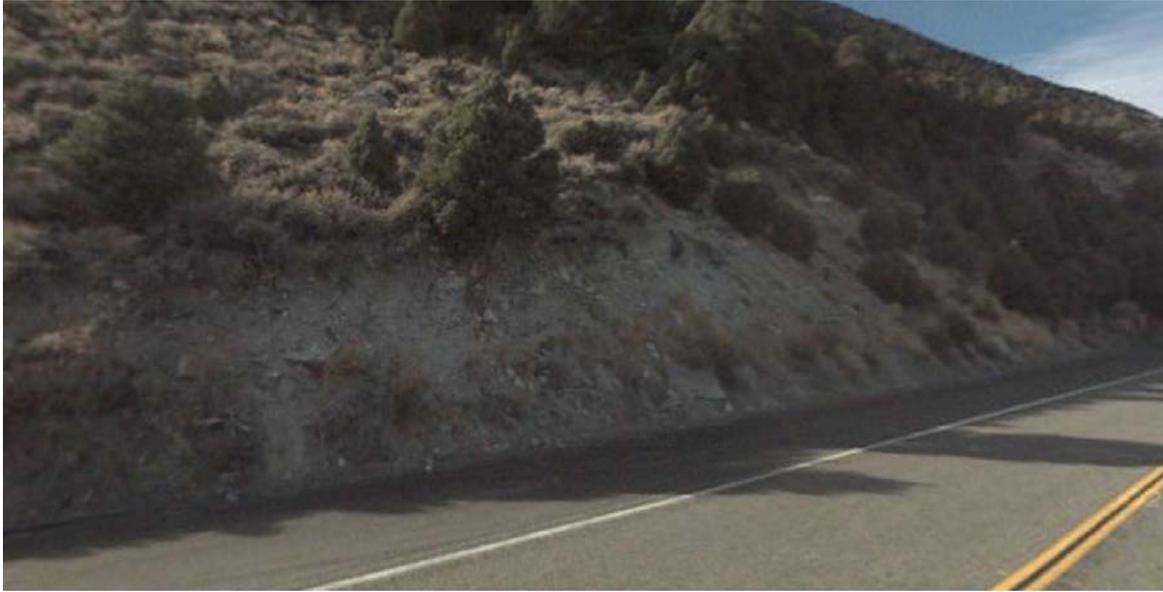
Slope 3 is located at postmile 52.93 and extends from Station 143+05 to 145+80. The slope lies at an angle of 0.75 :1 to 1:1 (h:v) with a maximum height of about 33-feet and a length of 260-feet. The slope then continues at 1.5:1 to 2:1. The rocks at this location are typically 8-inches to less than two-feet in diameter.

Figure 4: Photograph looking to the northwest showing Slope 3.

Slope 3 had the lowest RHRS number for all of the slopes analyzed. Due to the presence of a fifteen-foot unpaved shoulder and a close upslope catchment area, we recommend to grade the slope at a new ratio of 1.5:1 (h:v) or flatter. Excavation should be performed according to the 2006 Cal Ttrans Standard Specifications.

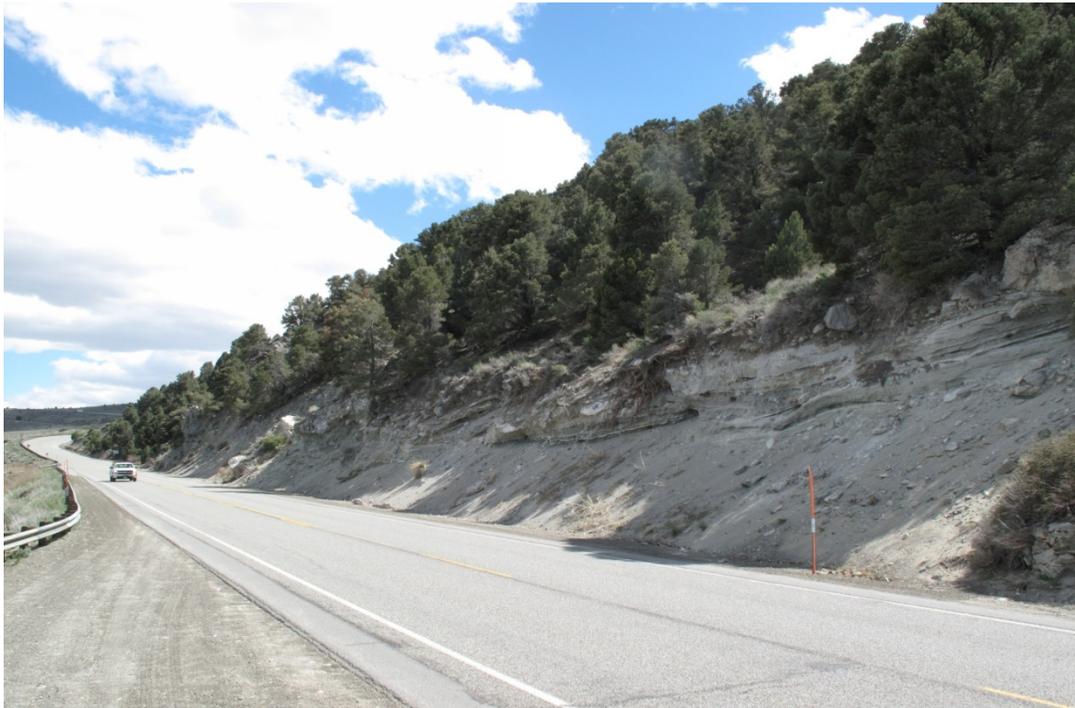
Slope 4 is located at postmile 53.05, north of the marina turn off. The slope extends from Station 149+90 to Station 159+95. The slope is currently at a ratio of 1:1 with a maximum height of 40-feet and a length of about 1000-feet. The slope then continues at 1.5:1 to 2:1 further west. The rocks at this location are typically 8-inches to 2-feet in diameter.

Figure 5: Photograph looking to the southwest showing Slope 4.

Slope 4 is recommended to be draped with Double Twisted Wire Mesh (DTWM) secured to the slope with a cable infrastructure anchored to the slope with grouted cable anchors.

The average size of the rocks falling from this location is typically less than 3-feet in diameter. The use of Double Twisted Wire Mesh (DTWM) drapery would be applicable at this location. Hand scaling and light grading can be performed prior to the mesh being draped on the slope to provide a more uniform surface especially the block of soil and rock at the southerly portion of the slope. The DTWM is anchored along the top. A seed bearing mat and erosion control fabric can be placed beneath the DTWM. If such a system is anticipated Geotechnical Design can aid in the design.

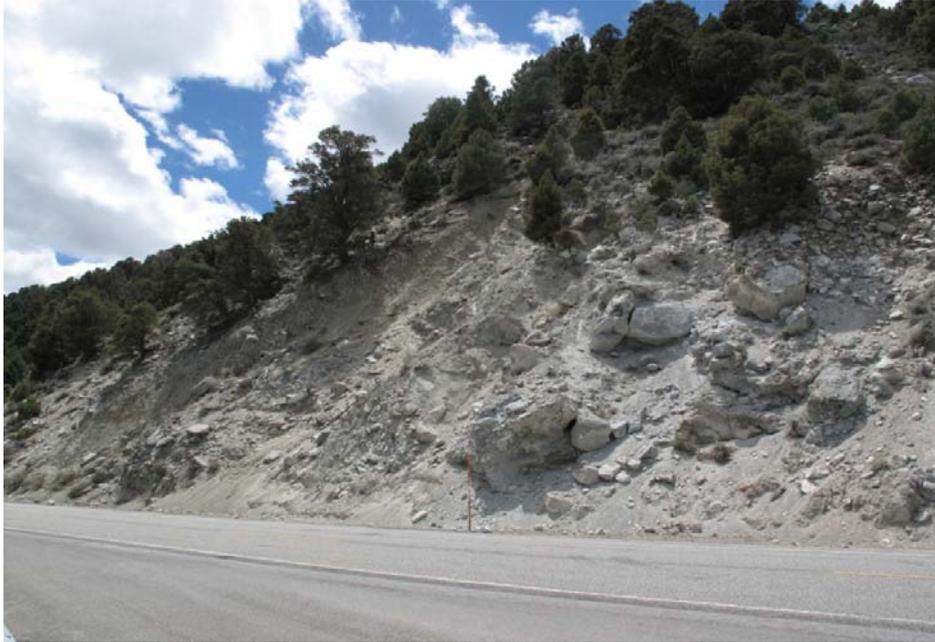
Slope 5 is located at postmile 53.30 and extends from Station 163+20 to 171+20. The slope lies at an angle of about 0.5: 1 to 0.75: 1 (h:v) with a maximum height of about 70-feet and a length of about 800-feet. The slope then continues at 1.5:1 to 2:1. The rock observed at the ground surface at this location is typically 8-inches to over 2-feet in diameter.

Figure 6: Photograph looking to the southwest showing Slope 5.

Slope 5 is recommended to have a rock fall attenuator system installed with approximate ten-foot steel posts, placed approximately twenty-feet on center, suspending a drapery consisting of cable net under DTWM.

Slope 5 has a relatively high RHRS rating, no upslope catchment area, and narrow shoulder widths. A drapery system is the most feasible option for mitigating rock fall generated from the slope. Due to the presence of large (greater than 4-foot) boulders in the cut slope material, and the potential for material to be released above the existing cut slope, the recommended system is an attenuator style system with cable net underlying DTWM (Figure 14). The system would span the large debris shoot in order to contain the material. The steel posts would be approximately ten-feet in height and spaced approximately twenty-feet on center.

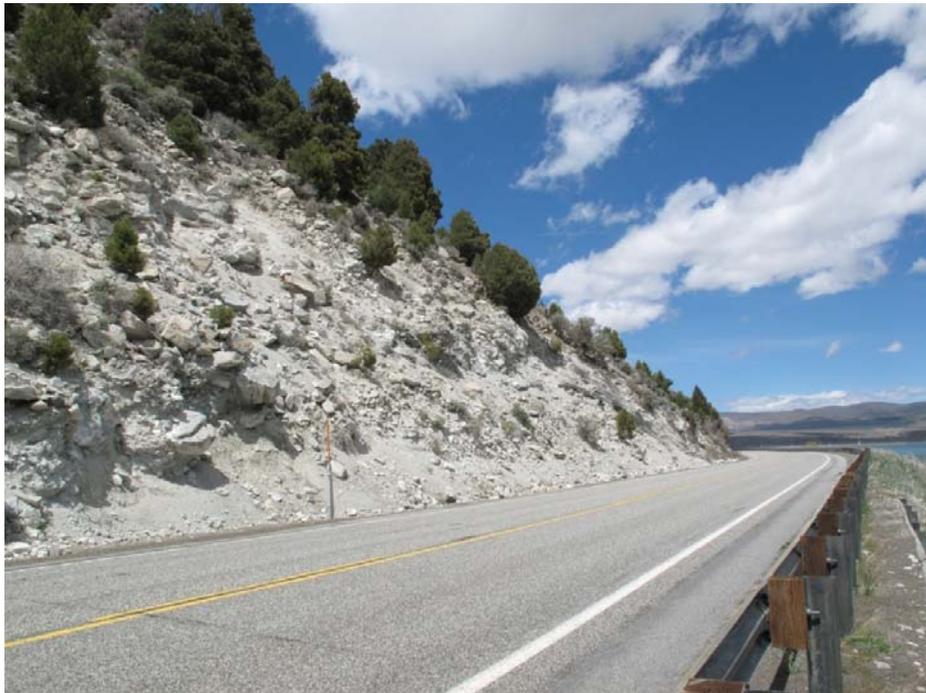
Slope 6 is located at postmile 53.59 and lies between Stations 175+60 and 179+00. The slope lies at an angle of 1:1 with a maximum height of 60-feet and a length of about 340-feet. The slope then continues at 2: 1(h:v). The rocks at this location are typically 18- inches to greater than four-feet in diameter.

Figure 7: Photograph looking to the north showing Slope 6.

Slope 6 is also recommended to have a rock fall attenuator system installed with approximate ten-foot steel posts, placed approximately twenty-feet on center, suspending a drapery consisting of cable net under DTWM.

Slope 6 has the highest RHRS rating of 567, primarily due to the lack of decision sight distance. There is very little shoulder (4-foot on either side). Due to the presence of large (greater than 4-foot) boulders in the cut slope material, and the potential for material to be released above the existing cut slope, the recommended system is an attenuator style system with cable net underlying DTWM (Figure 16). The upper posts should be approximately ten-feet in height and spaced approximately twenty-feet on center.

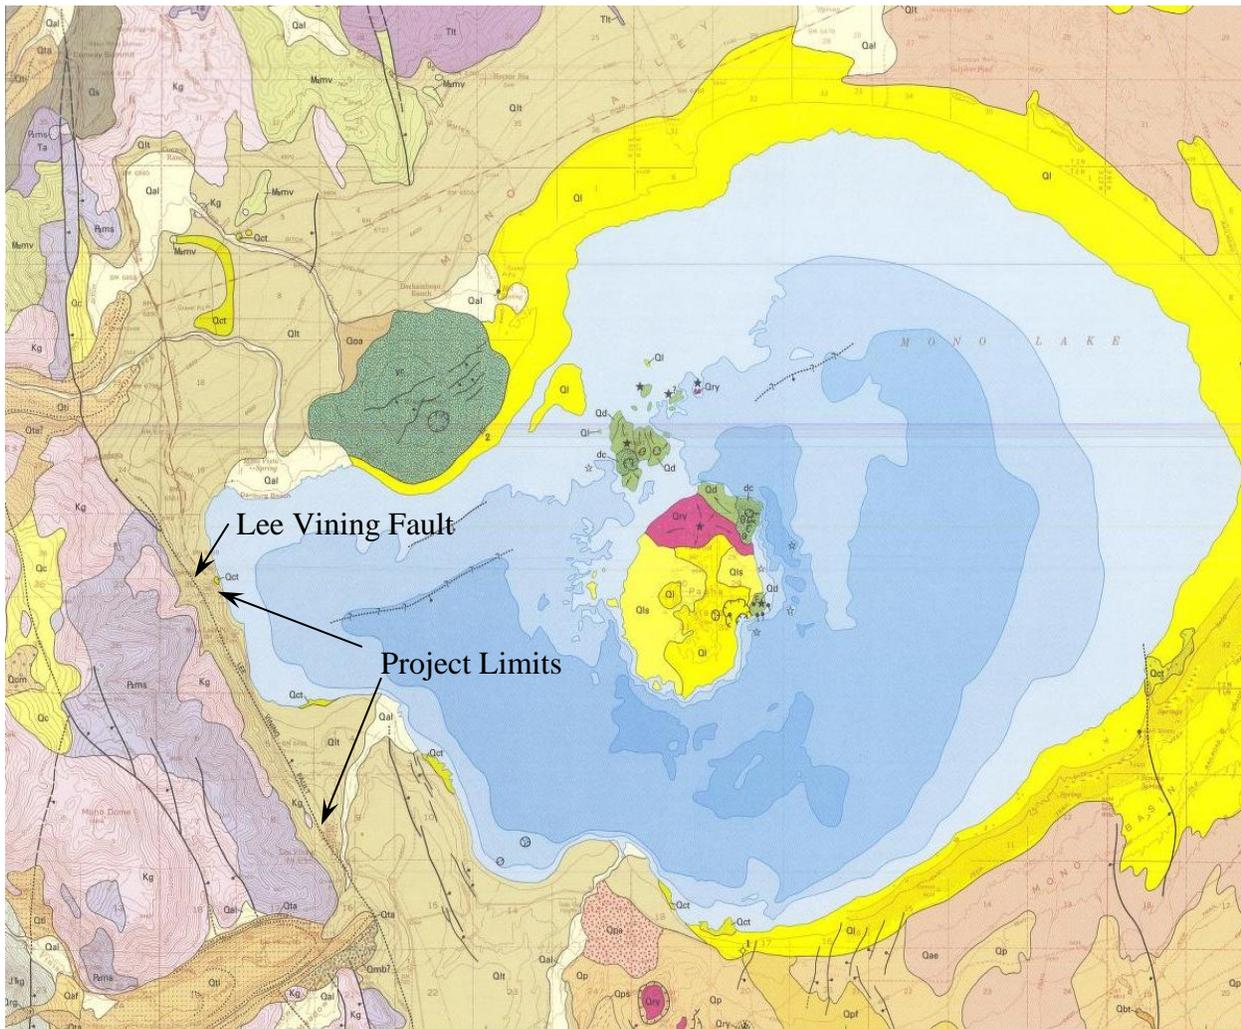
According to the Geologic map of the Long Valley Caldera, Mono-Inyo Craters Volcanic Chain and Vicinity, Eastern California (USGS, 1989) the site is underlain by Quaternary

lake deposits (Qlt). A section from this map showing the project location is attached as Figure 9.

The map shows the Lee Vining Fault trends parallel to the Highway. According to Caltrans ARS online, the fault has been renamed to the Mono Lake Fault. The Mono Lake Fault is a normal fault with a maximum moment magnitude (MMax) of 6.6.

Figure 9: A portion of the “Geologic Map of Long Valley Caldera, Mono-Inyo Craters Volcanic Chain and Vicinity, Eastern California”.

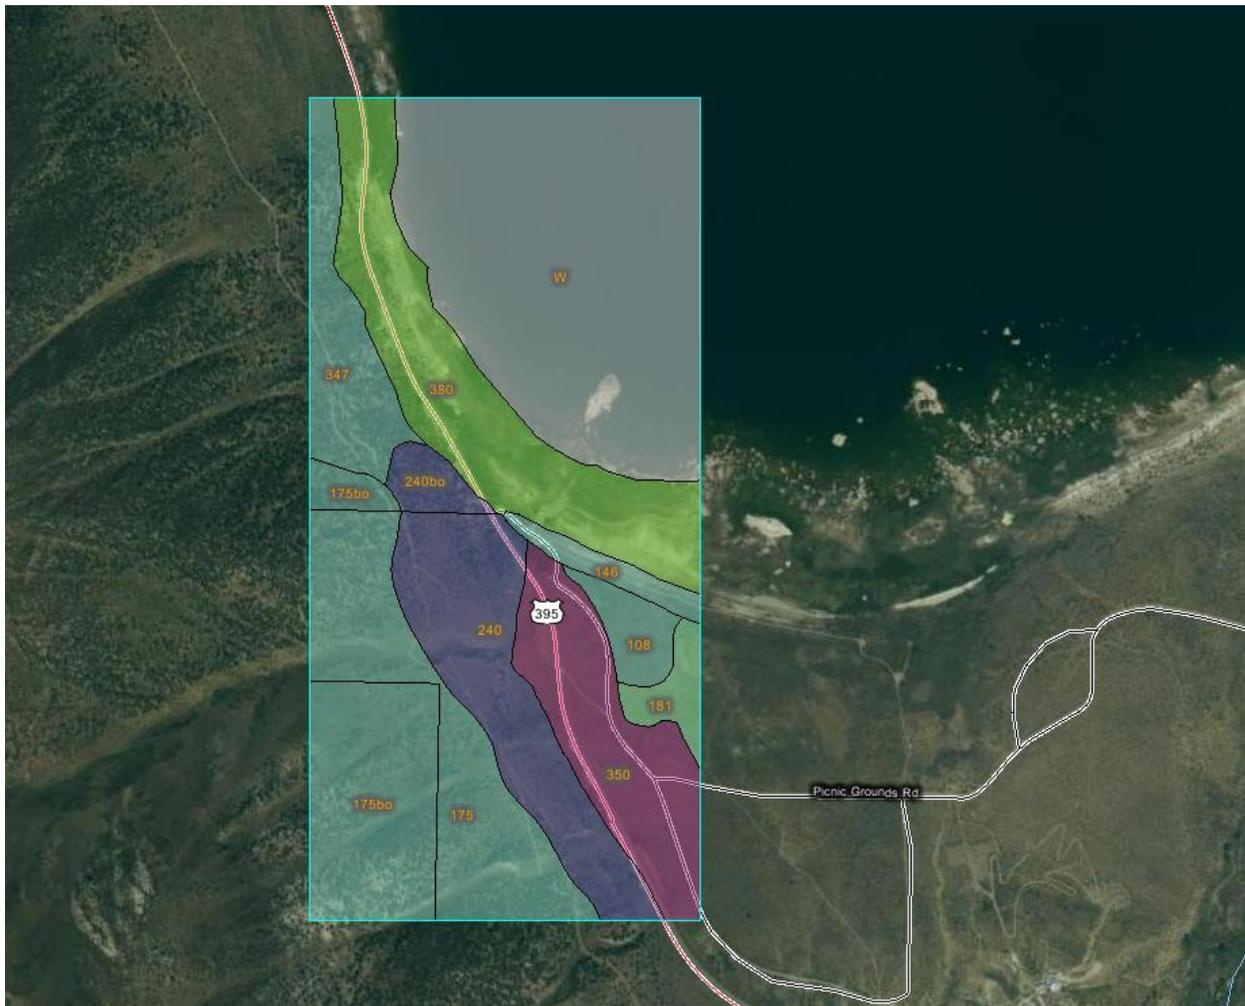
The online Web Soil Survey, <http://websoilsurvey.nrcs.usda.gov>, was utilized to provide a soil and erodability of the soils located at the Lee Vining rock fall project locations. The following Table and Figure describe the soil units observed at the site. There were two soil surveys utilized to provide soil classifications at the site, one, the “Soil Survey of Benton-Owens Valley Area, Parts of Inyo and Mono Counties” and two, the “Soil Survey of the Inyo National Forest, Western Part, California”.

Figure 11: Map denoting the soil units described in the online Web Soil Survey <http://websoilsurvey.nrcs.usda.gov>.

Map Unit Symbol	Map Unit Name	Erodability	USC soil classification
108	Alamedawell-Orecart complex	Slight	SM
175	Cryoborolls bouldery- Cryoborolls- Rock outcrop complex	Moderate	SM
181	Dechambeau very gravelly- Dechambeau complex	Slight	GC-GM
240	Lithic Xeric Torriorthents- Xeric Torriorthents-Rock outcrop complex	moderate	SC-SM
350	Watterson gravelly loamy sand	Slight	GM
146	Lakash-Brantel families complex	Slight	SM
175bo	Cryoborolls boulder-Cryoborolls- Rock outcrop complex	Moderate	SM
240bo	Lithic Xeric Torriorthents- Xeric Torriorthents-Rock outcrop complex	Moderate	SC-SM
347	Nanamkin family-Rock outcrop complex	Severe	SM
380	Vitrandic Torriorthents, ashy- Vitrandic-Haplodurids	Slight	SP-SM
W	Water	N/A	N/A

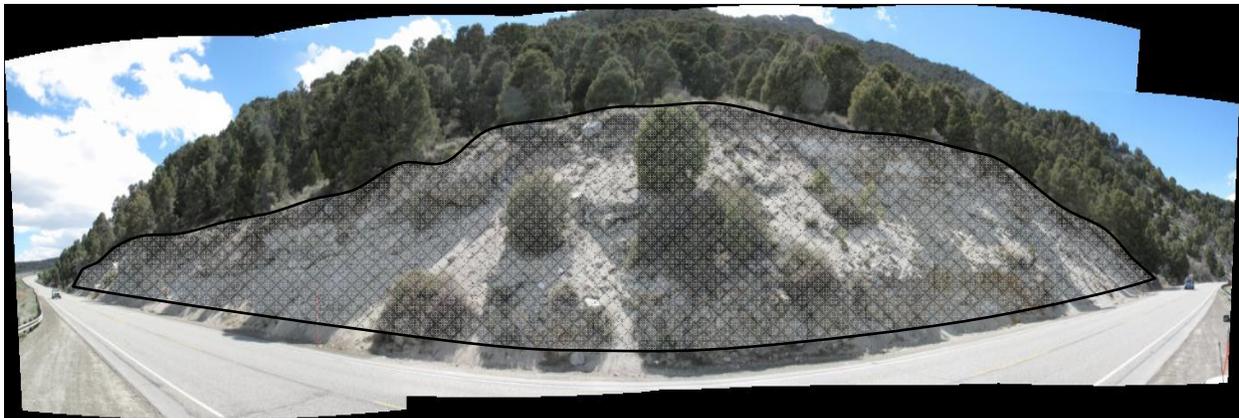
Figure 12: Depiction of the DTWM drapery for Slope 4 which can provide an indication of the vegetation that will need to be removed and/or trimmed.

It is anticipated that the DTWM drapery on Slope 4 will be held in place by a perimeter cable anchor system consisting of grouted steel cables in a three-inch diameter hole.

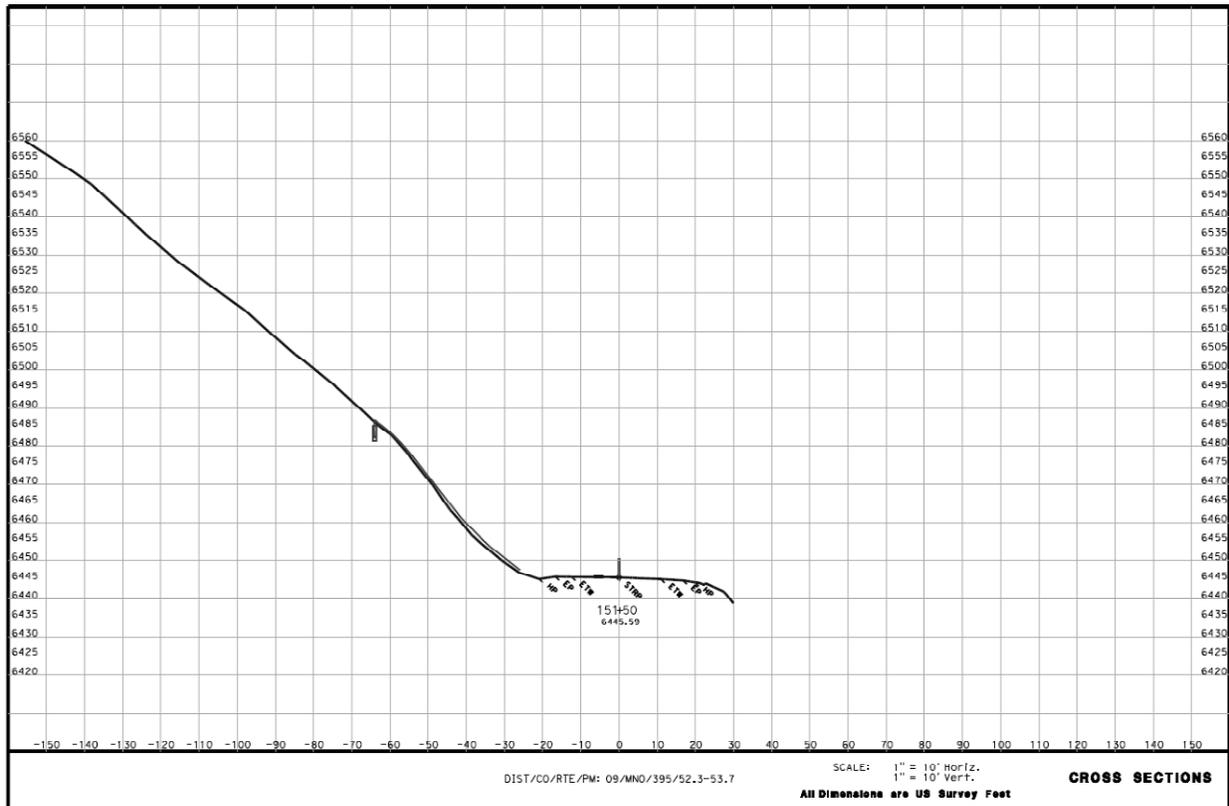
Figure 13: Cross Section of the drapery for Slope 4.

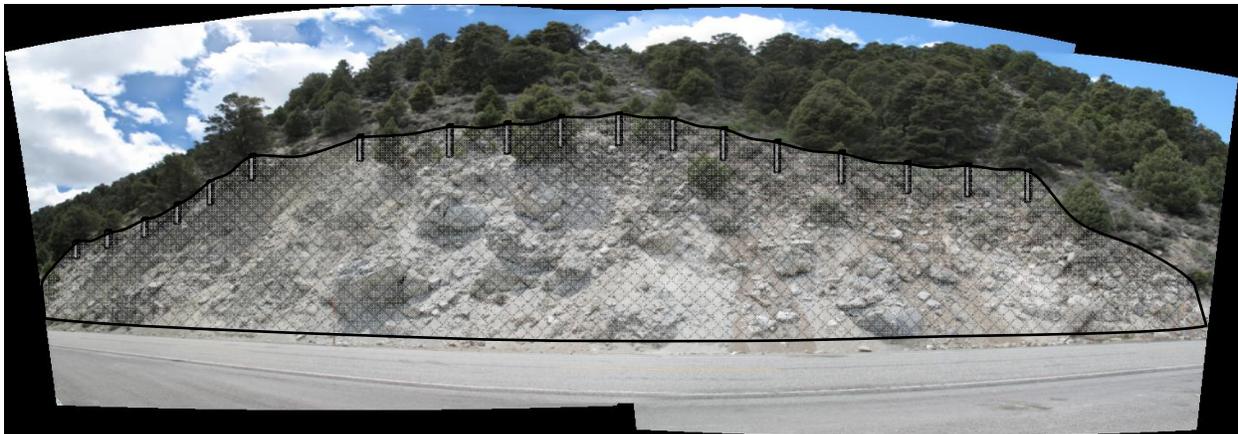
Figure 14: Depiction of the attenuator system for Slope 5 which can provide an indication of the vegetation that will need to be removed and/or trimmed.

The steel posts for the attenuator systems on Slopes 5 and 6 will need concrete foundations consisting of 2-foot by 2-foot by 2-foot spread footings. The top of the footing will remain exposed.

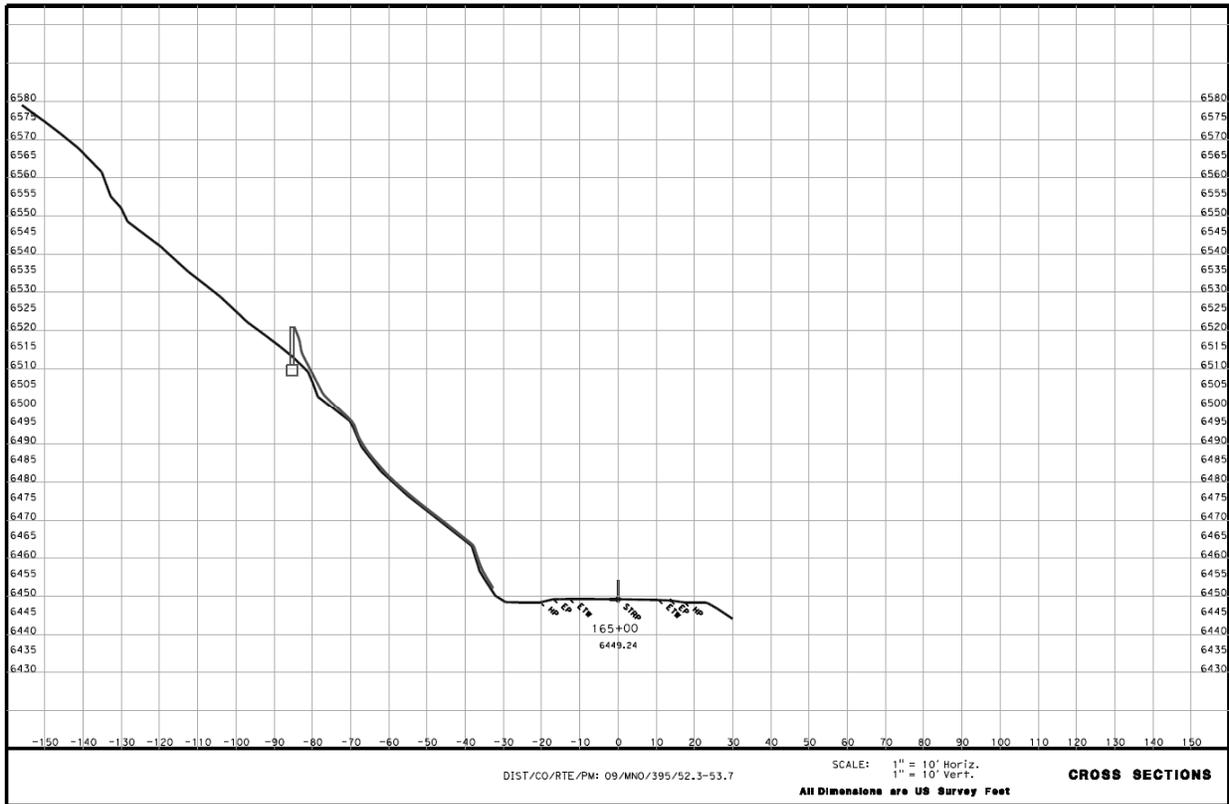
Figure 15: Cross section of the attenuator system for Slope 5.

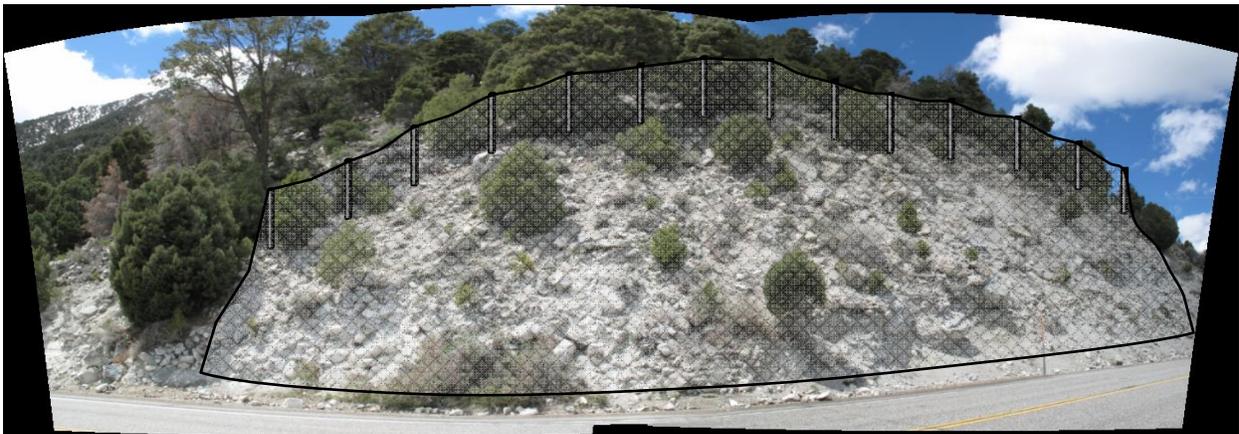
Figure 16: Depiction of the attenuator system for Slope 6 which can provide an indication of the vegetation that will need to be removed and/or trimmed.

It is anticipated that boulder lashing may be needed on up to ten boulders in Slope 6. The cable lashing will be held in place by cable anchors similar to the perimeter anchor system for Slope 4.

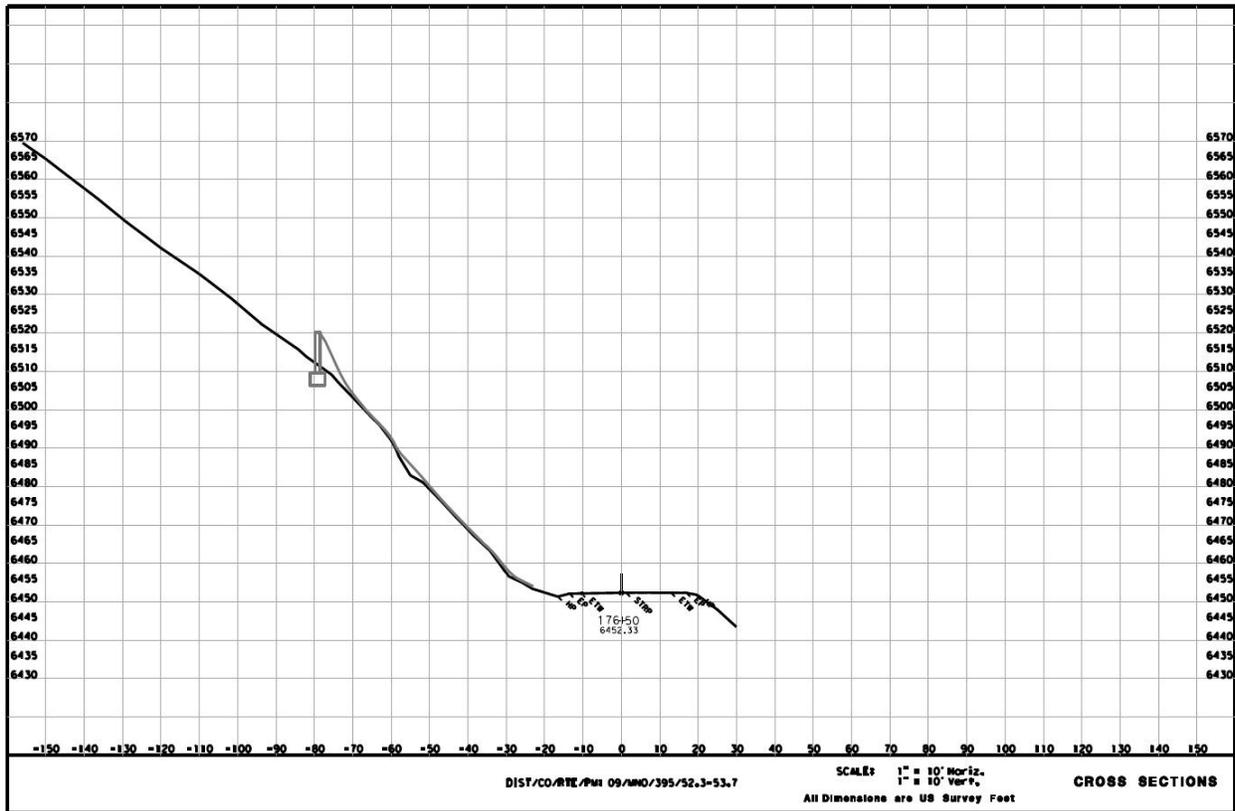
Figure 17: Cross section of the attenuator system for Slope 6.
