SANTA MARIA BUS STOP IMPROVEMENT PLAN

City of Santa Maria Public Works, Transit Division

Developed by
Erin Gorman & Jessica Wafer

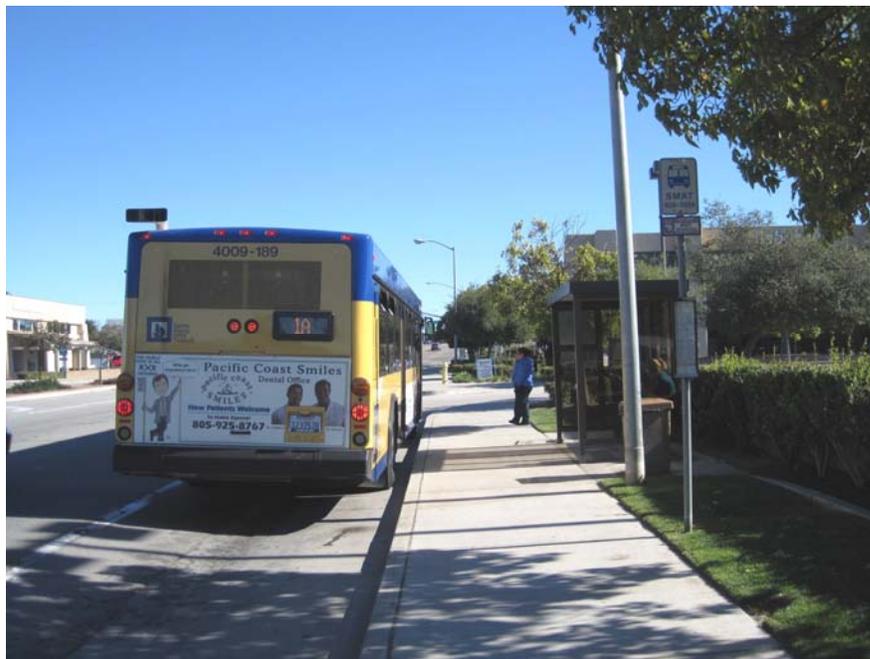
Figure 2: The Clark Avenue at Bradley Road Northbound stop illustrates well-maintained landscaping and proper placement of amenities.

Objective 1-3: Maintain proper landscaping of bus stops to allow proper distribution of lighting and mitigate any hazards from tree branches, oversized bushes, or overgrown grass. See example in Figure 2.

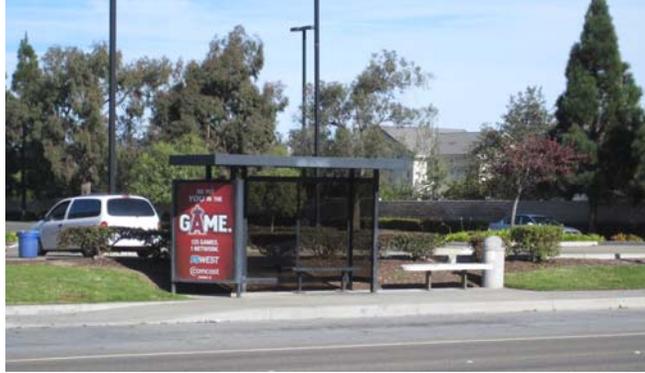
Figure 3: McCoy Lane at Albertson's stop utilizes the available advertisement space, creating additional revenue for the transit system.

Objective 2-1: Utilize advertisement space on shelters, benches, and buses to raise additional revenue. See example in Figure 3.

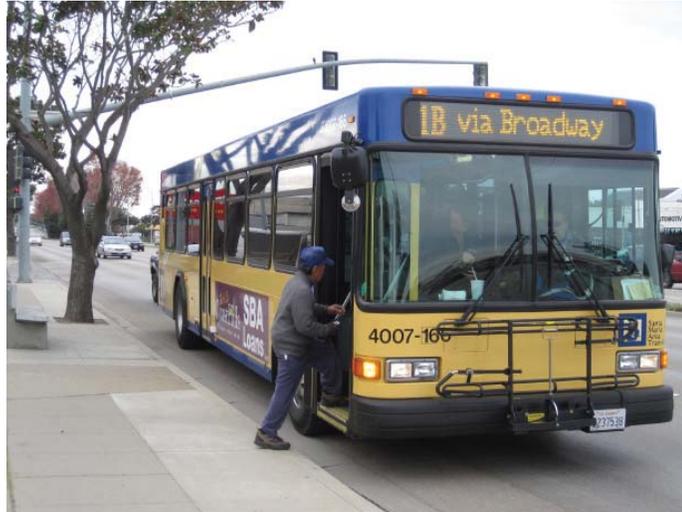
Figure 5: Passenger boarding bus from accessible landing pad.

Objective 3-2: Develop and improve bus stops (where reasonable) to comply with standards set by the Americans with Disabilities Act (ADA). See example in Figure 5.

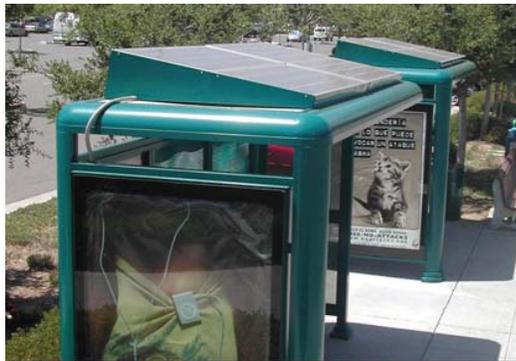
Figure 6: Solar lighting used for evening shelter and advertisement lighting.

Objective 4-3: Include solar lighting at appropriate bus shelters for shelter lighting, advertisement lighting, schedule lighting and/or sign lighting. See example in Figure 6.

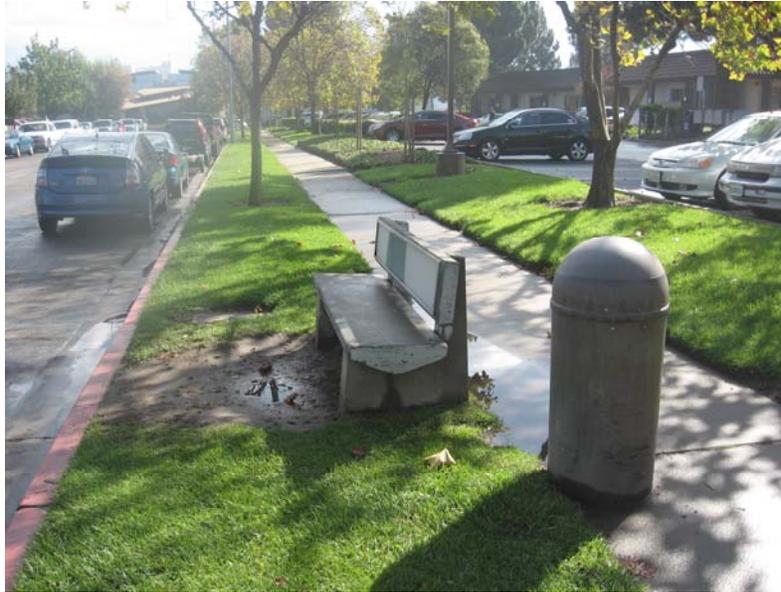
Figure 8: The Cypress Street at Nicholson Avenue bus stop does not have an appropriate landing pad or adequate space on the sidewalk.

In December, 2010, 27 bus stops were classified as being minimally accessible or not accessible due to landing area material. The most problematic materials were grass, dirt, and gravel. During the winter, muddy conditions make the landing area difficult to navigate (e.g. Figure 8). As a result, riders are forced to walk in the street or access stops by neighboring driveways. These stops should receive priority for landing area updates with concrete or asphalt connections.

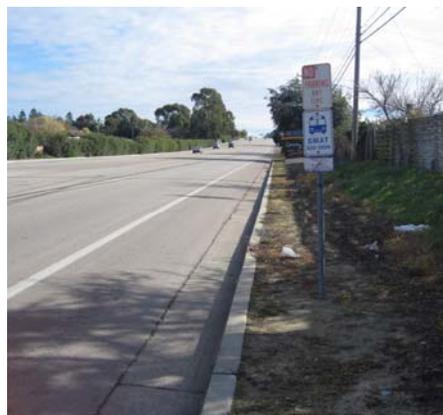
Figure 9: Santa Maria Way at Holly Oak Lane stop with no pedestrian connections.

The majority of landing areas within Santa Maria are made of concrete; however, these landing areas still pose accessibility issues. Several stops were noted for not having adequate space between stop amenities and the curb, and many intersections do not have curb cuts or sidewalks (e.g. Figure 9). These findings suggest that pedestrian and rider mobility is severely limited, creating hazardous transit stops at certain locations.

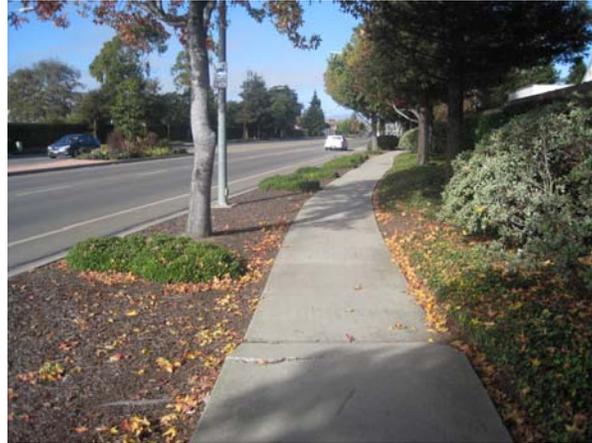
Figure 10: Miller Street at Battles Road stop with uneven sidewalk.

Landscaping has also created accessibility issues, with roots uplifting the sidewalk or overgrown bushes impeding sidewalk space (e.g. Figure 10). In order to mitigate any

landscaping issues, proper maintenance and planning of sidewalks, landing areas, and landscaping features is necessary.

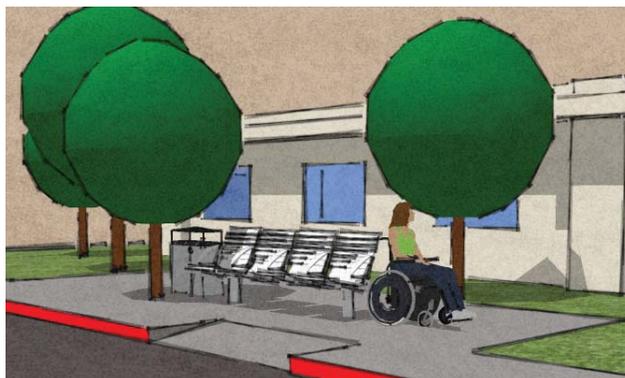
Figure 18: Type 2 includes a transit sign, a painted red curb, schedule information, seating, and a trash receptacle.

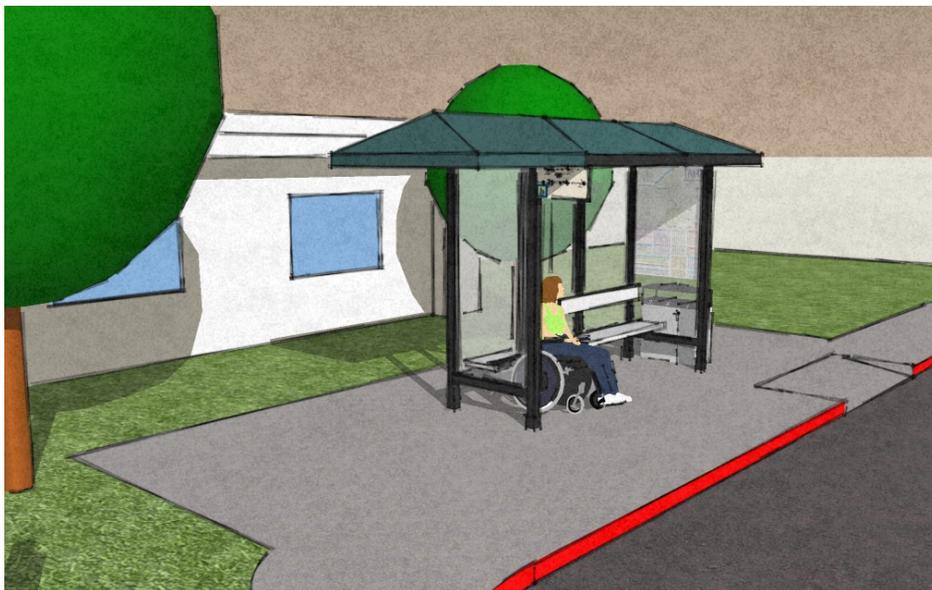
Figure 20: Type 3 bus stop with all necessary amenities, including ADA accessibility.

Type 3 bus stops include a transit sign, a painted red curb, schedule and route information, a trash can, and a shelter. Below are two illustrations showing the amenities found at Type 3 bus stops.

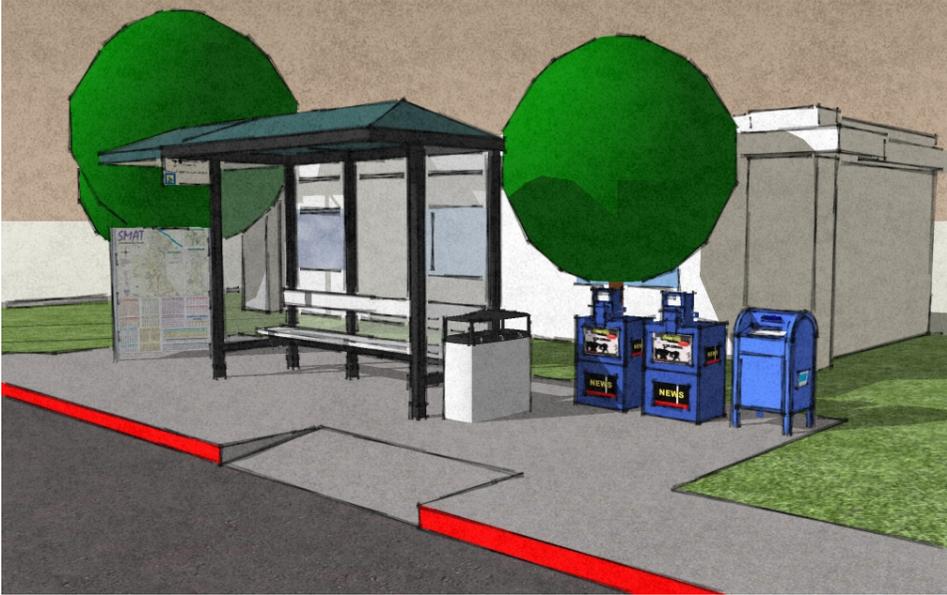
Figure 21: Type 4 bus stop with newspaper boxes and all-routes map.

Type 4 bus stops include all the amenities found in Type 3 bus stops along with several additional amenities as shown in Figures 21 and 22. Type 4 bus stops include an all-routes map and advertising within the shelter. Depending on location, Type 4 bus stops may also include bike racks, newspaper stands, additional seating, or an additional shelter.

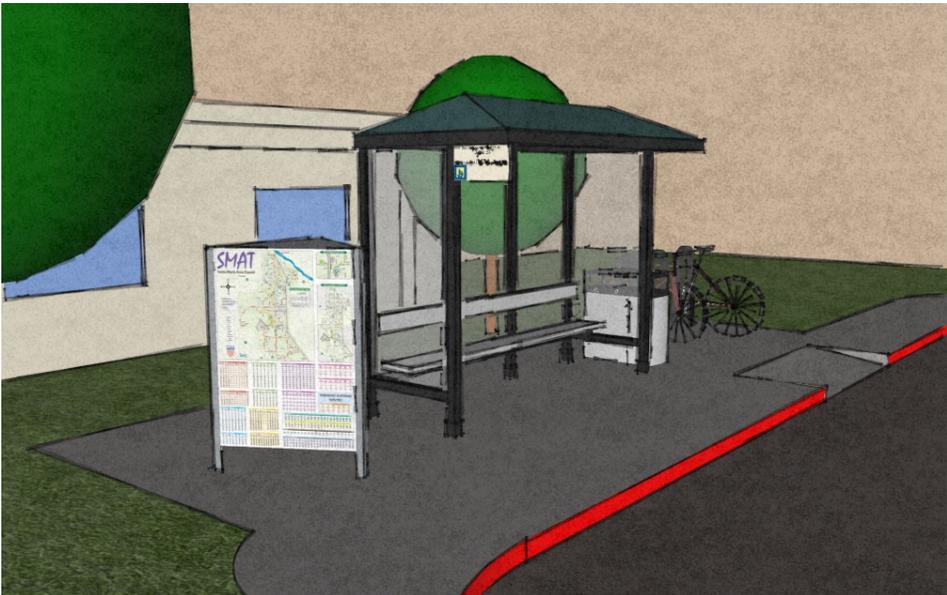
Figure 22: Type 4 bus stop with bike racks and all-routes map.

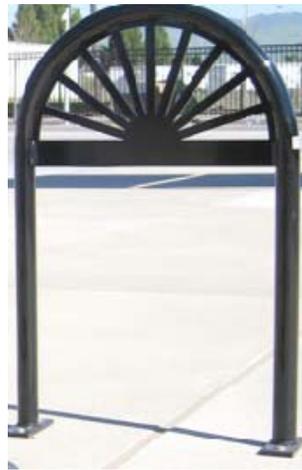
Figure 23: Cycle-Safe, Breton Bicycle Rack

Bicycle racks should be included at bus stops that have potential to attract bicycle riders. Figure 23 shows an example of a bicycle rack. This will be encouraged in order to be compliant with the Santa Maria Bikeway Master Plan, implemented in 2009. By encouraging cyclists to bike to transit stops, it will encourage more sustainable practices and an active lifestyle within Santa Maria.

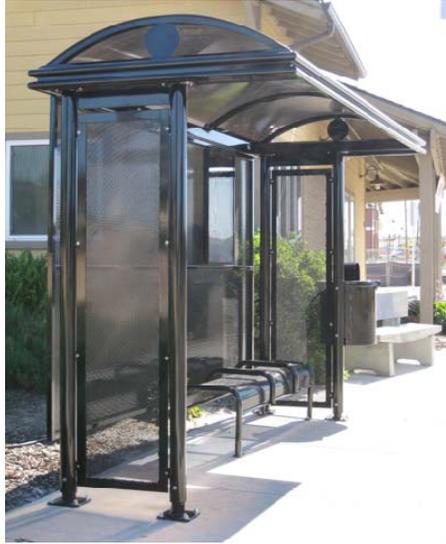
Figure 24: Covered bus shelter (Tolar Manufacturing) with perforated metal siding and bench, with anti-vagrant bars.

The style of new shelters should mimic the style of the shelters found at the new Transit Center. Perforated metal should be the dominant material for the shelter in order to discourage any graffiti. Roofs should be included on all shelters in order to provide shade during Santa Maria's warm summers. Three-sided shelters are encouraged in order to protect users from Santa Maria's strong winds in the fall and winter (e.g. Figures 24 and 25). All seating in shelters should have anti-vagrant bars, shown in Figure 24. Bus stops that are categorized as Type 4 should have shelters that include advertisements. Advertisements can be located on the shelter or on a kiosk attached to the shelter. Advertisements must have their own lighting if on a kiosk. Shelters must be lighted by in-shelter lighting. If possible, the shelter panels and advertisements should be coated with anti-graffiti paint. Trash cans should be attached to shelters (e.g. Figure

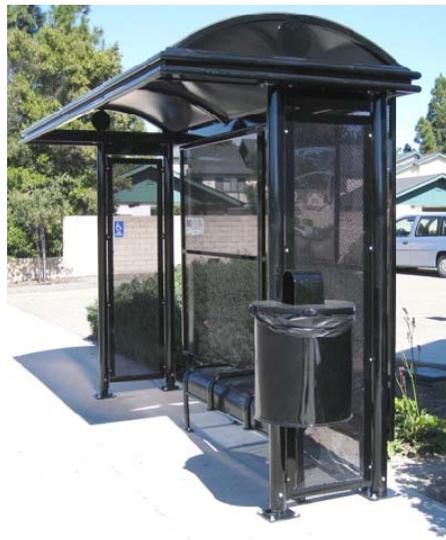
Figure 25: Covered bus shelter (Tolar Manufacturing) with perforated metal siding and a trash can.

25) and additional trash or recycling cans can be installed, but they must meet the guidelines discussed in the trash and recycling sections. All shelters should be ordered in black to match the bus stop amenities at the Transit Center.

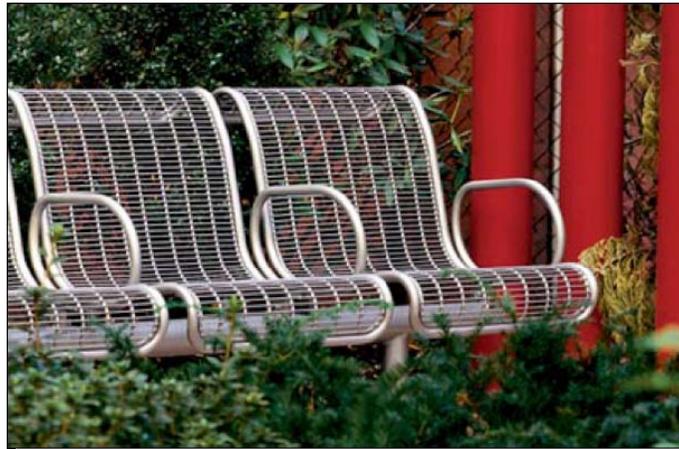
Figure 26: Metal seating with a back and anti-vagrant bars, matches trash can in Fig. 30
Source: Landscape Forms (Plexus)

All seating will have anti-vagrant bars and be made of perforated metal (Figures 26 and 27). Seating styles will also mimic the shelter designs and will be ordered through either Landscape Forms or Tolar Manufacturing. The bench in Figure 27 will be used throughout the downtown area, while the bench in Figure 26 will be used in all other parts of Santa Maria and Orcutt. If possible, the seating will be coated with anti-graffiti paint. Seating in shelters will also have anti-vagrant bars and be made of perforated metal, and will be ordered through Tolar Manufacturing, along with the shelters. All seating will be ordered in black to match the shelters.

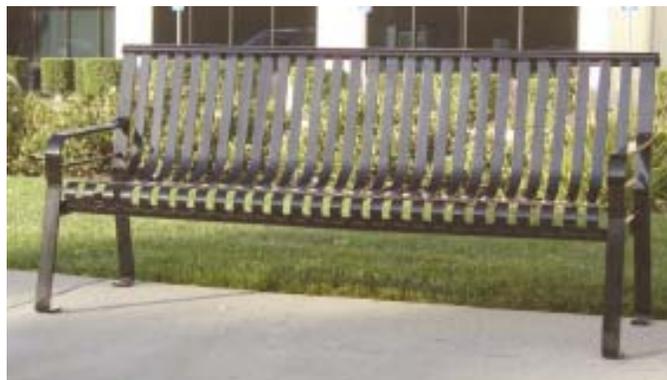
Figure 27: Metal seating (possible anti-vagrant bars), matches trash can in Fig. 31
Source: Tolar Manufacturing

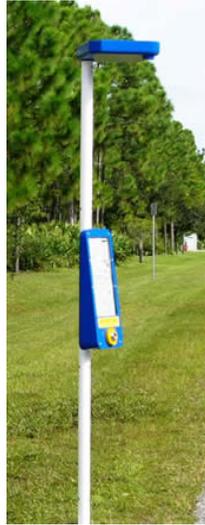
Figure 29: Adequate bus stop lighting.

Light should be distributed adequately, properly lighting all signage. Figure 29 shows a freestanding *Omnilight* light fixture with an attached schedule rack. When appropriate, street lighting can serve as the primary bus stop lighting. Solar lighting should be considered for any new light installation at all bus stops. Shelters can implement solar lighting into advertisements and shelter lighting. Shelters ordered from Tolar

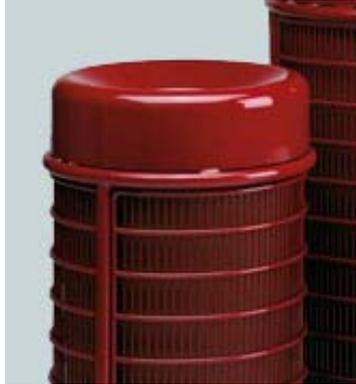
Figure 30: Trash receptacle to match the bench in Fig. 26

Trash receptacles will be installed at all bus stops that include a shelter and at all bus stops including a bench, unless there is strong evidence that it is not needed. For bus stops without shelters, trash receptacles will be bolted to the sidewalk in an accessible area that is visible to users. The receptacles will be made of galvanized steel with a polycarbonate shield which makes them less prone to permanent graffiti. If possible, receptacles will also be coated in anti-graffiti paint. The trash receptacles in Figure 30, to be used outside of the downtown area, and Figure 31, to be used in the downtown area, will be used at any Type 2 bus stops, as well as any Type 3 or 4 bus stops that need additional trash containers. For stops with large amounts of discarded cigarettes, ash trays will be considered as an addition to trash, and bolted onto the side or incorporated into the top of the receptacle. All trash receptacles will be ordered in black to match the shelters.

Since almost all items thrown away at bus stops are recyclable and in order to promote sustainability through Santa Maria's Recycling Program, all stops that require a trash receptacle will also require a recycling receptacle. Similar to the trash receptacle, the can will be made of galvanized steel covered with a polycarbonate shield which makes them less prone to permanent graffiti. If possible, receptacles will be coated in anti-graffiti paint. The same containers used for trash will also be used for recycling, but will be ordered in blue instead of black in order to distinguish the two receptacles (Figure 30 and 31).
