# **APPENDIX B**

Photographs 1-22

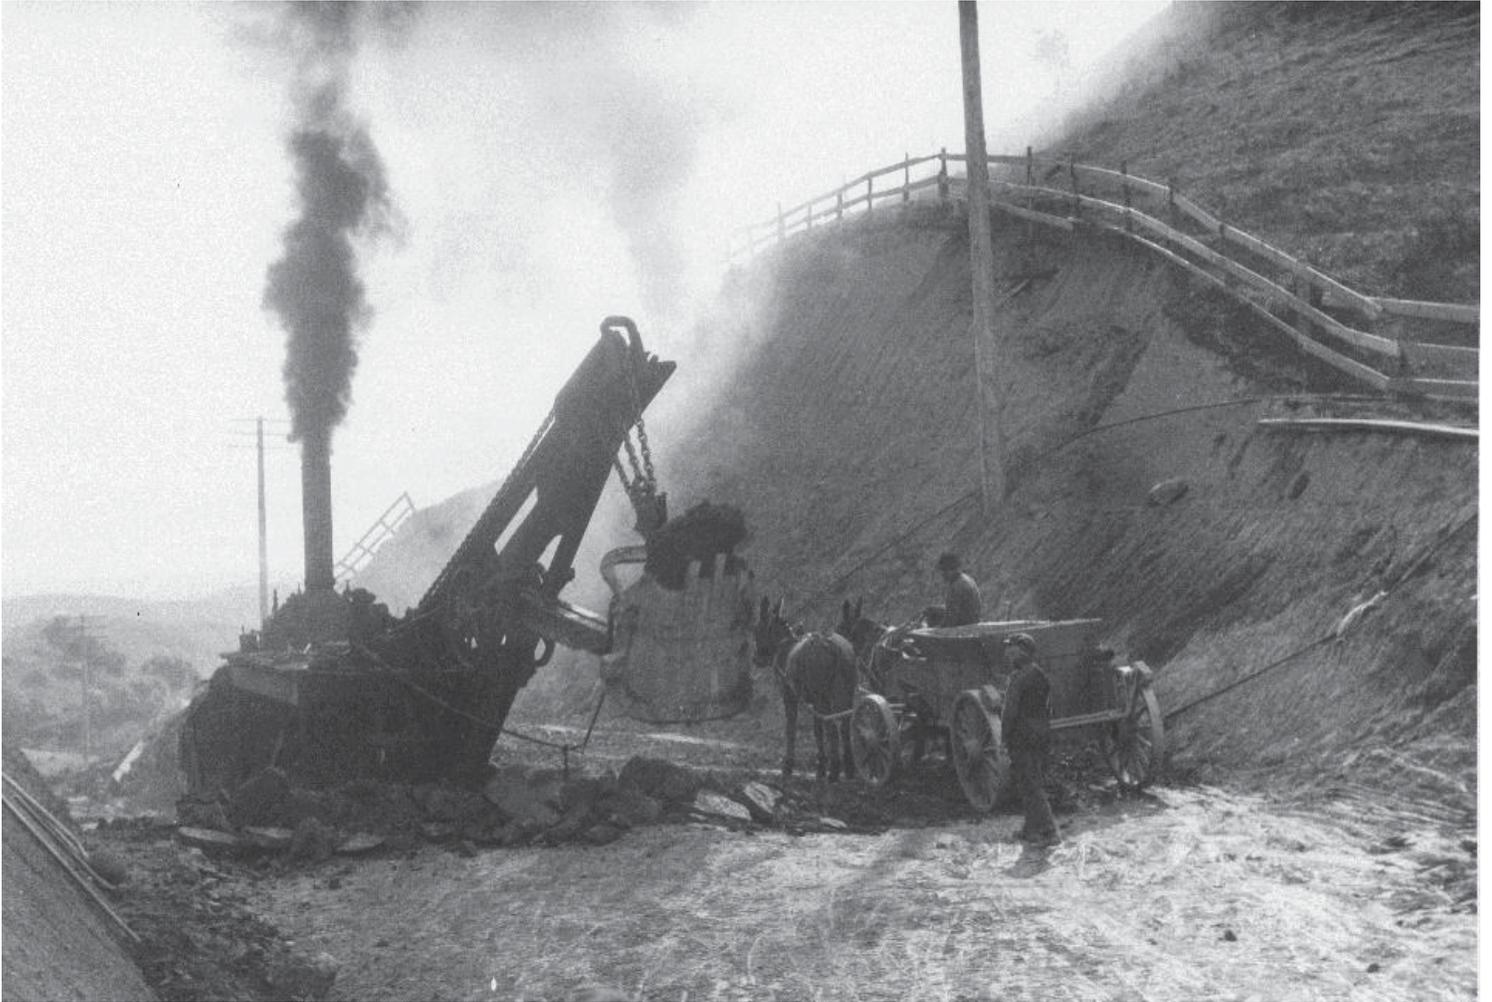
2. **March 1916:** Building U.S. 101 near San Rafael, California. (Caltrans Transportation Library and History Center, Sacramento)

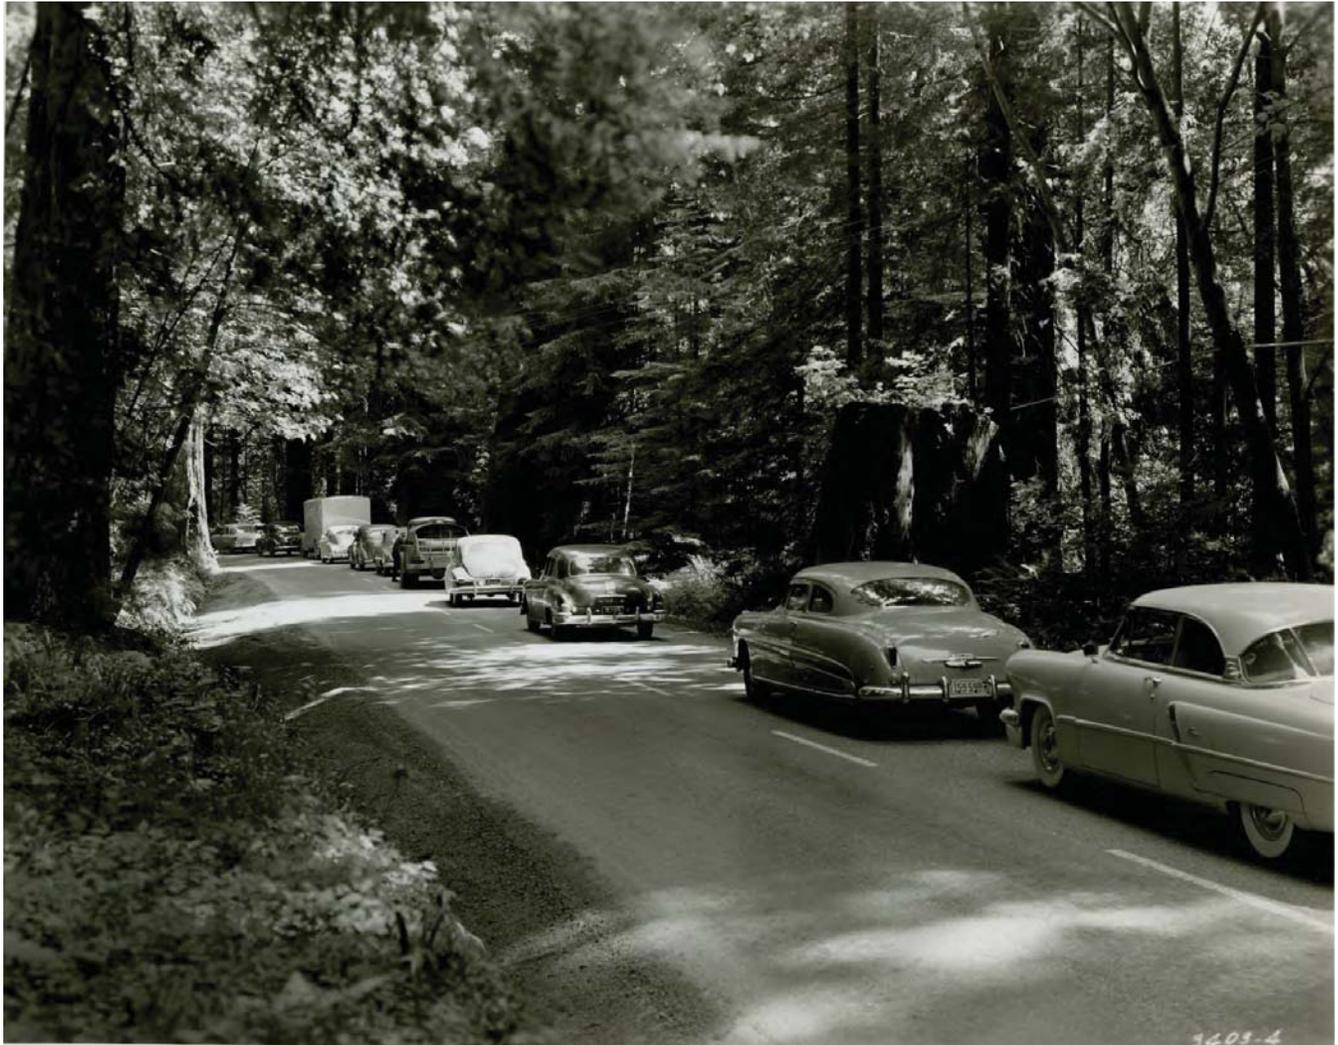
4. **June 1953:** U.S. Highway 101 north of Myers Flat in Humboldt County. (Caltrans Transportation Library and History Center, Sacramento)

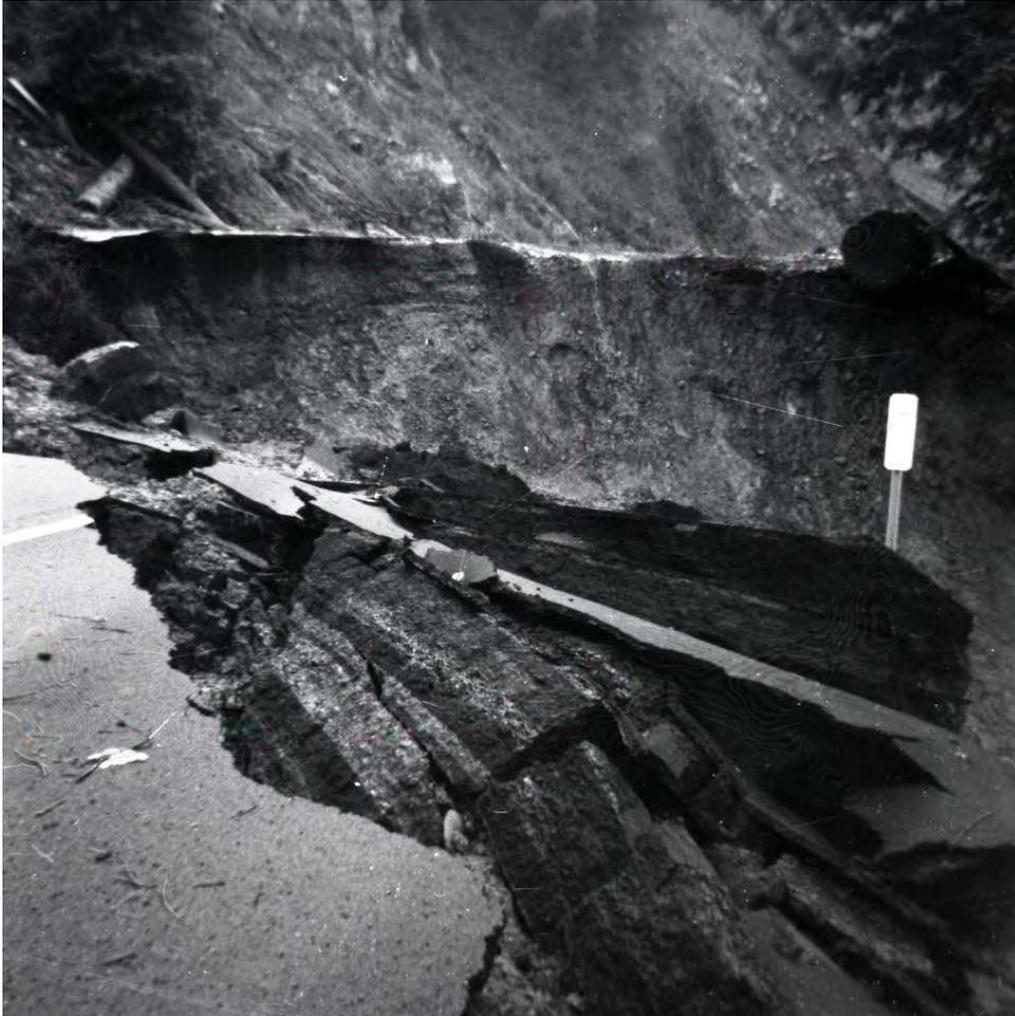
5. **December 1964:** U.S. Highway 101 flood washout in Richardson Grove reveals the depth of road material. (Courtesy of California State Parks, 2011, Catalog #090-17559)

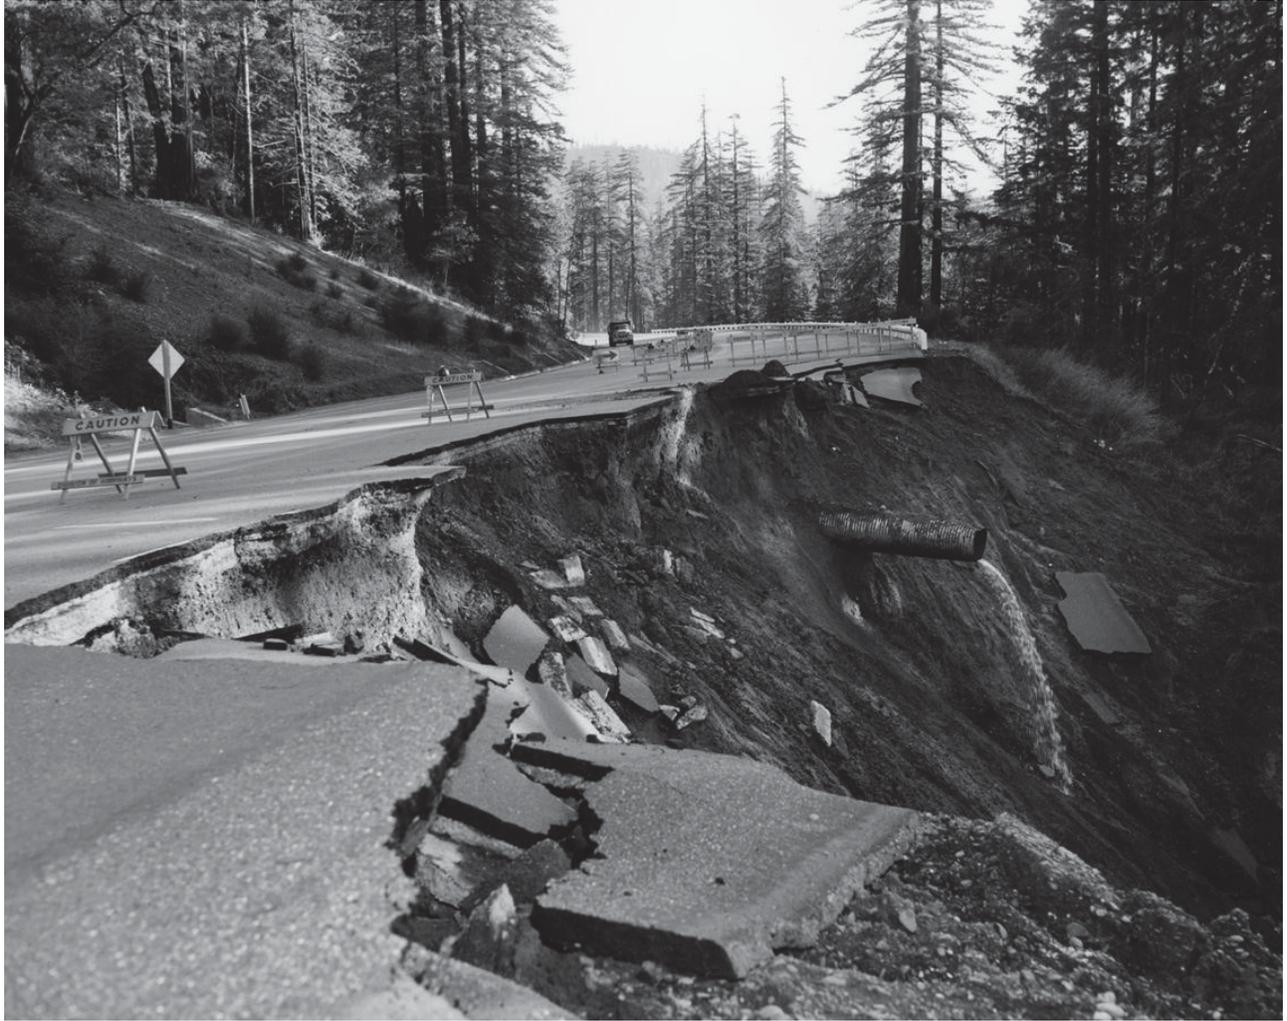
6. **January 1965:** U.S. Highway 101 flood washout near Myers Flat in Humboldt County reveals the depth of road material. (Caltrans Transportation Library and History Center, Sacramento)

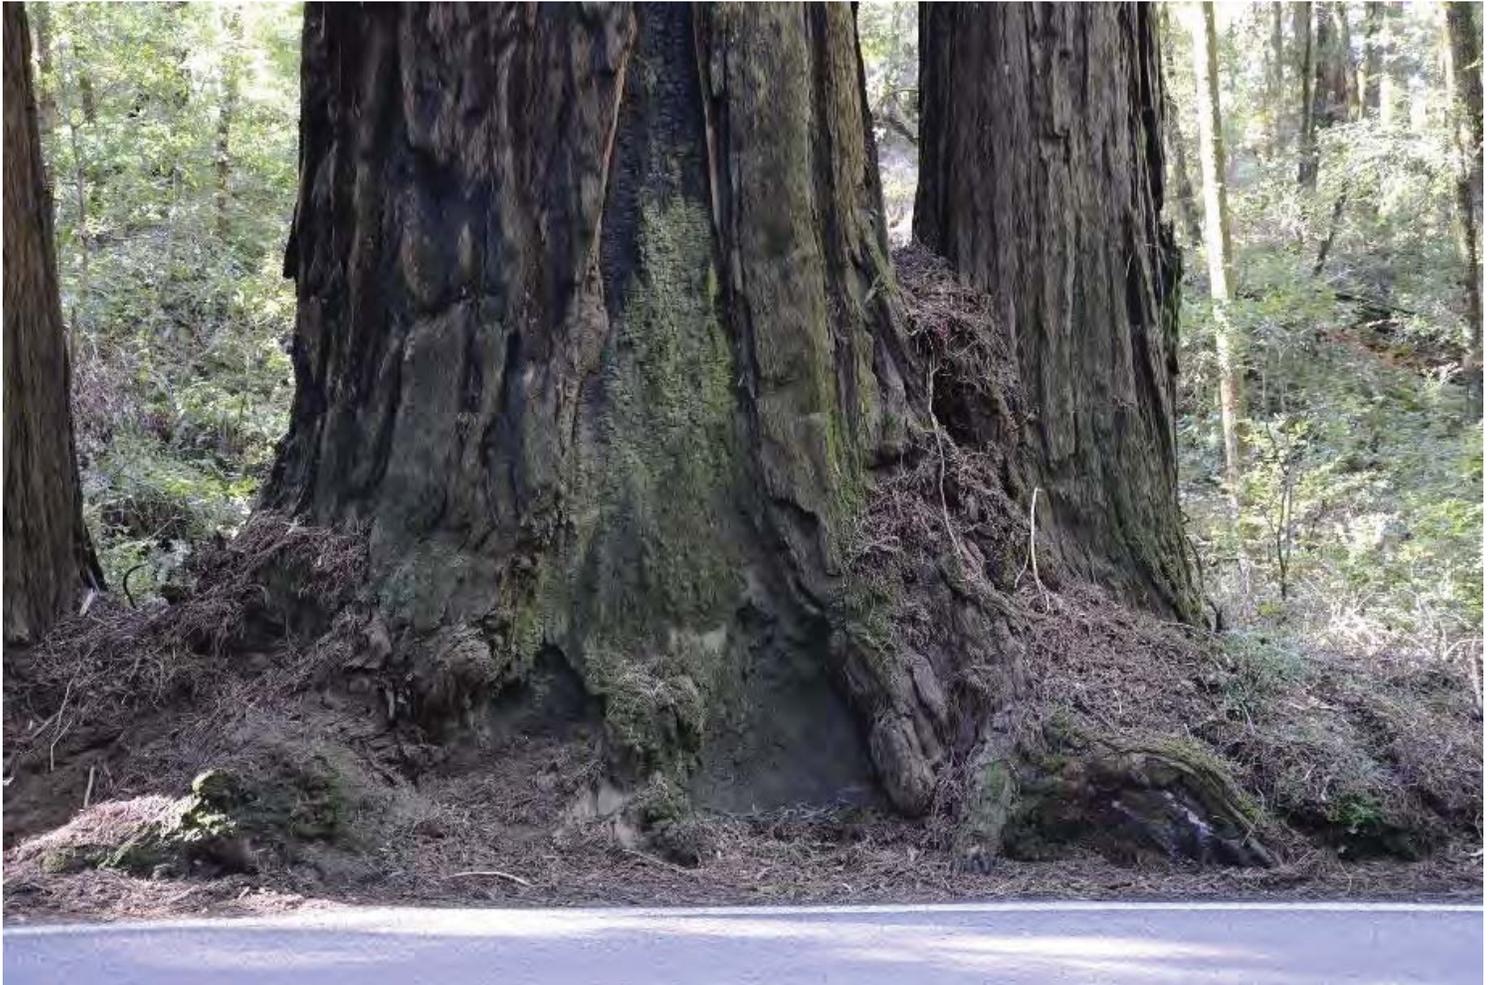
7. **2012:** Tree No. 20 alongside U.S. Highway 101 in Richardson Grove. Very large buttress roots were severed for highway construction, causing the top of the tree to dry out and form a "spike top." No buttress roots of old-growth redwoods would be severed during the Richardson Grove Operational Improvement Project.

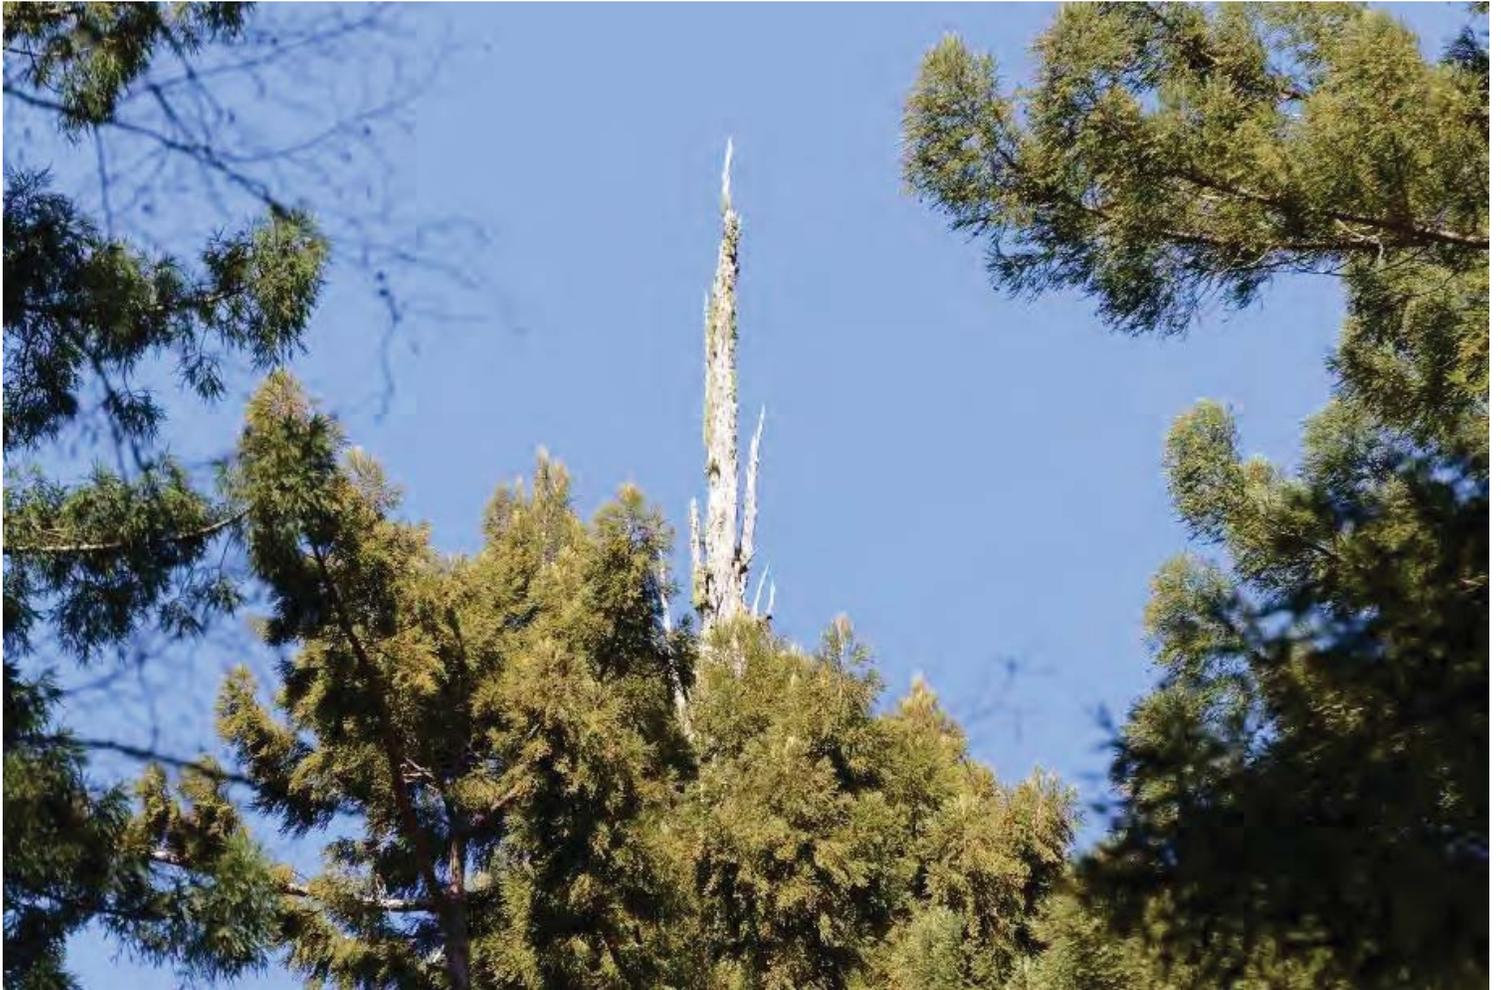
8. **2012:** Top of Tree No. 20, showing a "spike top" most likely caused by severance of major buttress roots several decades ago during highway construction. No buttress roots of old-growth redwoods would be severed during the Richardson Grove Operational Improvement Project.

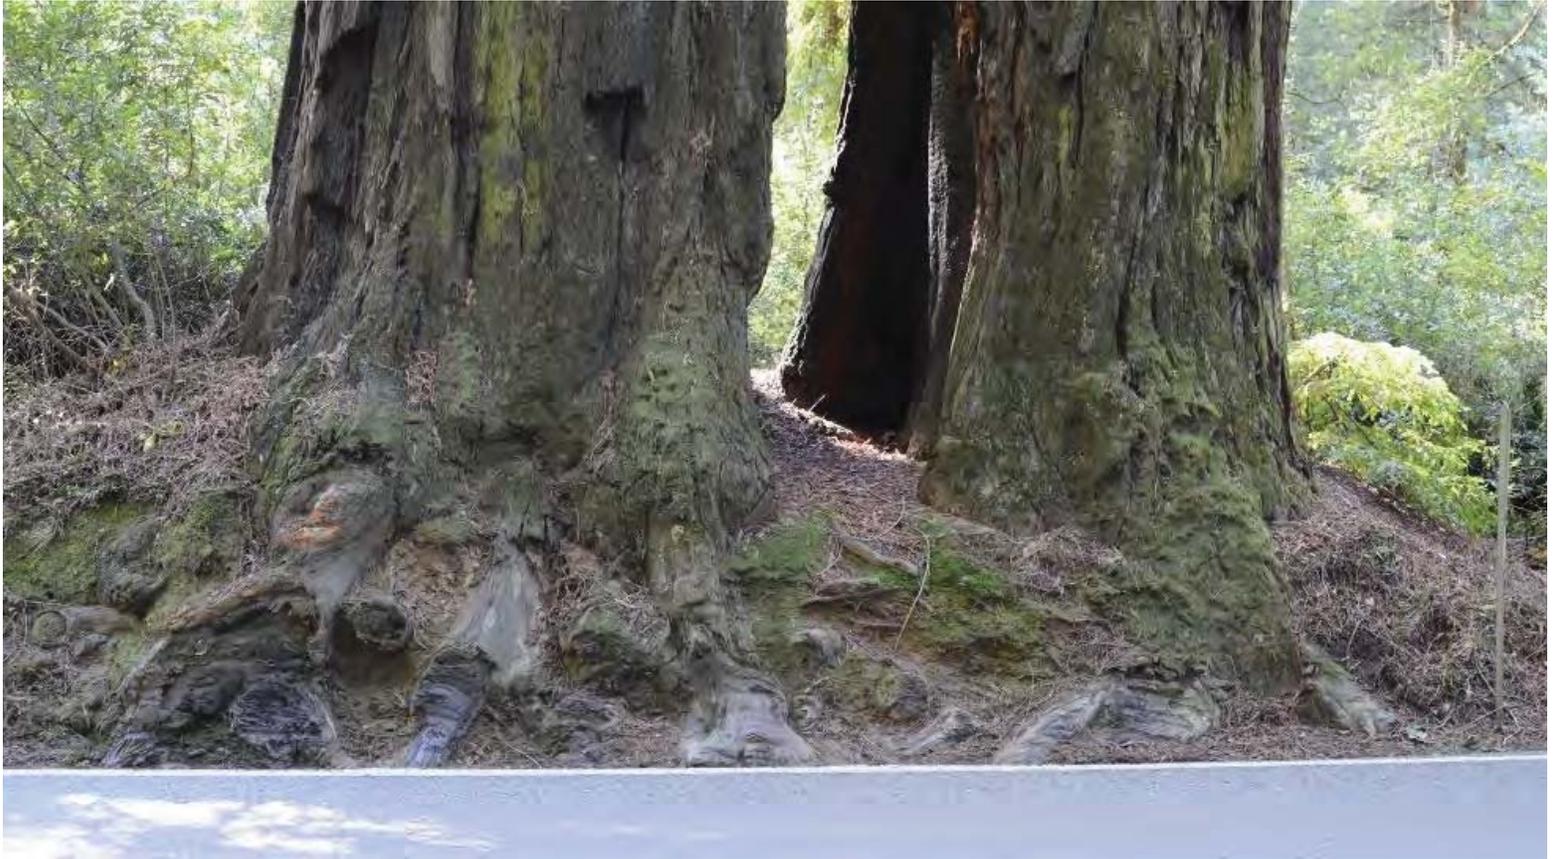
9. **2012:** Trees No. 89 and 90 alongside U.S. Highway 101 in Richardson Grove. Several decades ago, very large buttress roots of these redwoods were severed for highway construction, causing the topmost part of the trees to dry out and form a "spike top." No buttress roots of old-growth redwoods would be severed during the Richardson Grove Operational Improvement Project.

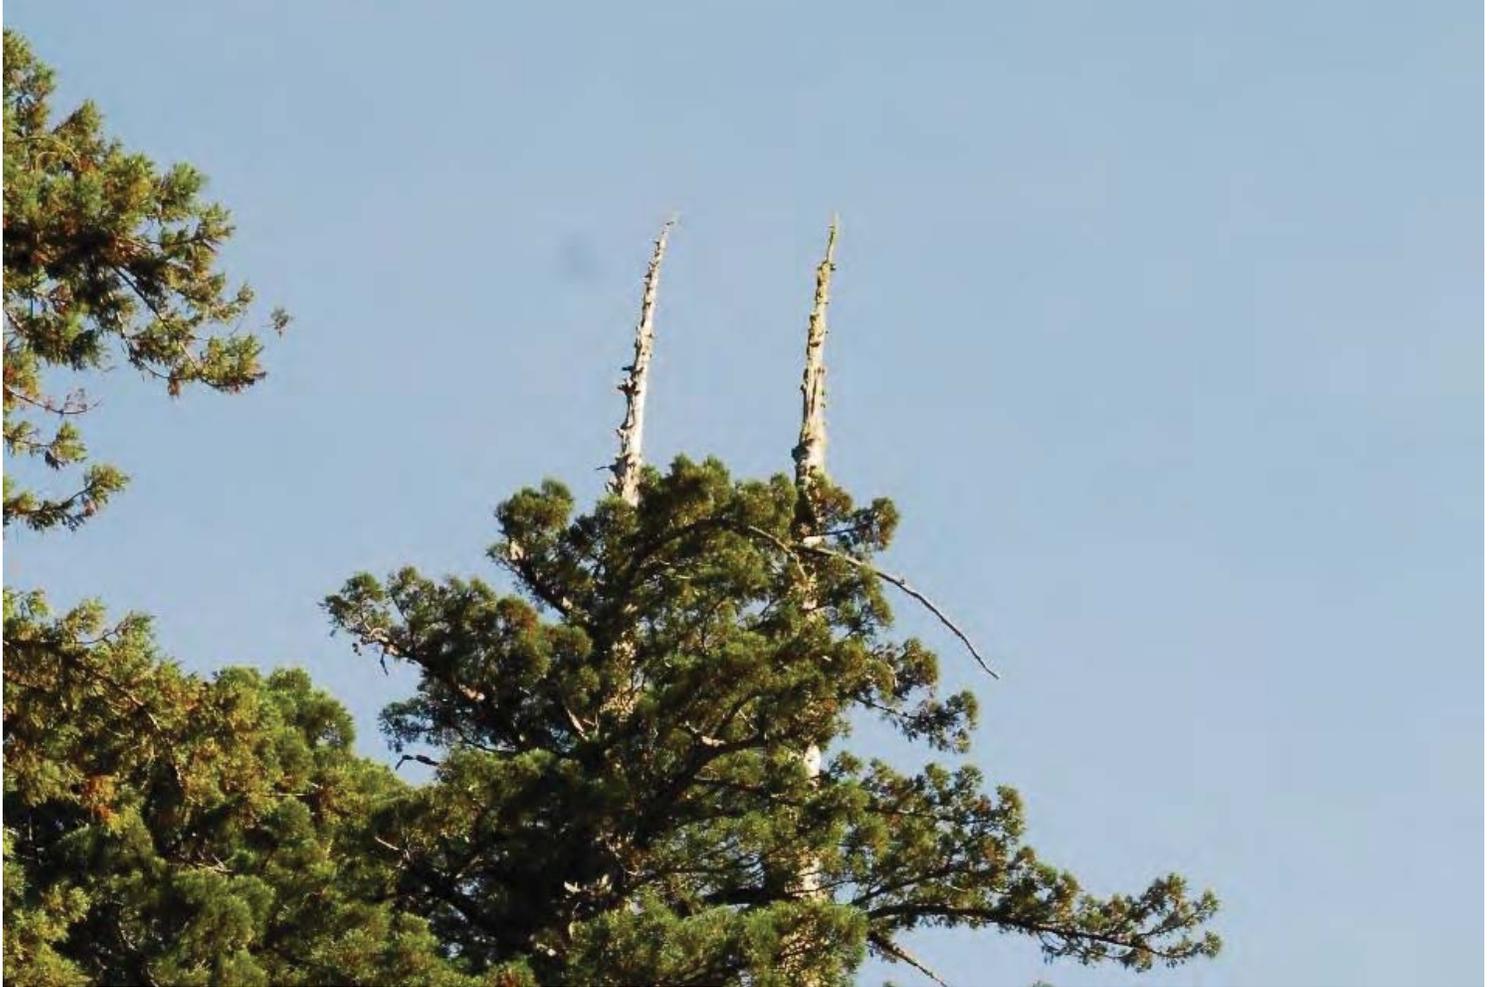
10. **2012:** The tops of Trees No. 89 and 90 showing "spike tops" apparently caused by severance of major buttress roots during highway construction. No buttress roots of old-growth redwoods would be severed during the Richardson Grove Operational Improvement Project.

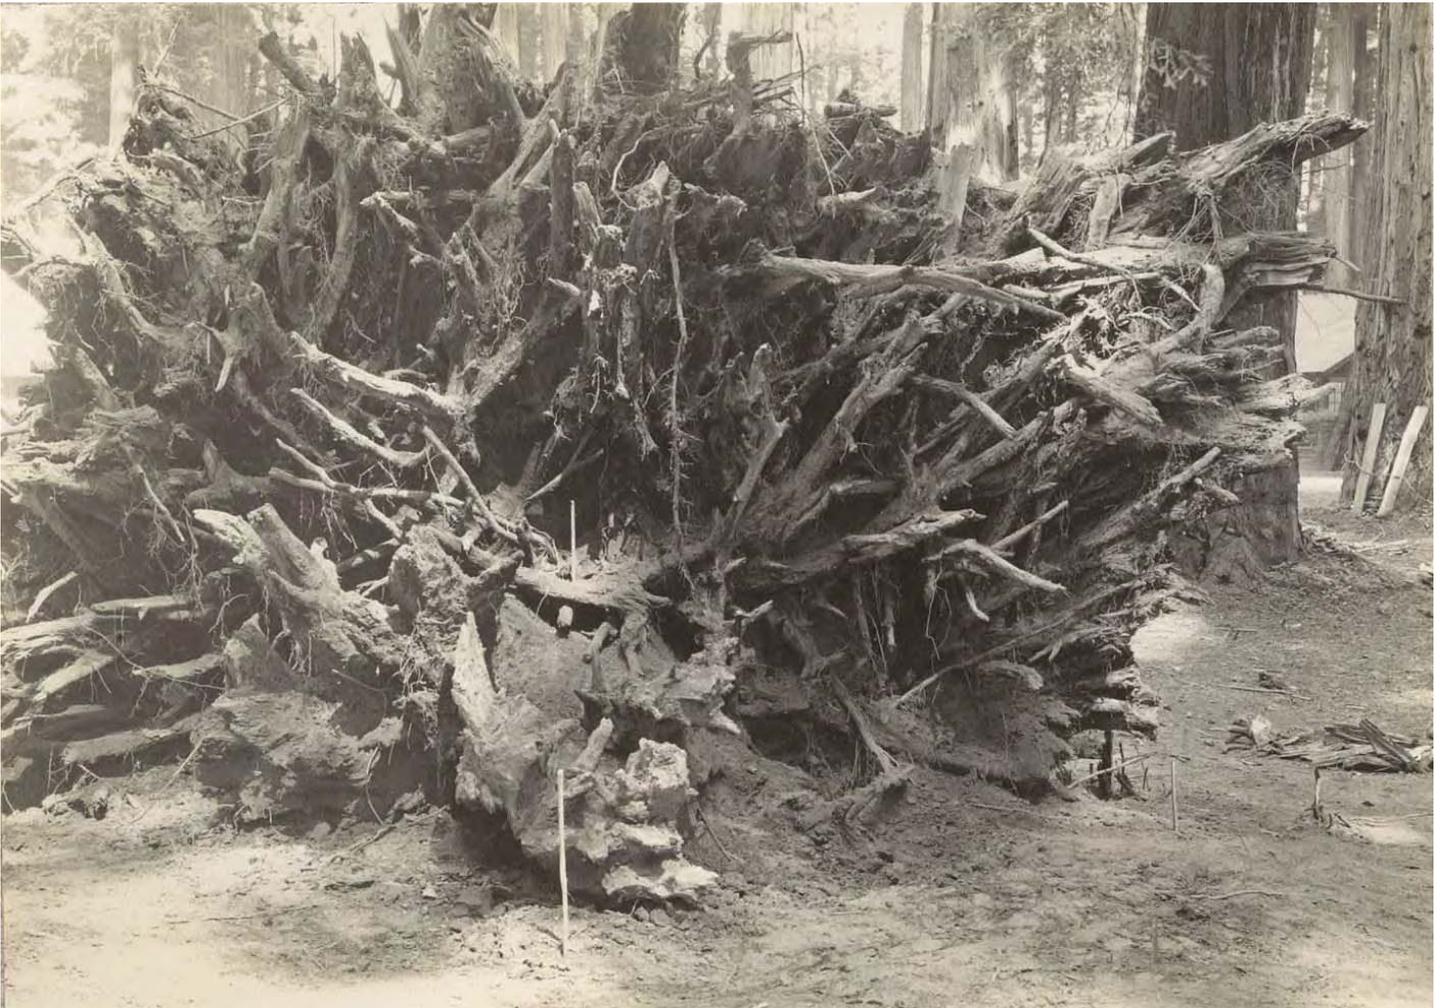
11. **1933:** This redwood was more than 1,200 years old when it fell in Richardson Grove in 1933. During its lifetime, the depth of soil at its base had increased by about 11 feet because of silt deposited by periodic floods. As soil accumulated, seven distinct layers of roots had formed. (Courtesy of the Marian Koshland Bioscience and Natural Resources Library, University of California, Berkeley: [lib.berkeley.edu/BIOS/](http://lib.berkeley.edu/BIOS/))

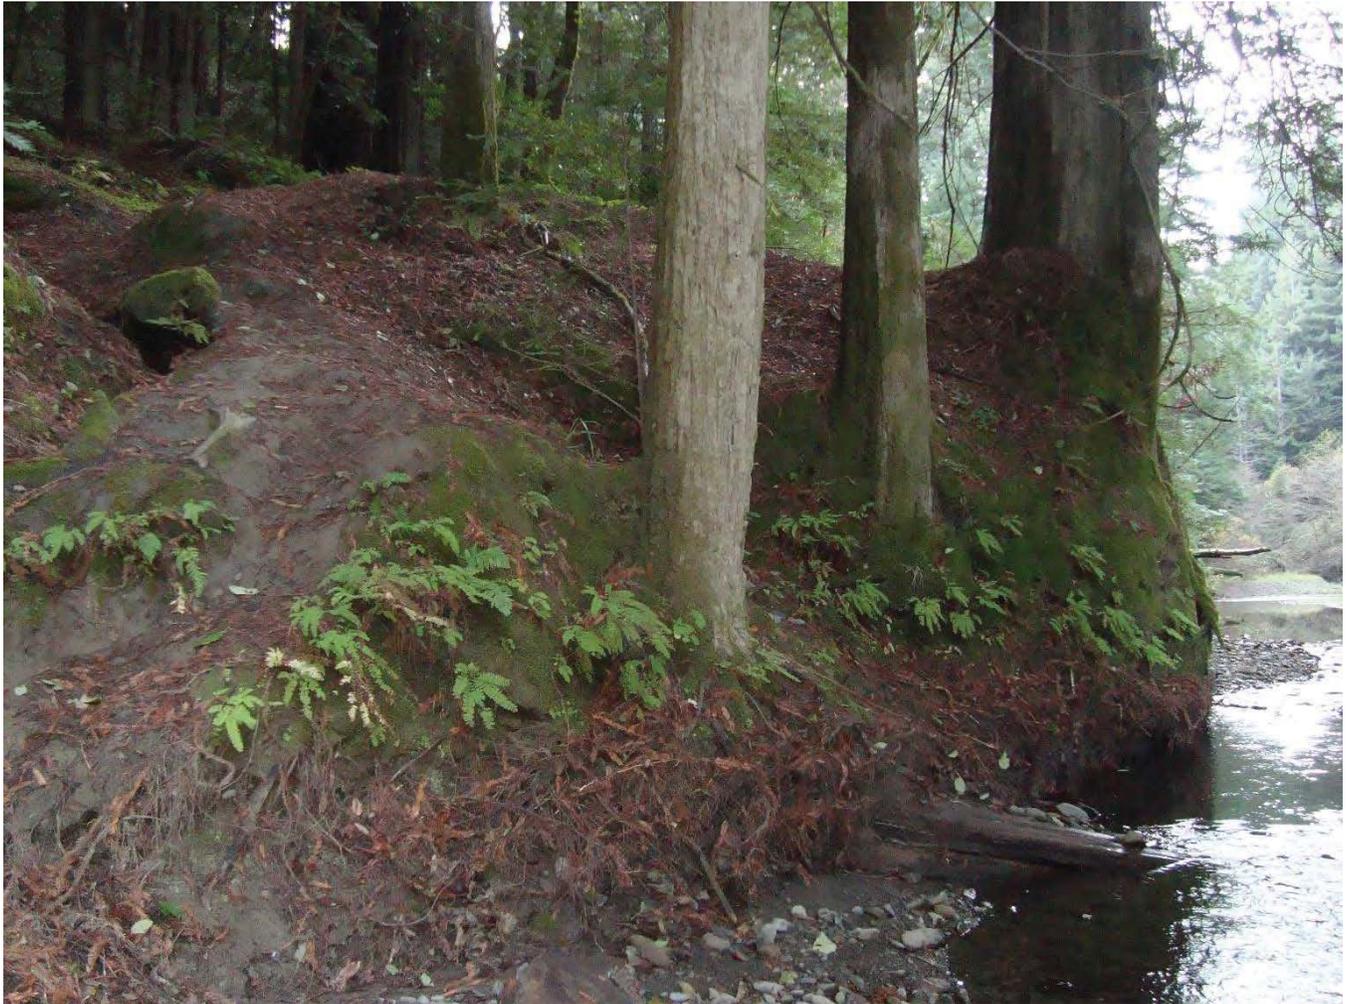
12. **2011:** Natural silt deposits alongside coast redwoods adjacent to Bull Creek, in the Rockefeller Grove in Humboldt County. Redwood trunks form new layers of roots below accumulated soil.

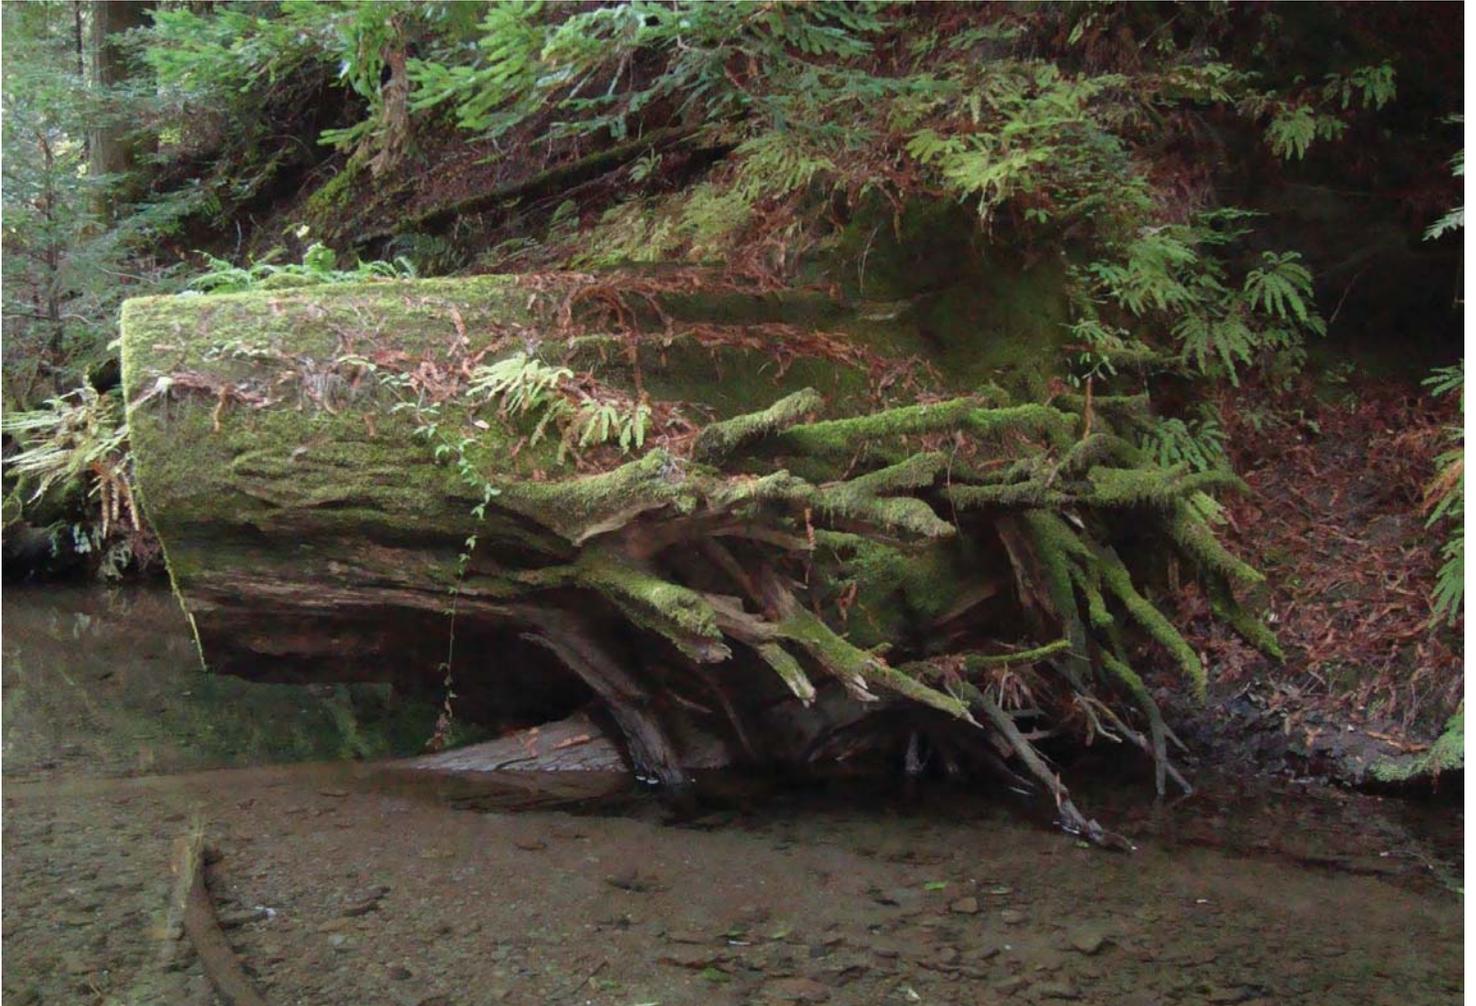
13. **2011:** This old-growth coast redwood toppled in the 1950s or 1960s during an extreme flood in Bull Creek. Soil had accumulated alongside the standing tree and new roots had formed from buried trunk tissue. This successful survival tactic enables redwoods to survive repeated flooding and sedimentation.

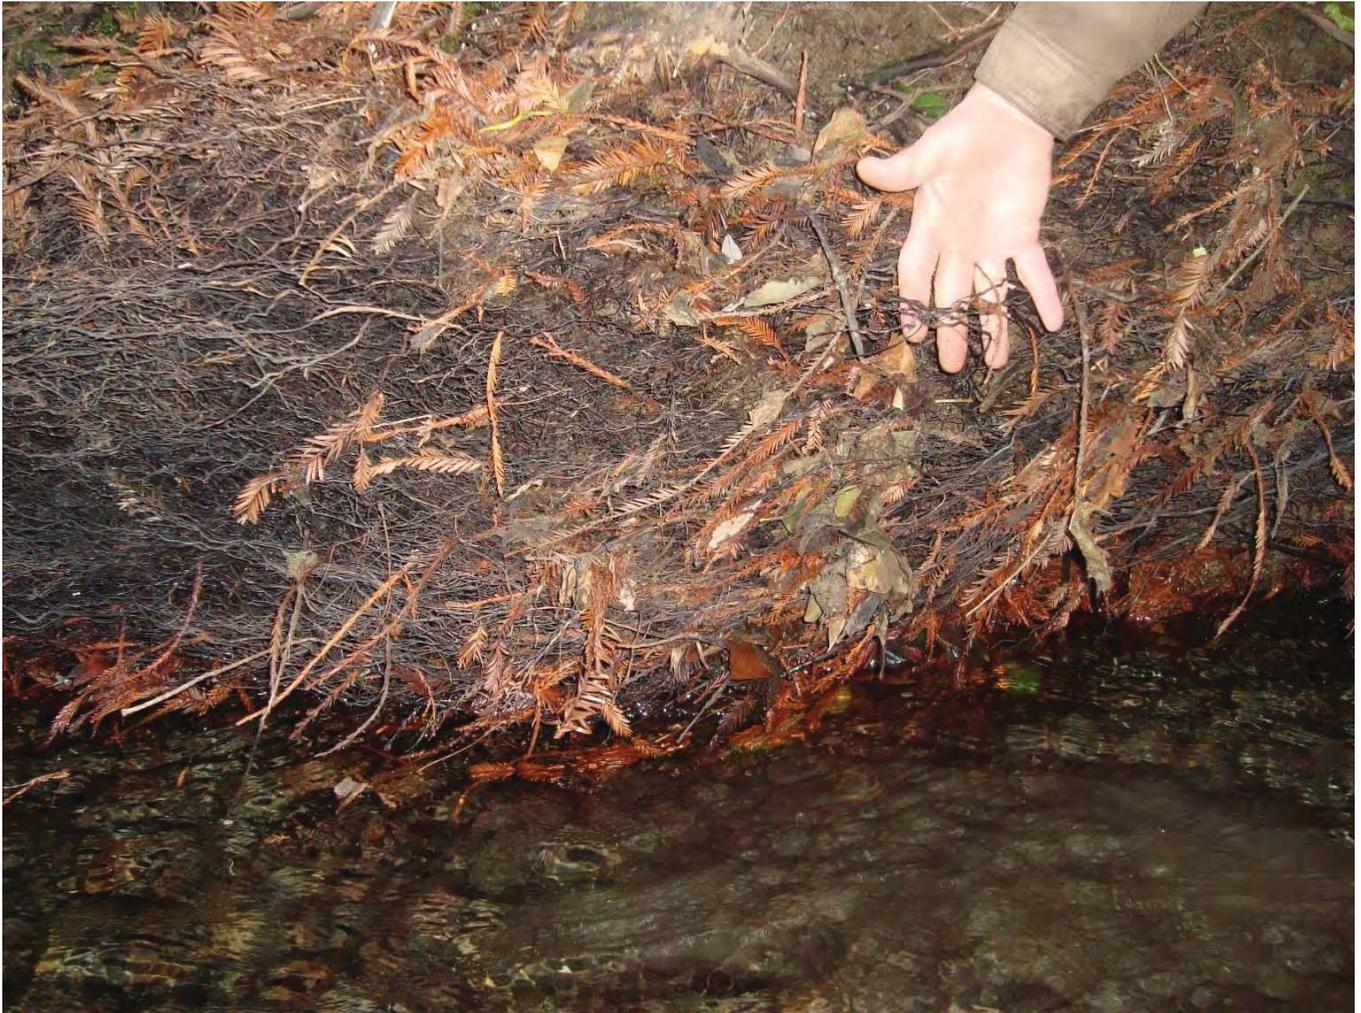
14. **2011:** Fibrous redwood roots growing alongside Bull Creek in the Rockefeller Grove in Humboldt County. Old-growth redwoods have very wide-spreading structural roots that form massive quantities of fibrous roots that help absorb water and minerals.

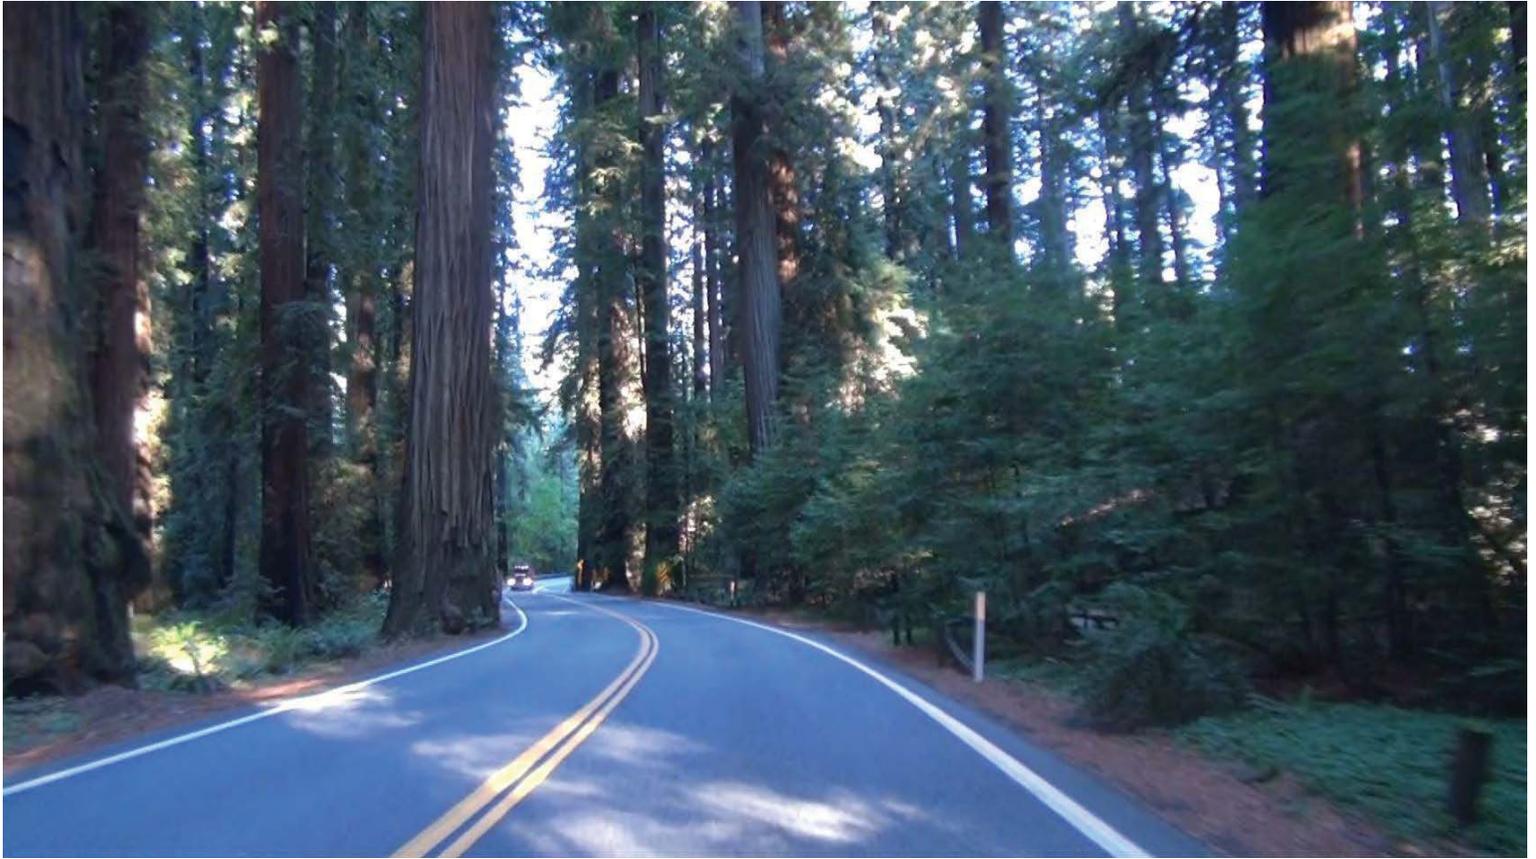
17. **2011:** Current view of Richardson Grove, facing north. The Visitor Center is obscured on the right by young trees growing in a former parking area.

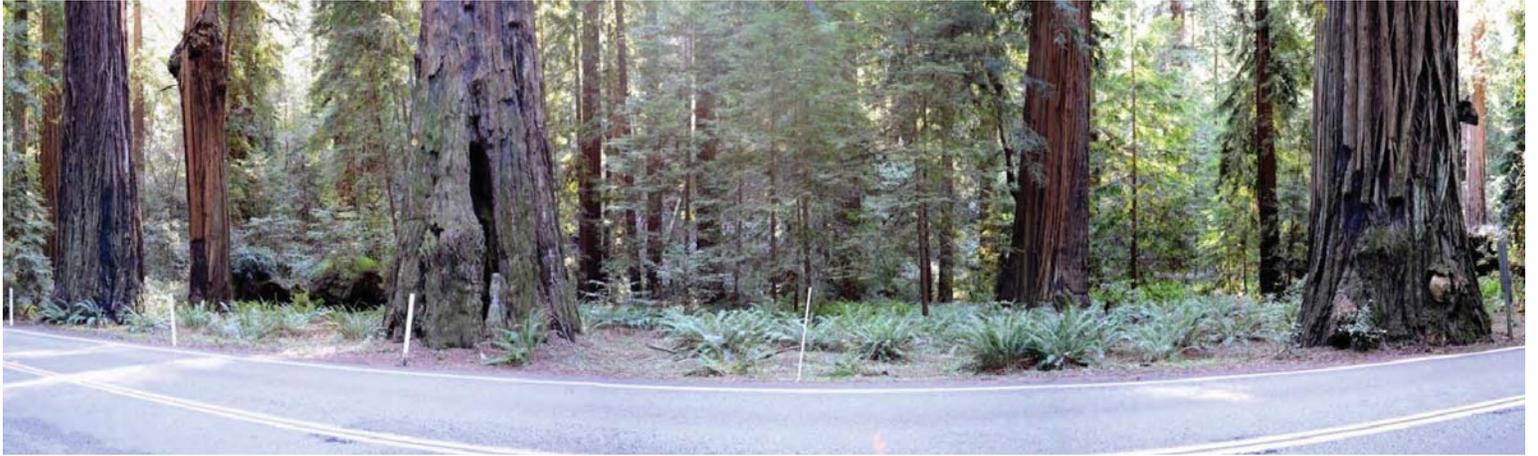
19. **2013:** Redwoods alongside U.S. Highway 101, as viewed facing west from the current site of the Visitor Center. A parking area and museum have been replaced by young redwoods, ferns, and duff.
