**PHASE 1 ENVIRONMENTAL SITE ASSESSMENT  
FOR THE  
STATE ROUTE 94 / JAMACHA ROAD INTERSECTION

STATE ROUTE 94 IMPROVEMENT PROJECT**

June 5, 2014

G. O. Graening, PhD, MSE  
(Registered Environmental Assessor 1, License #08060)

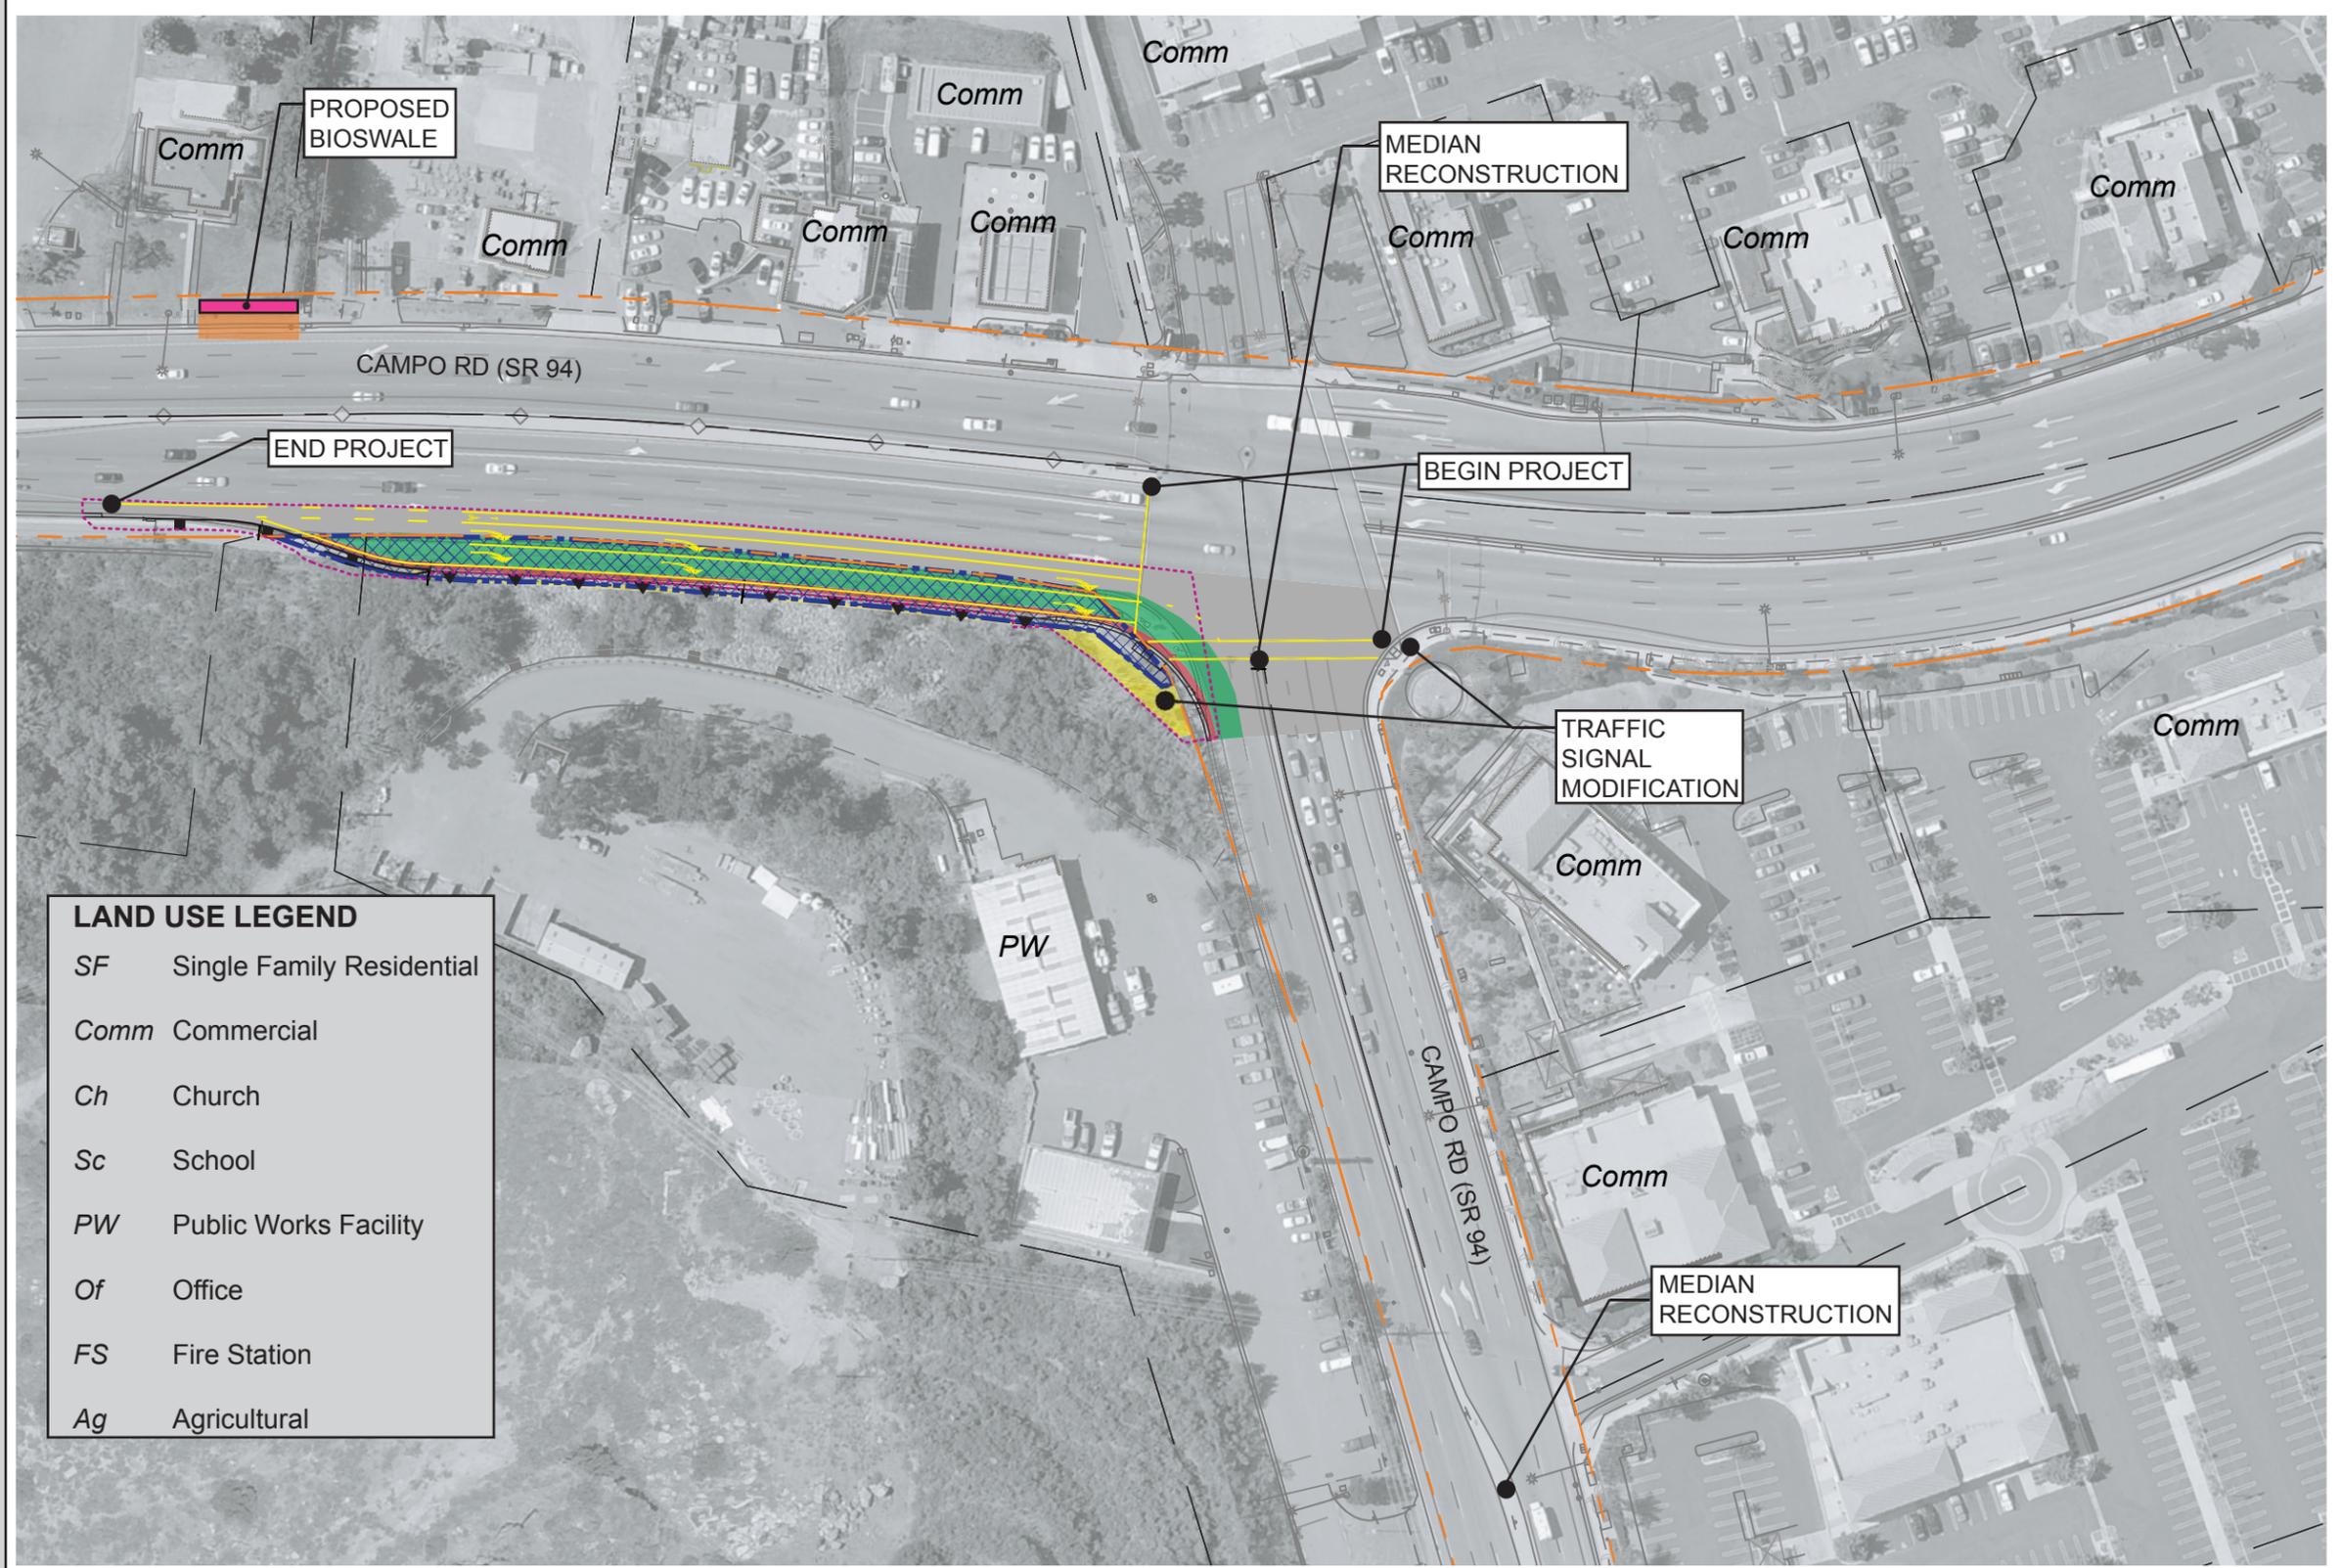
**FIGURE 2-1**  
**Common Design Features:**  
**SR 94 (Campo Road) and Jamacha Road**  
**SR 94 Improvements**

The subject property of this Phase I ESA is a traffic improvement Study Area in unincorporated San Diego County, California (Figure 2-1). Although Study Area parcels do not have specific addresses, the intersection is at approximately 12002 Campo Rd, El Cajon, 2949-2977 County Highway S17, El Cajon, and 11843-11867 Campo Rd., Spring Valley.

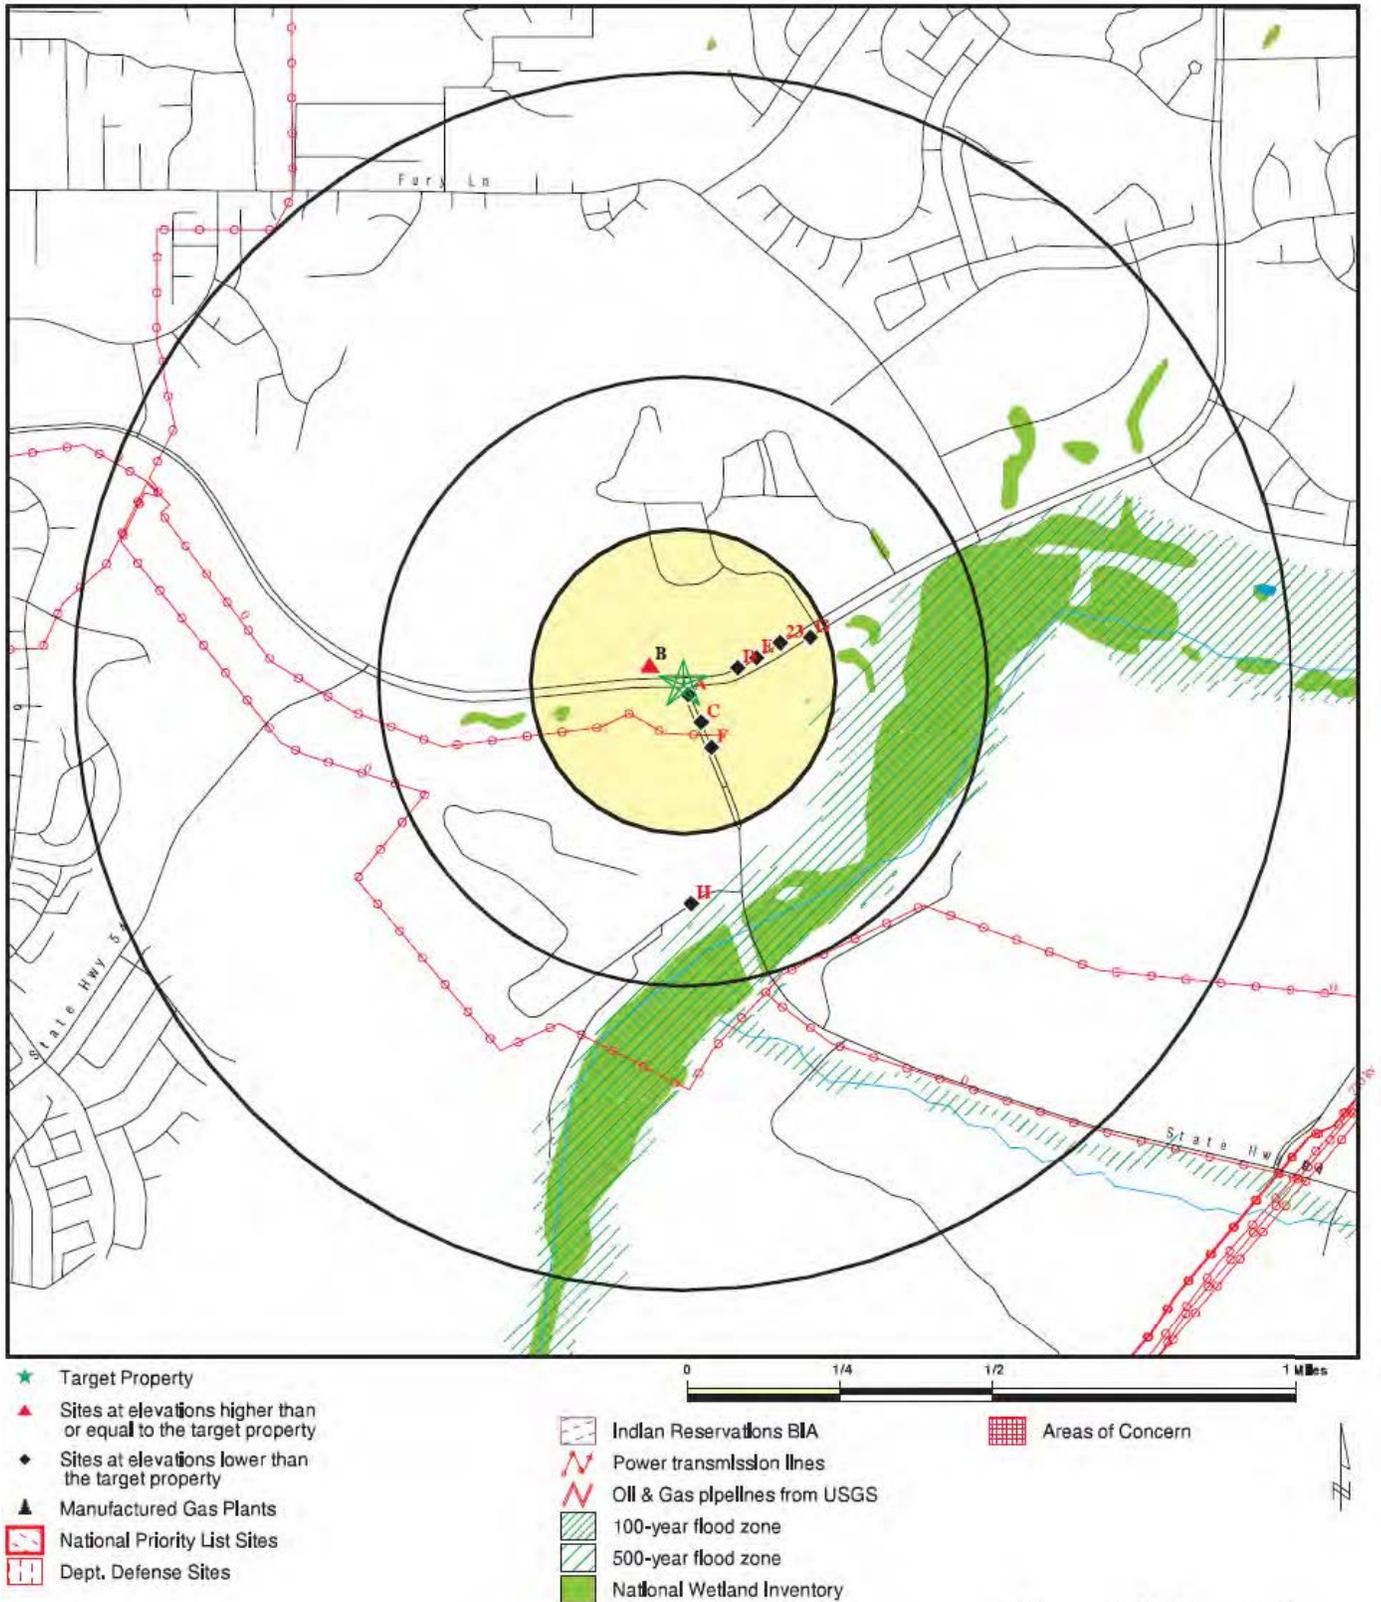
Figure 4-1. Overview map from EDR's Radius Map report

- Mapped elements B8, B9 – 11900 Hwy 94, Jamacha Road Station. From: HIST UST database. 2 10,000 gallon USTs diesel and unleaded gasoline. Small scale generator hazardous waste associated with rental truck maintenance.

- Mapped elements C10, C11 – 11928 Campo Road, Atlas Rents / Best Rentals. From: HIST CORTESE, LUST, San Diego Co. HMMD, San Diego Co, SAM databases. 1/1/1950 leak discovered, 6/9/1995 tank closure, 7/9/1997 closure via NFA letter. Small scale generator of hazardous waste.

- Mapped elements D12, E16 – 2966 Jamacha Road, Pacific Bell. From: UST, SWEEPS UST, San Diego Co. HMMD, RCRA-SQG, FINDS databases. 2000 gallon UST, fuel. Small scale generator hazardous waste associated with service truck maintenance.

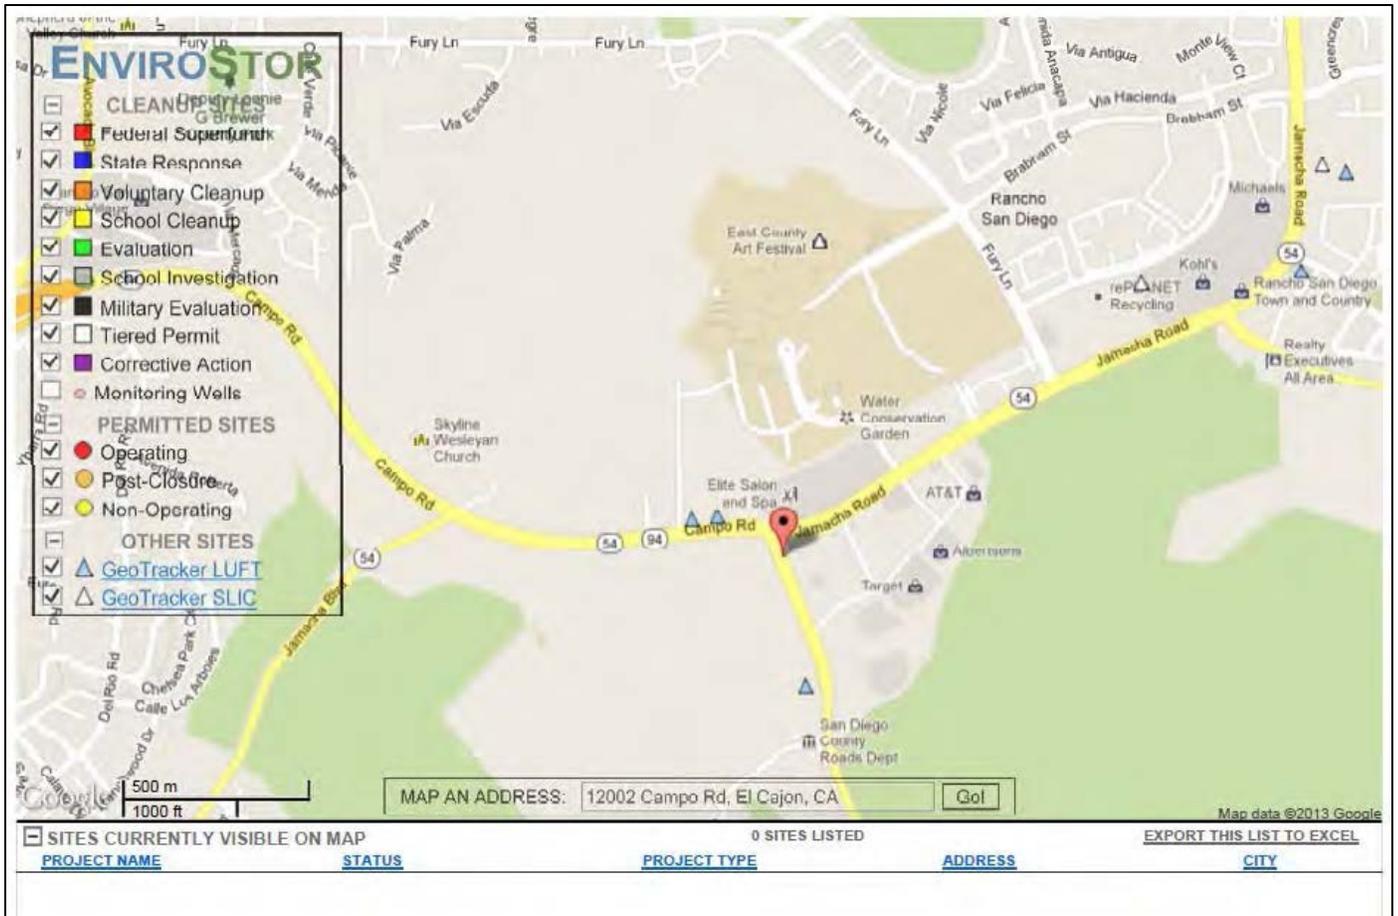
Figure 4-3. Screen capture of EnviroStor database query

The EnviroStor database was queried on May 30, 2013. The following screen capture (Figure 4-3) summarizes the results of the query. No reported cases were found on the Property. No new information was retrieved beyond that already found from EDR's report, summarized in the previous section of this assessment. The following cases were returned within 4,000 feet of the Study Area:

- County of San Diego Jamacha Road Station, 11900 Hwy 94, LUST cleanup site; case closed
- Best Rentals, 11928 Campo Rd., Spring Valley: LUST cleanup site; case closed
- Spring Valley Hdqtrs/Div I, 11970 Singer Ln, Spring Valley: LUST Cleanup Site; Cleanup Status: Open - Site Assessment
- Otay WD Reclamation Plant, 11901 Singer Ln, Spring Valley: LUST Cleanup Site; Cleanup Status: Completed - Case Closed
- Advantage Cleaners, 2522 Jamacha Rd., El Cajon: Cleanup Program Site; Cleanup Status: Completed - Case Closed

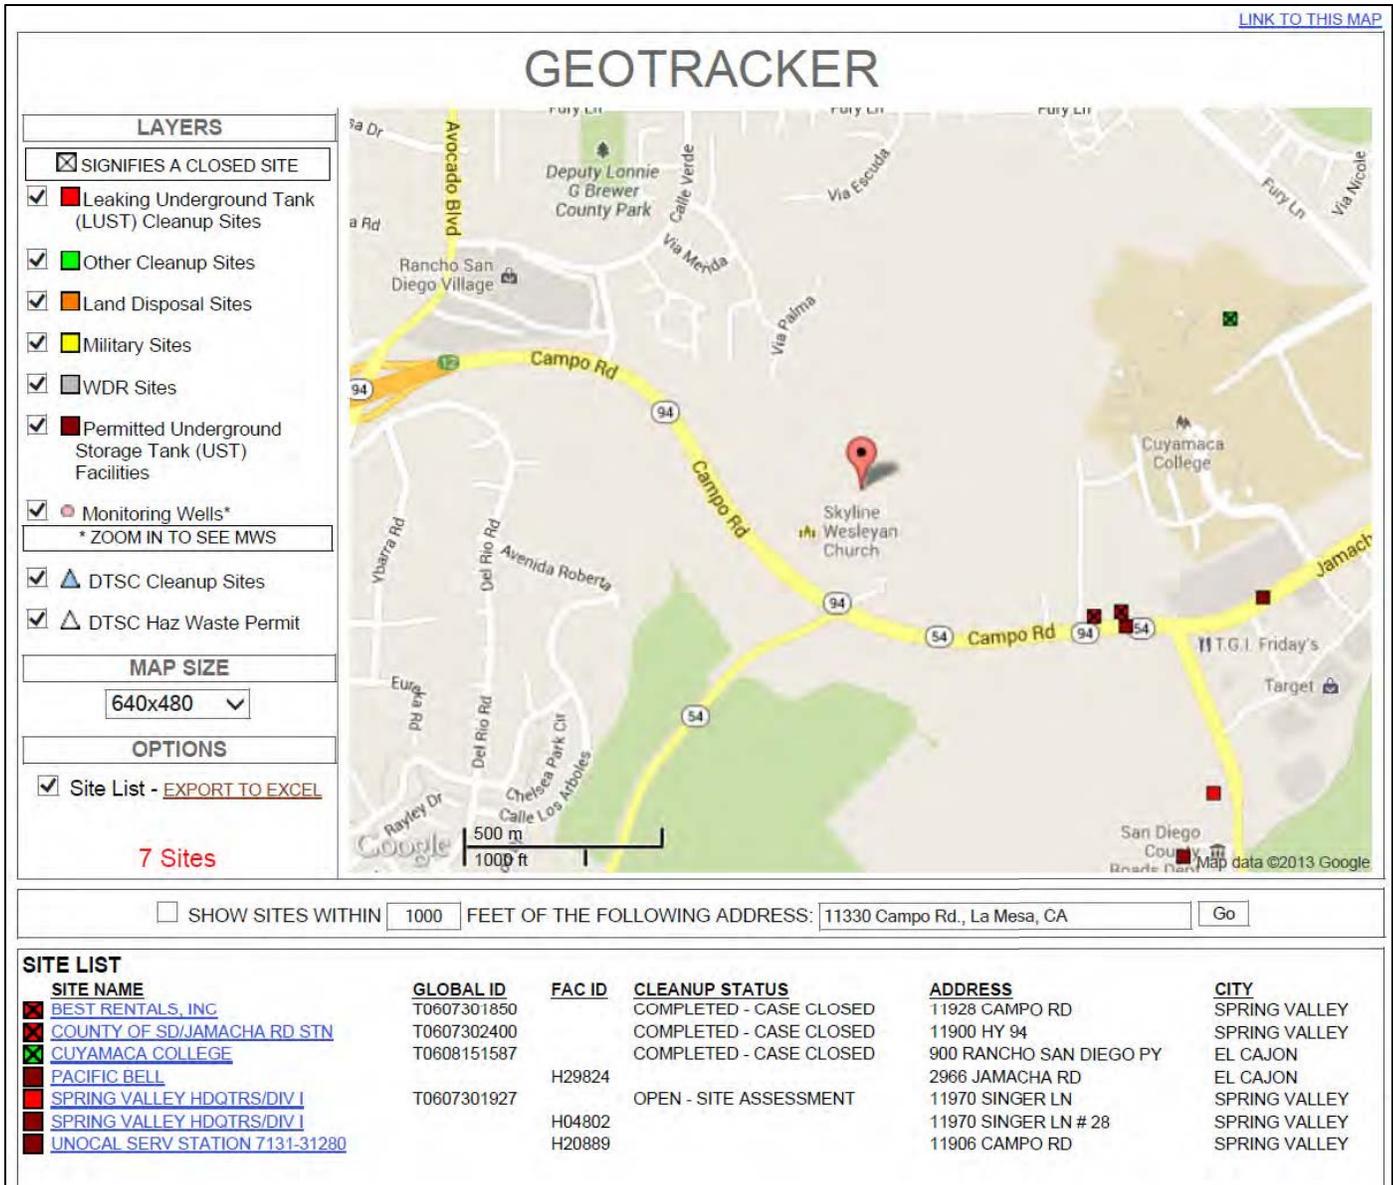
Figure 4-4. Spatial results of GeoTracker query

The GeoTracker database was queried for environmental data pertaining to the Site on May 30, 2013. Using both spatial queries and text-based searches of bounding street addressees in GeoTracker, no reported cases were found on the Property or adjoining properties (Figure 4-4). The nearest reported cases are shown in the following table.

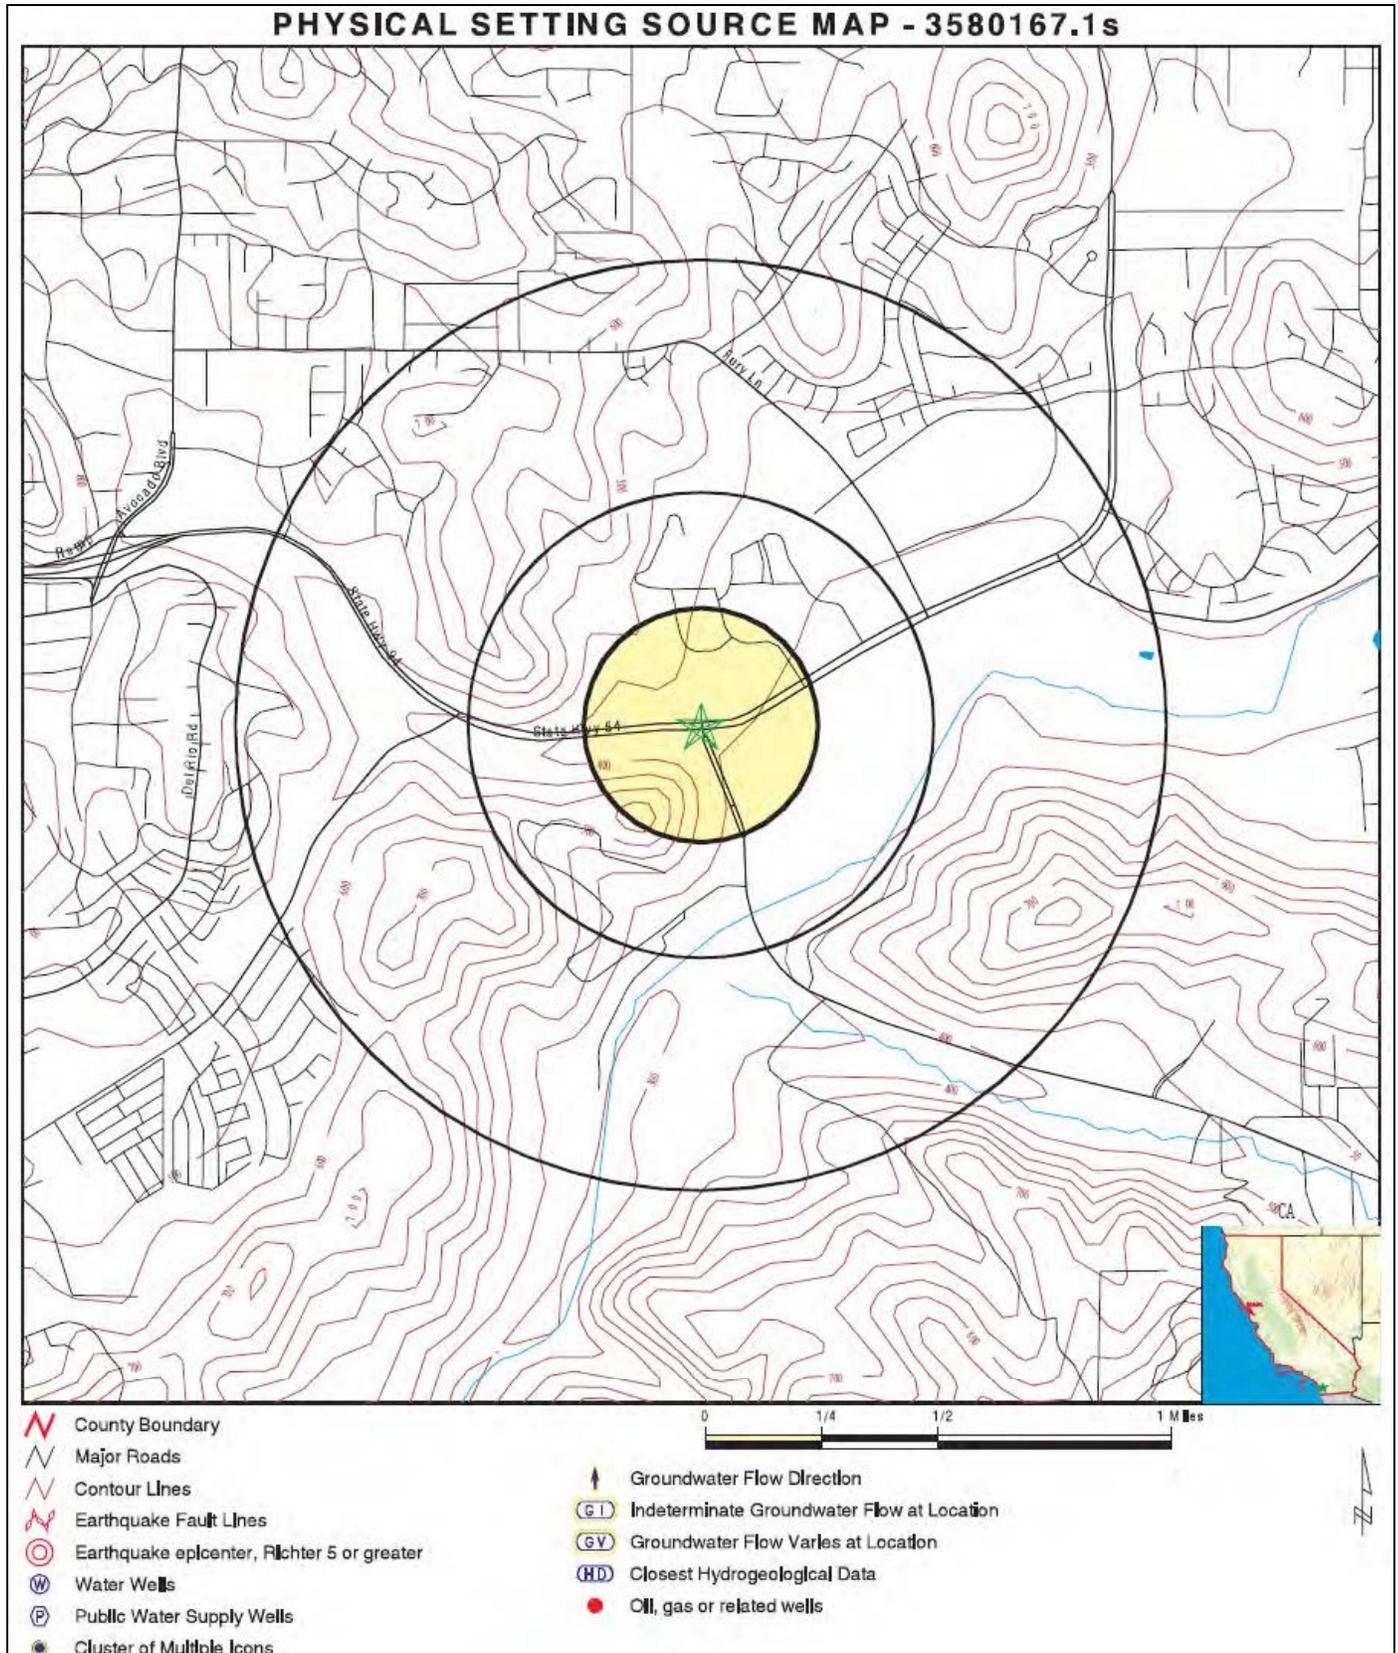
Figure 4-5. EDR's Physical Setting Map

Naturally occurring soils in the vicinity of this intersection include Placentia sandy loam (PfC), Friant rocky fine sandy loam (FxG), Visalia sandy loam (VaA), gravel pits, and Las Posas fine sandy loam (LpD2). At the SR-94 / Jamacha Road Intersection, topography is flat, and an unnamed intermittent drainage runs east toward Sweetwater River, but continues southeast under SR-94 and a commercial center as part of the municipal storm sewer system (Figure 4-5). The Study Area is located in the Sweetwater River watershed. The Study Area is not located within a 100-year or 500-year floodplain, as defined by the Federal Emergency Management Agency Flood Insurance Rate Maps, according to the EDR report. Public and private groundwater wells and public water supplies identified in EDR's query of readily-available databases are over ½ mile from the Study Area. No hydrogeologic data were readily available.

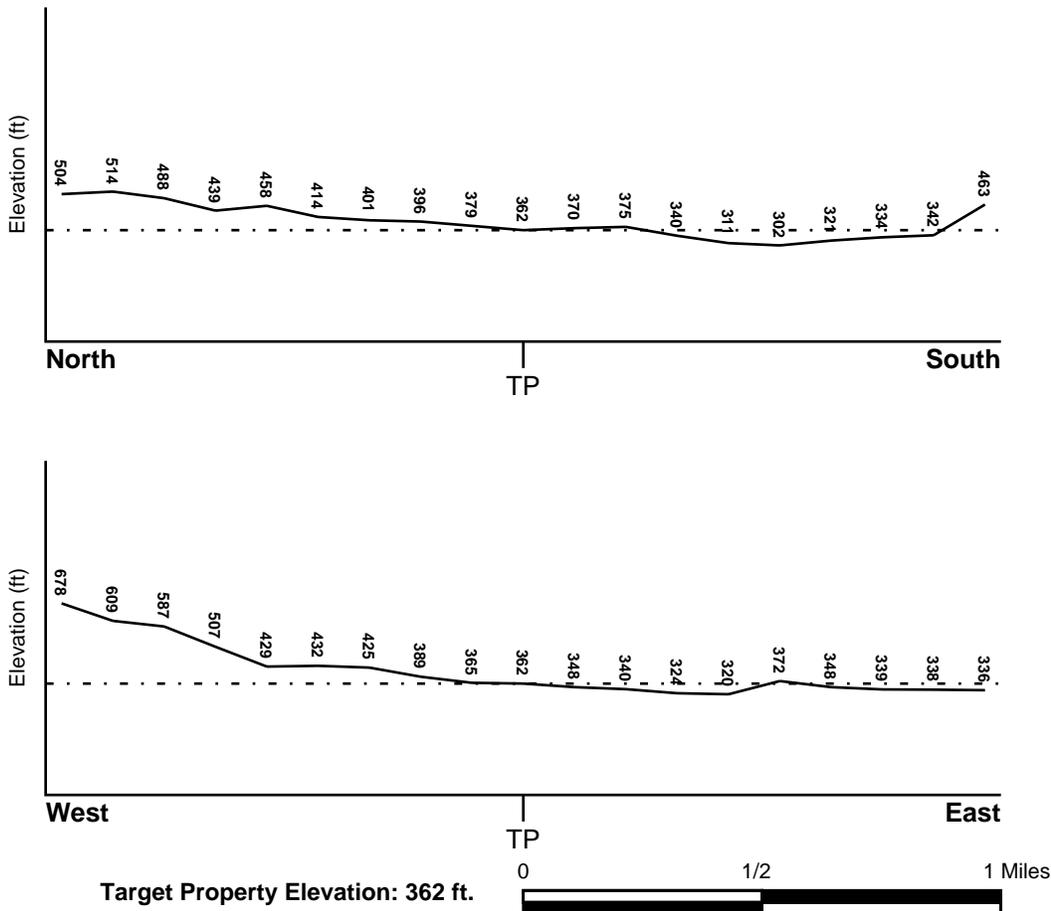
## SURROUNDING TOPOGRAPHY: ELEVATION PROFILES

General Topographic Gradient: General ESE

Source: Topography has been determined from the USGS 7.5' Digital Elevation Model and should be evaluated on a relative (not an absolute) basis. Relative elevation information between sites of close proximity should be field verified.
