**Visual Impact Assessment
Route 74 Route Widening Project**

December 20, 2006

12-Ora-74
KP 1.0/1.9
EA 086900

**Prepared by:
Caltrans District 12**

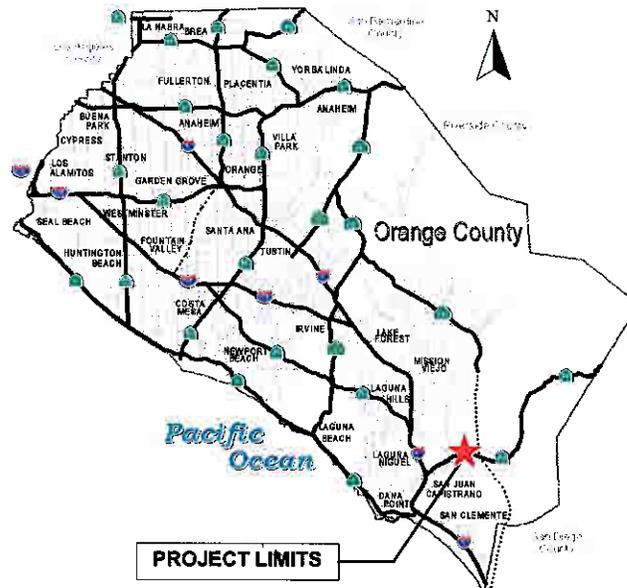
The focus of the visual study for the proposed project on Route 74 and includes a section of the Highway within the City of San Juan Capistrano from Calle Entradero to the City limits.

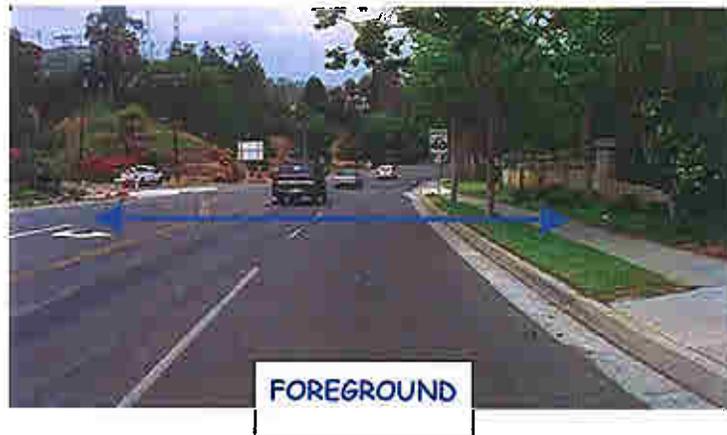
Fore ground – the area where designation clarification and simplification is not possible in middle and background since the observer is a direct participant.

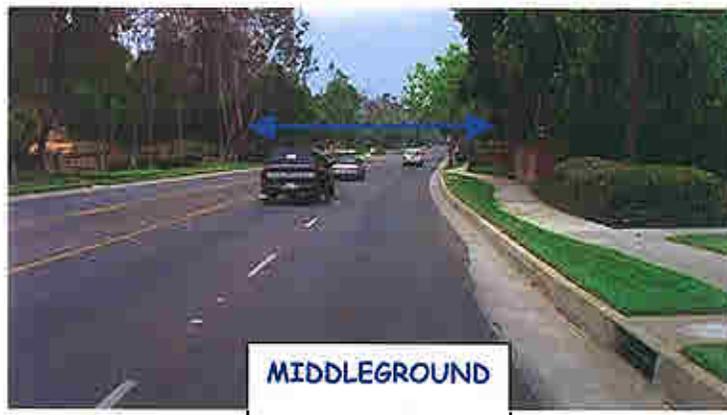
Middle ground – the area where the parts of the landscape visually join together; where hills become a range or trees make a forest.

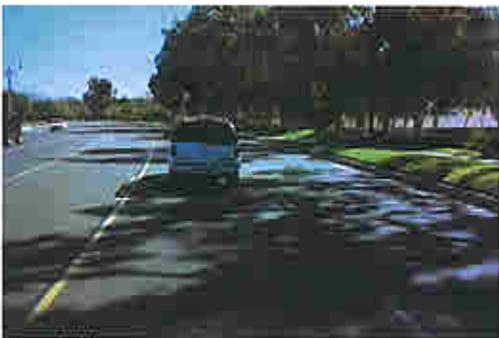
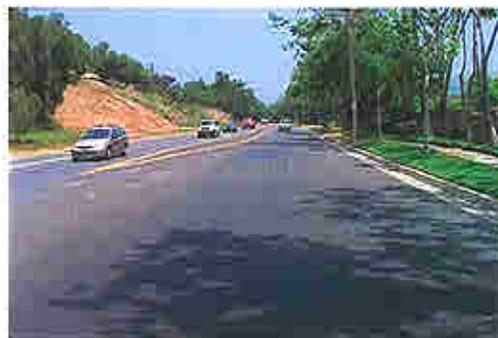
Examples of lighting conditions on the landscape

Light has an affect on views. In general, back lighting from the sun tends to wash out detail and increase ridgeline prominence. Foreground lighting from the sun increases detail, texture and color differences. Clouds and fog can also change view conditions by the increase and decrease of contrast.

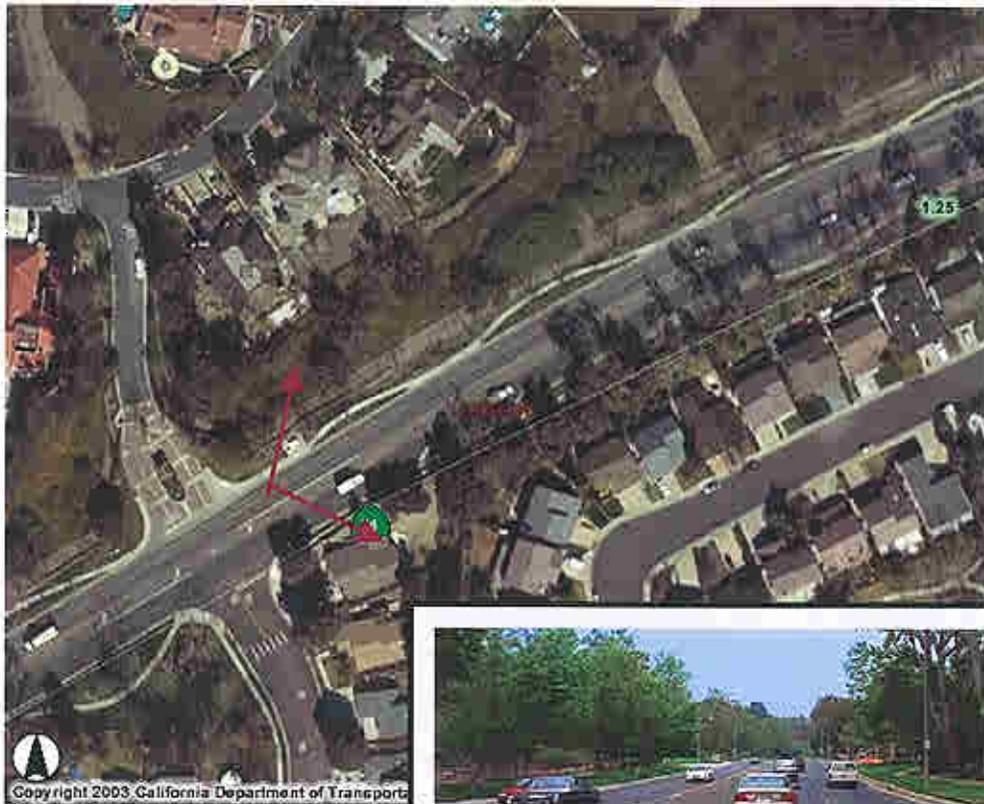
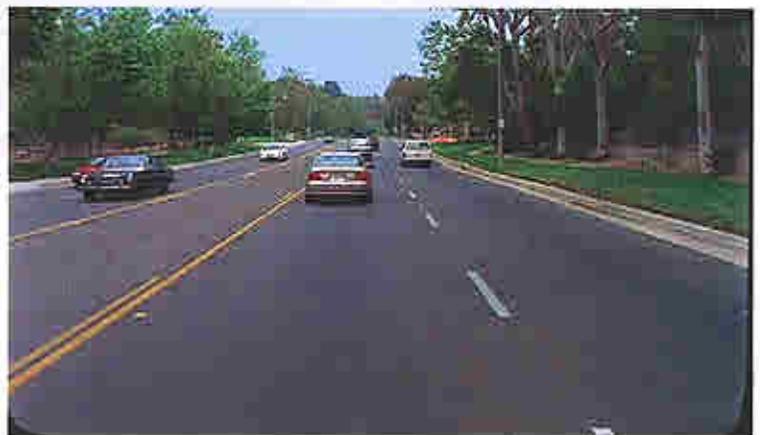
Existing easterly view at the beginning of project

- **Assessment of the Visual Quality of Pre-Project Conditions**

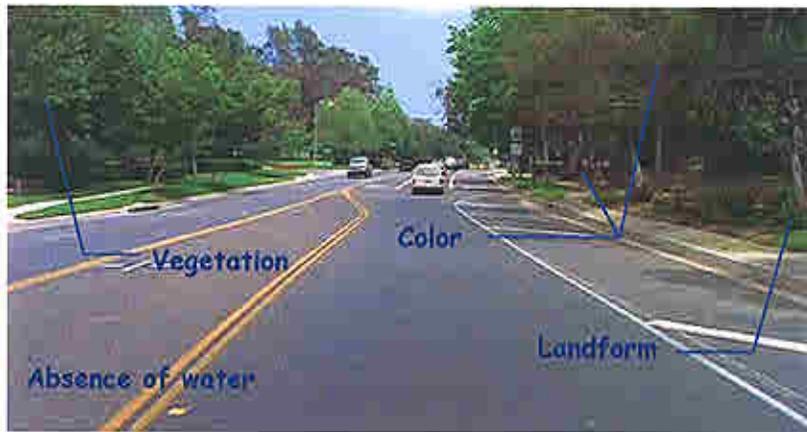
Water	<ul style="list-style-type: none"> • Clear and clean appearing, still, or cascading white water, any of which are a dominant feature in the landscape. 	<ul style="list-style-type: none"> • Flowing or still, but not dominant in the landscape. 	<ul style="list-style-type: none"> • Absent, or present, but not noticeable. 	Low
Color	<ul style="list-style-type: none"> • Numerous (>5), colors in the soil, rock, vegetation or water. 	<ul style="list-style-type: none"> • Some colors (3-5) but not a dominant element. 	<ul style="list-style-type: none"> • Few color variations (<3) with generally mute tones. 	High/Moderate

□ **The physical quality factors are moderate.**

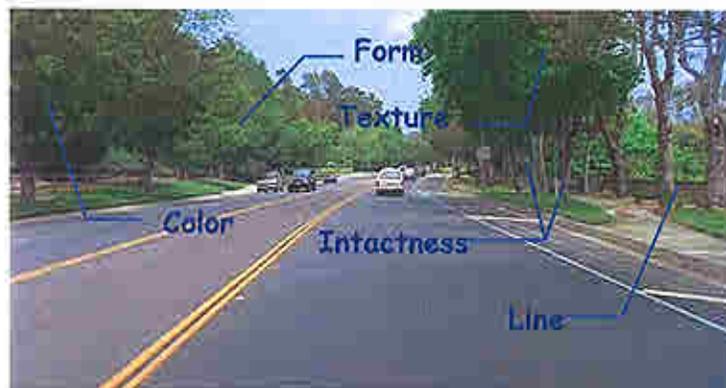
HIGH QUALITY	MODERATE QUALITY	LOW QUALITY	EVALUATION
Form	• Single dominant form.	• Many similar forms.	• Many different forms.	Moderate
Line	• Curvilinear.	• Naturally geometric.	• Man-made geometric.	Moderate
Color Contrast	• Dominant mono-color.	• Consistent variety of color contrast.	• Overwhelming variety of color contrasts.	Moderate
Texture	• Dominant mono-texture.	• Consistent variety of textures creating perceivable pattern.	• Overwhelming variety of textures in chaotic pattern.	Moderate
Intactness	• Natural.	• Disturbed.	• Scarred.	Moderate

- **Since the environment is a combination of built and natural elements, there is a disturbance to the intactness yet the change is not major. The sensitivity to change factors is moderate.**

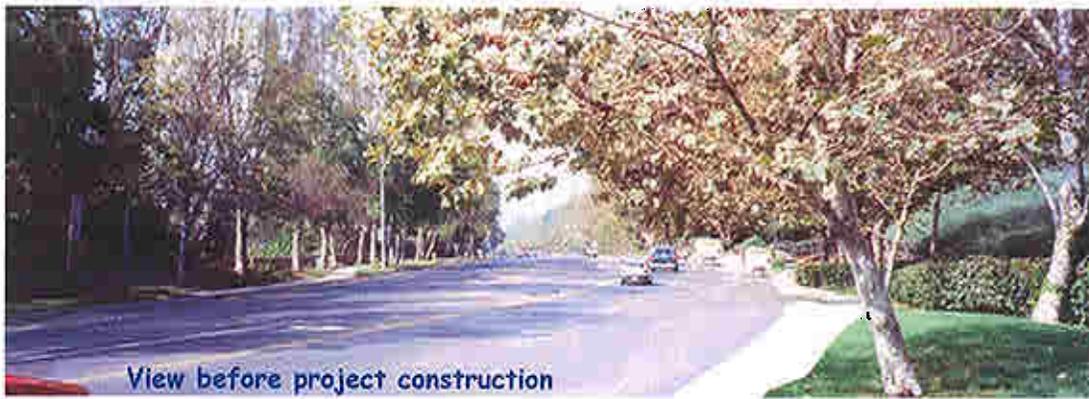
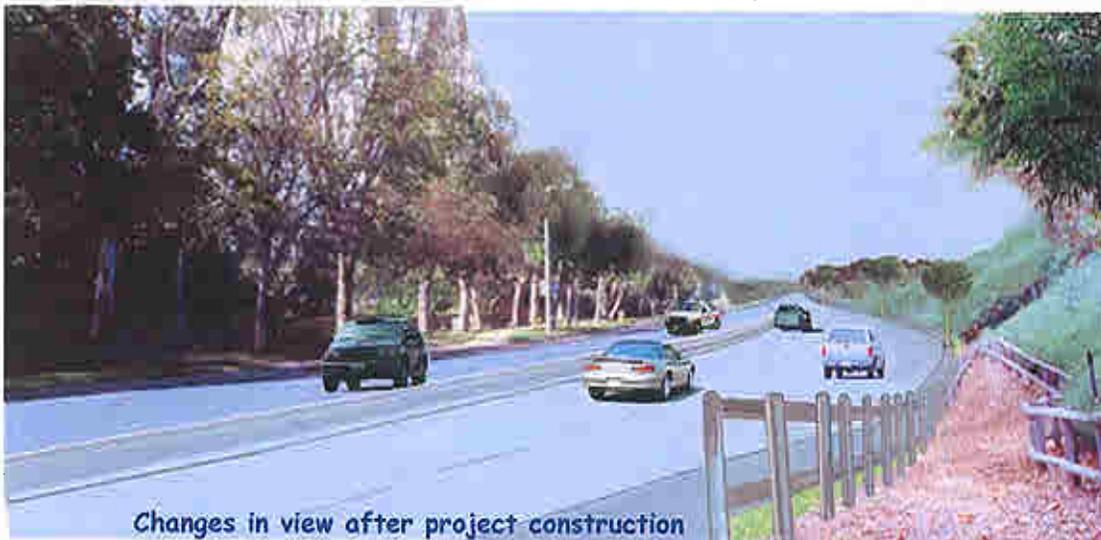
- There are several changes in the views after project construction.
- The road is to have 2 additional lanes with shoulders on the north and south sides of Route 74.
- There is to be a sound wall along the south side of the highway from Via Cordova to Via Errecarte to reduce any traffic noise associated with the closer proximity of the roadway to the residents along Ortega Highway. The changes in the views are to the highway users and viewers.

- Assessment of the visual quality change is by matrix evaluation.
- Nearby residential viewers have the highest view duration and experience high sensitivity. The expectation is the proposed alterations are to have adverse impact on the adjacent and affluent community and a high sensitivity to change.

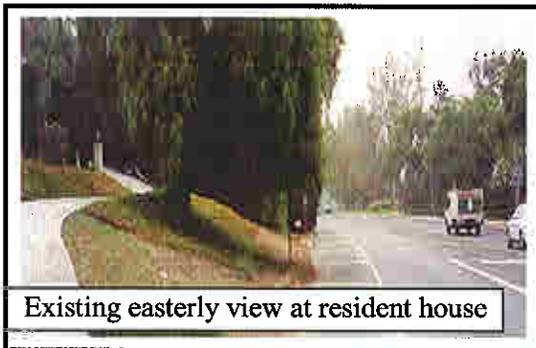
Existing easterly view at resident house

- **Location:**
 - East view of the widened highway of the residents on the north side of Route 74.
- **Current conditions:**
 - There are several residences located on the northern side of the street.
 - There are no roadway sidewalks, curbs or gutters.
 - The views see a residential home driveway with a steep grade.
- **Assessment View:**
 - The assessment is a foreground view of westbound highway users on highway.
 - This location is a typical view of the visual impact of the road widening.

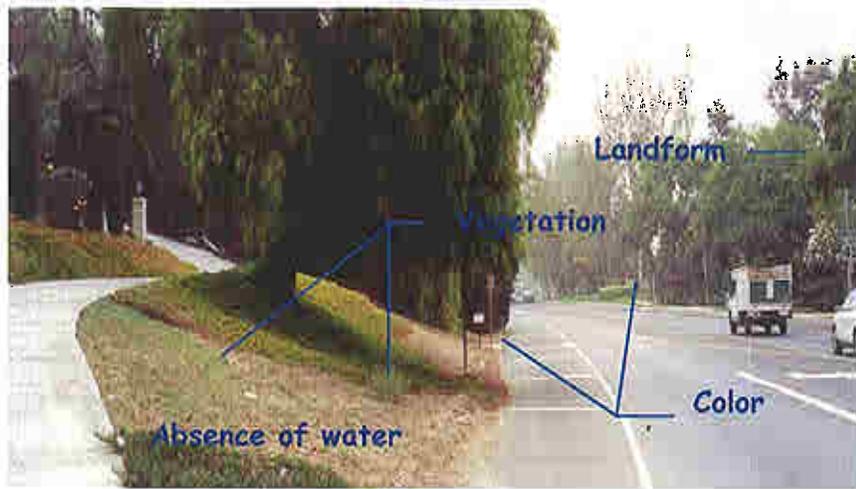
PHYSICAL QUALITY FACTORS

- The evaluation of landform, vegetation and water is low to moderate quality due to the lack of features variation.
- The area is flat except for the driveway slope.
- There are limited distant views.
- The existing vegetation is sparse on the north side and there is the absence of water features.
- Color is of moderate quality from the ornamental landscape on the south side of the highway.

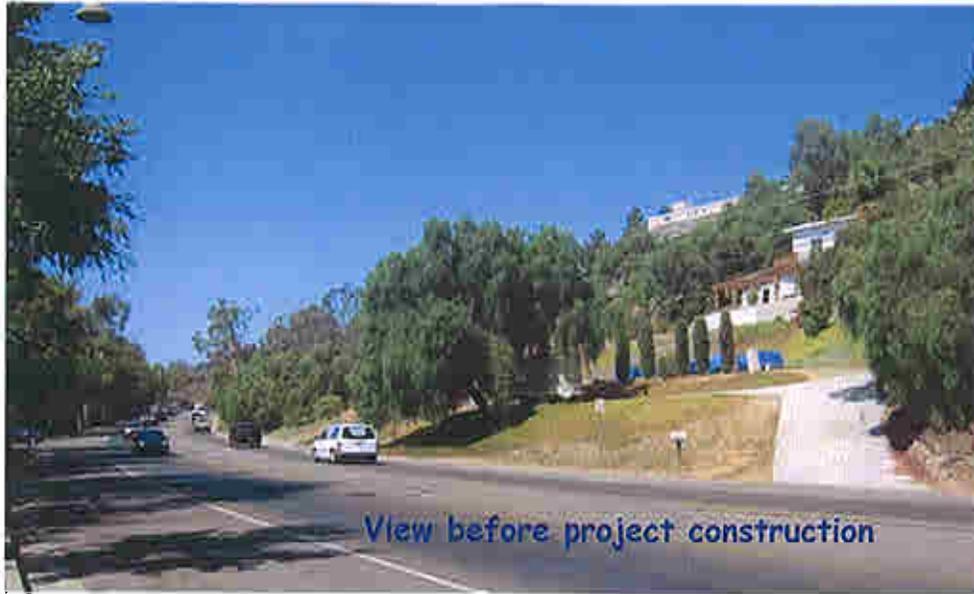
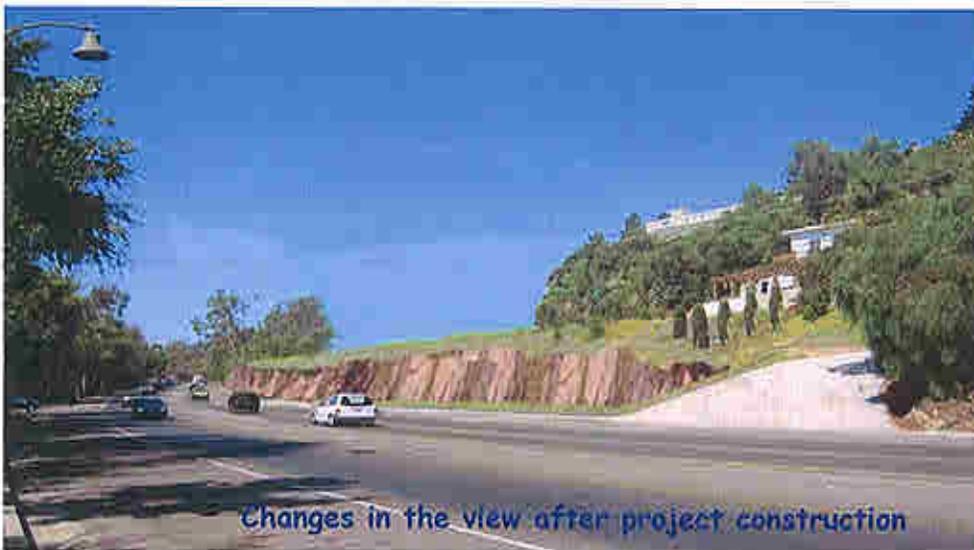
- The project widens Route 74 by two lanes and a shoulder in both directions.
 - On the north portion of the highway, the existing residential use slope is to be cut to grade the roadway. A retaining wall is necessary to hold back the soil.
 - On the south portion of the highway, there is a sound wall in a residential land use area. Removal of the existing streetscape on the south. This includes the meandering sidewalk. The change after project construction is to a linear sidewalk next to the new sound wall with the absence of any landscape.

- It is possible that the large mature tree in the front yard will need to be removed. Otherwise, the tree may sit right at the edge of the road and the branches may pose a sight distance problem for motorists.
- Slopes and driveways need to be cut back to properly grade the road. This leads to steeper slopes and driveways on the residential property and the need for retaining walls adjacent to the highway. At this location it is proposed to place a 4.5-meter (15 feet) retaining wall.
- On the south, the removal of all existing landscape is to accommodate the widening project. There is to be a replacement of the meandering sidewalk with a linear sidewalk and a sound wall.
- When looking at the viewer groups, both the motorists and the residential viewers will be negatively impacted.

- Any large-scale wall detracts both from the motorist and residential view and an engineered wall takes away from the rural environment found here.
 - The height, length and texture of the wall shown above are only used to portray negative view impacts.
 - There are different types of walls, textures, and color that will need further study with the determination some type of wall is needed and no other alternative can be implemented.
- The perceptual quality factors and sensitivity to change factors after construction are of low quality and have a negative visual effect.

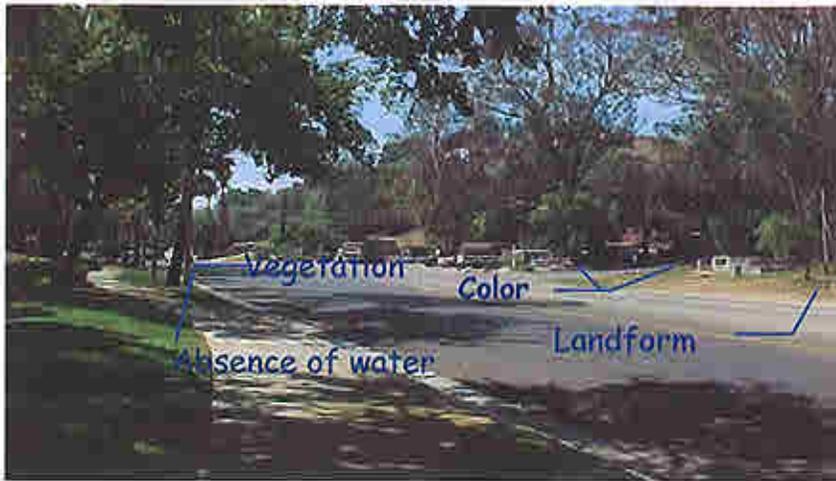
PHYSICAL QUALITY FACTORS

- The highway is tree lined with a variety of vegetation types in view.
- The area is flat terrain with limited distant views.
- The rating of landforms and water are of low quality since the landform features do not have variation and since there is a lack of water visible at this location.
- Vegetation and color are of moderate quality.

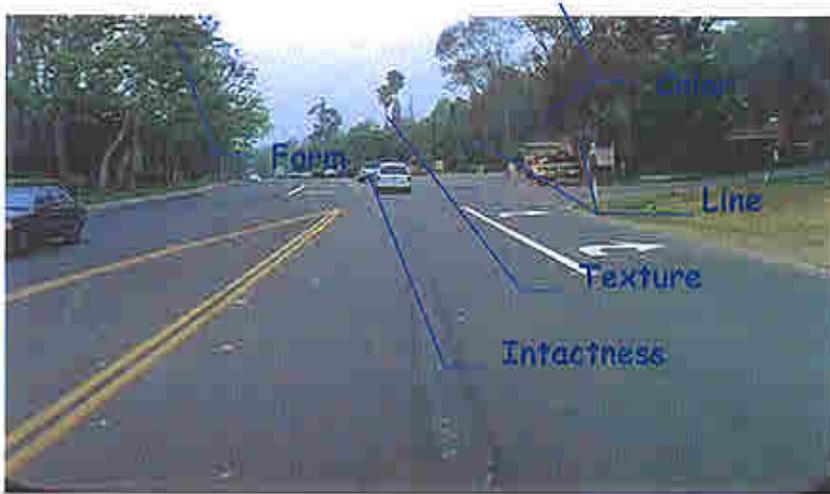
SENSITIVITY TO CHANGE FACTORS

- There is a combination of ornamental landscape on the south side of the highway.
- The rural environment begins on the north side of the highway.
- The sensitivity to change is moderate to moderate/low quality.

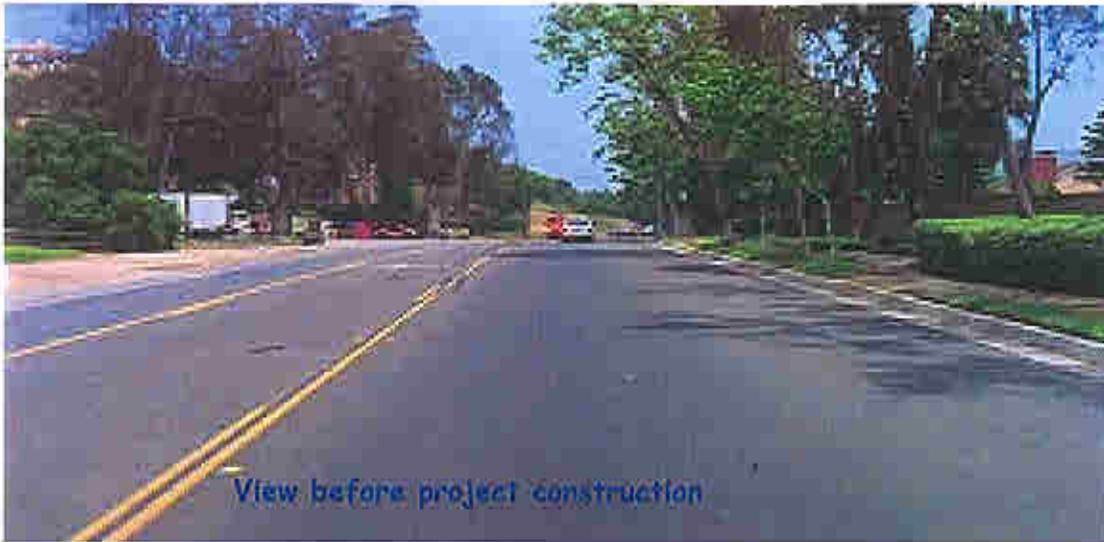
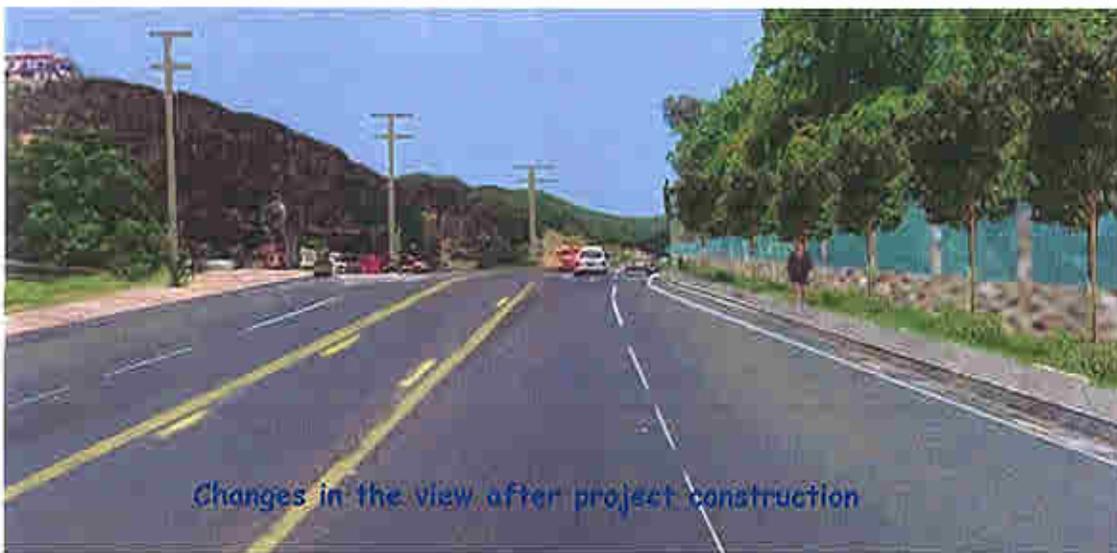
- As a result of the new construction, Tanaka Farms and the associated building are close to the highway and more visible to the highway user.
- Absence of existing trees.
- The tree removal makes the overhead utilities visible.
- There is a sound wall and sidewalk on the south side next to the residential land use.
- The construction of these features requires removal the existing landscape and sidewalk. The existing tall trees in the adjacent residential help to lessen the visual impact.

- There is the loss of existing trees along the north side of the highway. As a result there is no longer a screen of tree for the overhead utilities visual encroachment for the highway users and viewers.

- Along the south side of the highway a sound wall and sidewalk replaces the sidewalk, ornamental landscape and street trees. As a result of the project construction the adjacent residence will be closer to the roadway and have a view of 4-meter sound wall in their rear yard.

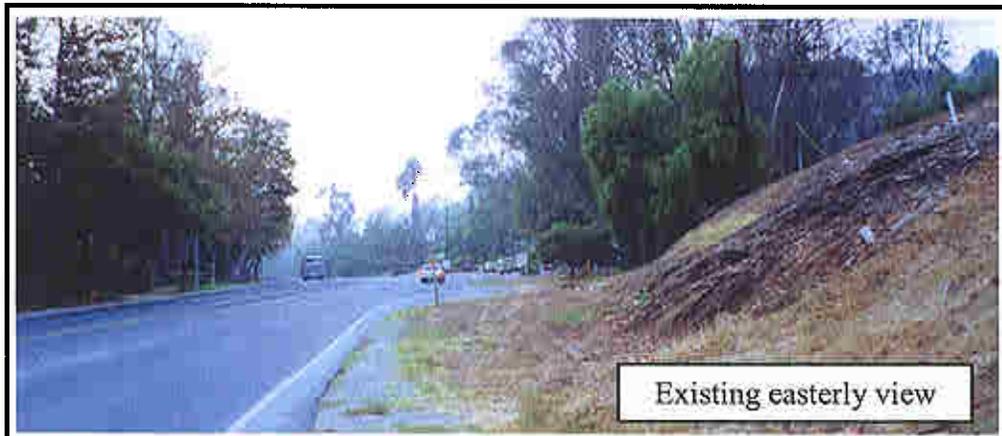
Visual Assessment #4

- **Assessment of the Visual Quality of the Pre-Project Conditions**

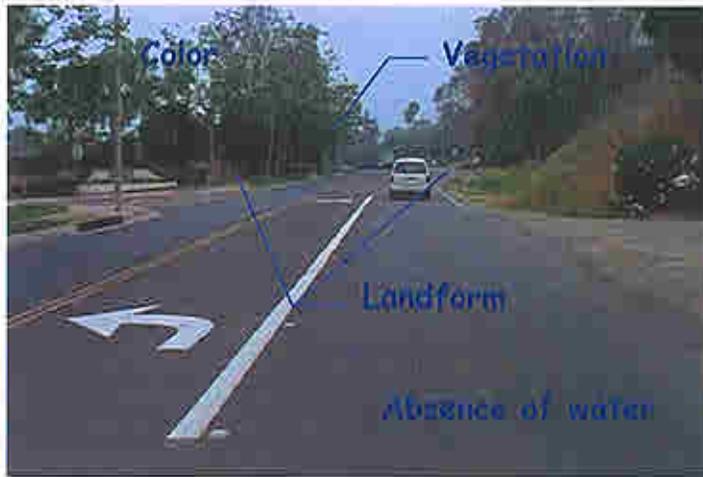
PHYSICAL QUALITY FACTORS

- The rating of landform is low quality, as the land features do not have any significant variation.
- The area is flat terrain with limited distant views.
- Vegetation and color are moderate physical in quality.
- There is a combination of ornamental landscape on the south side of the highway and large overgrown trees and shrubs on the north side.
- Water is of low physical quality as there is the absence of any water

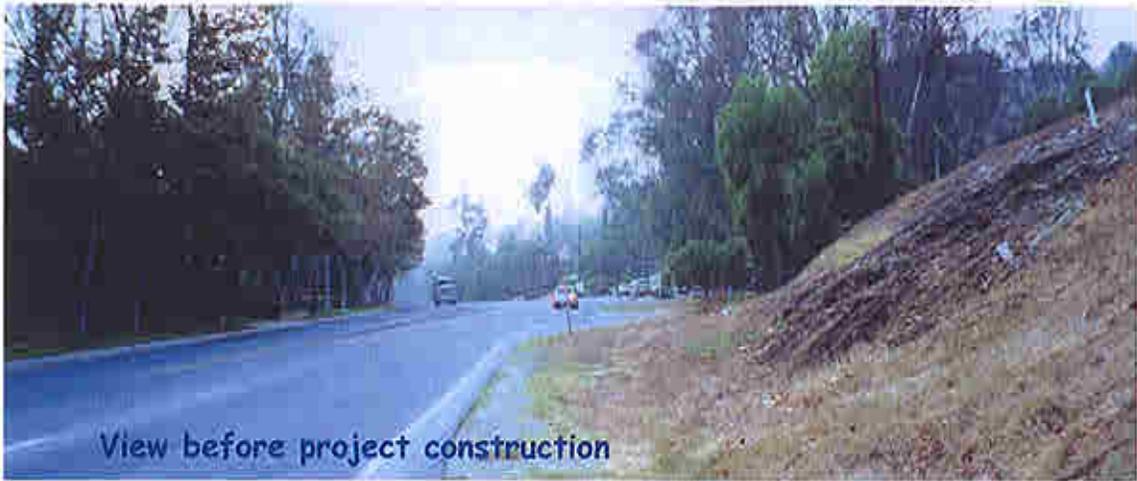
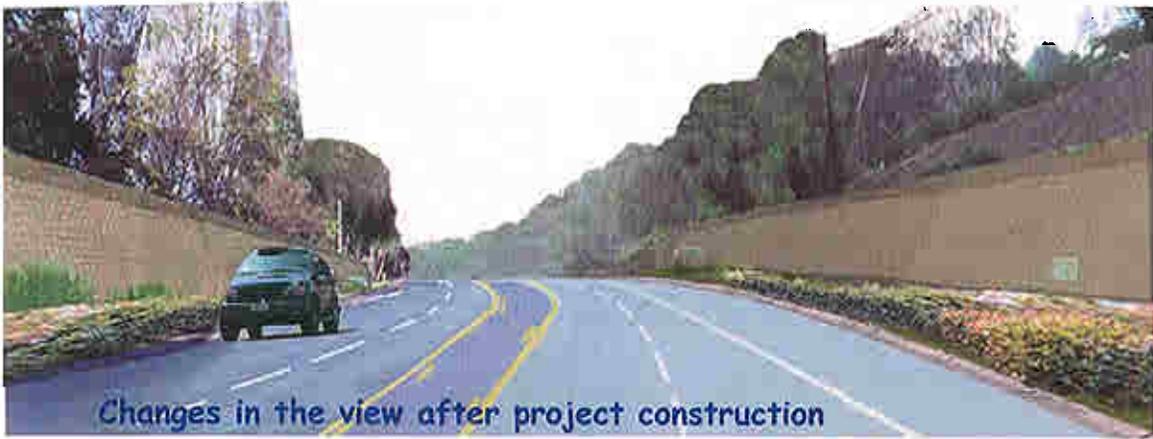
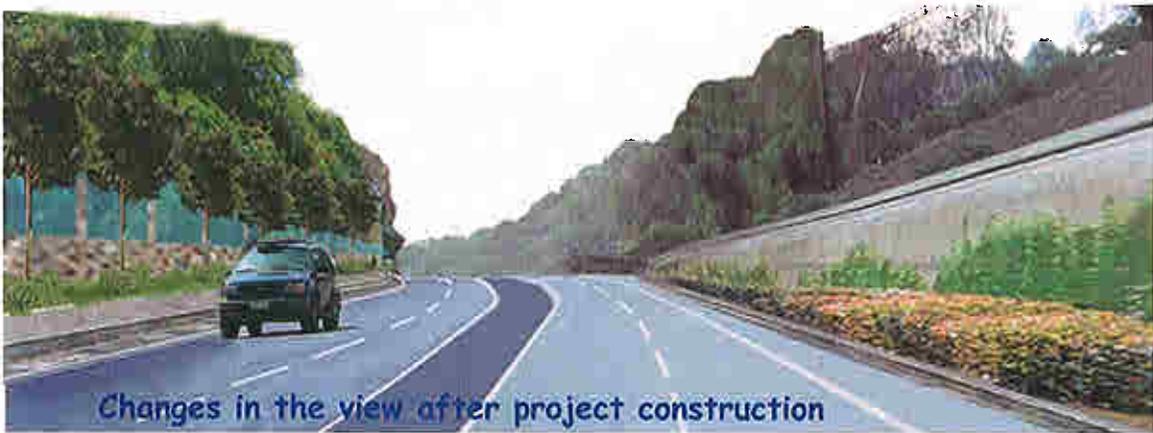
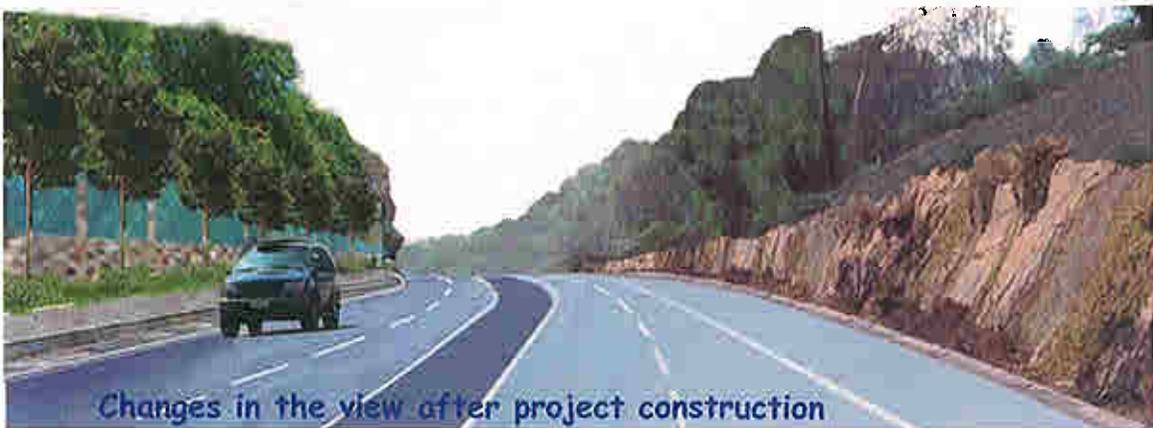
- Along this portion of highway, retaining walls are on the north side to accommodate the construction of the two additional lanes, median and shoulders.
- Along the south side of the highway, a sound wall begins at Via Errecarte and continues to the west to Via Cristal. This eliminates all the existing ornamental landscape.

The proposal is to build a 12 foot (3.7-meter) retaining wall at this location to accommodate the new widening project.

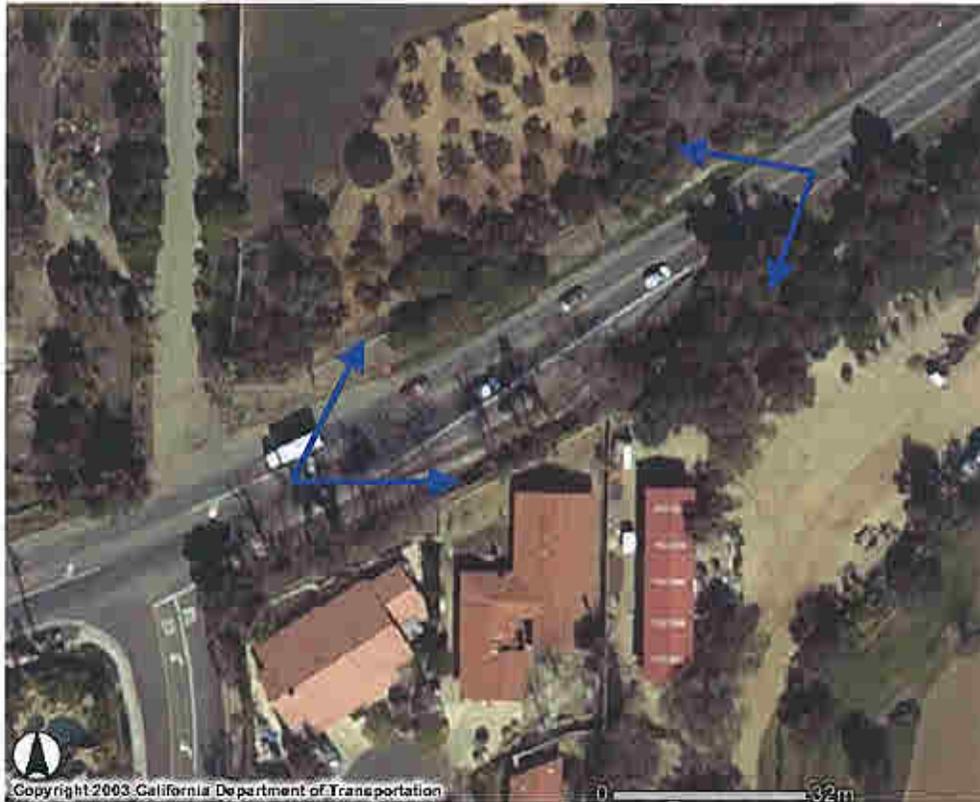
Visual Assessment #5

Existing westerly view along Route 74

- Distant views on Ortega Highway are first seen.
- The assessment analyzes the entire view of eastbound drivers on Ortega Highway. The current conditions include one-lane road in east and west direction, a median that narrows to a painted yellow strip, trees and vegetation.
- Utility poles line the north side of the highway that string across the landscape.

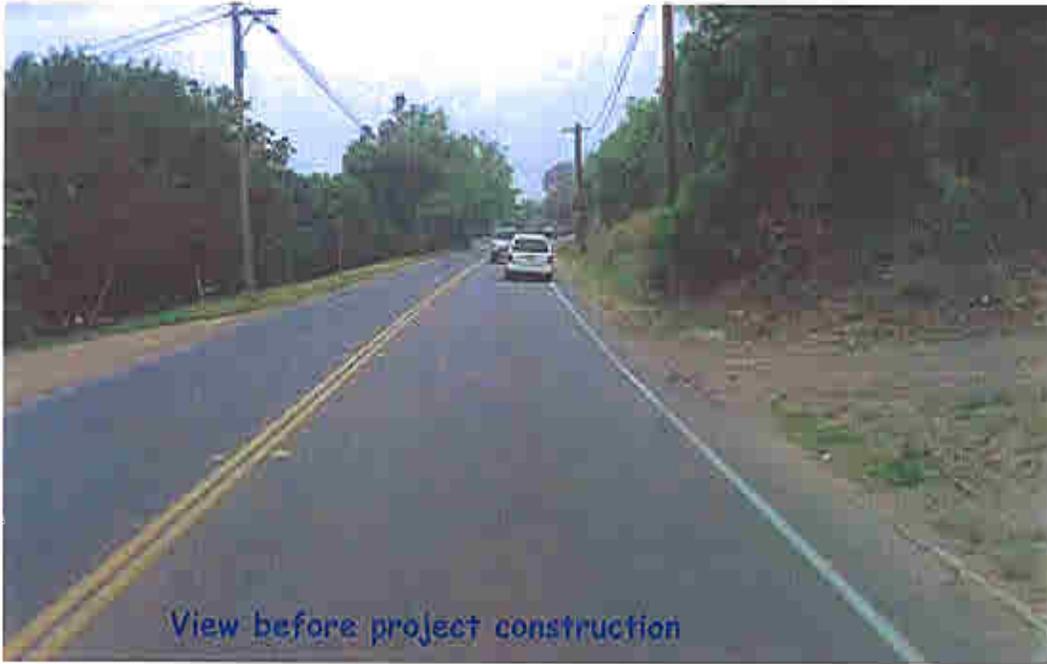
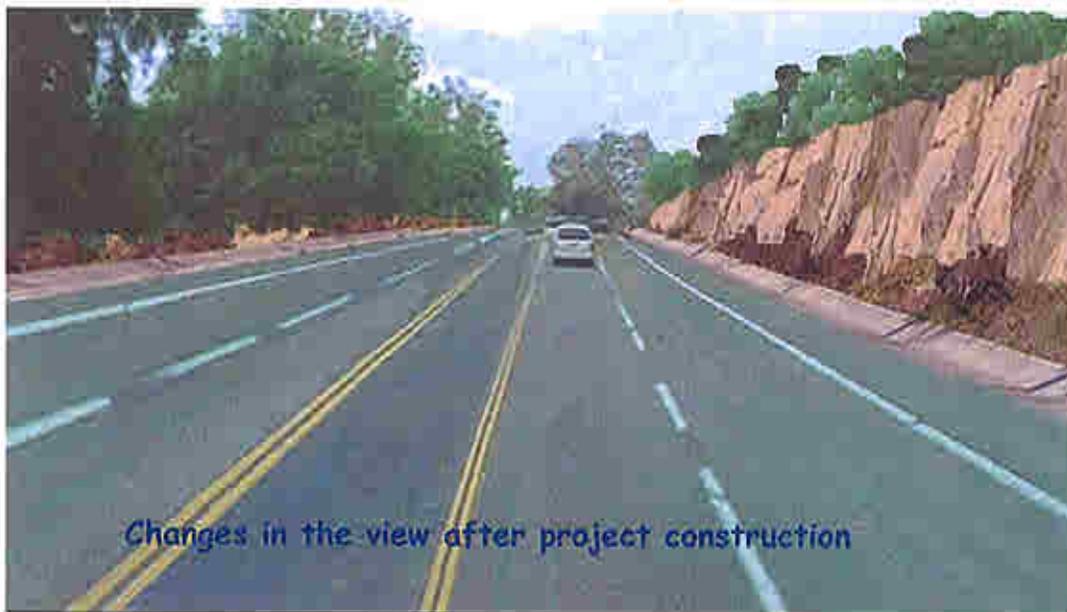
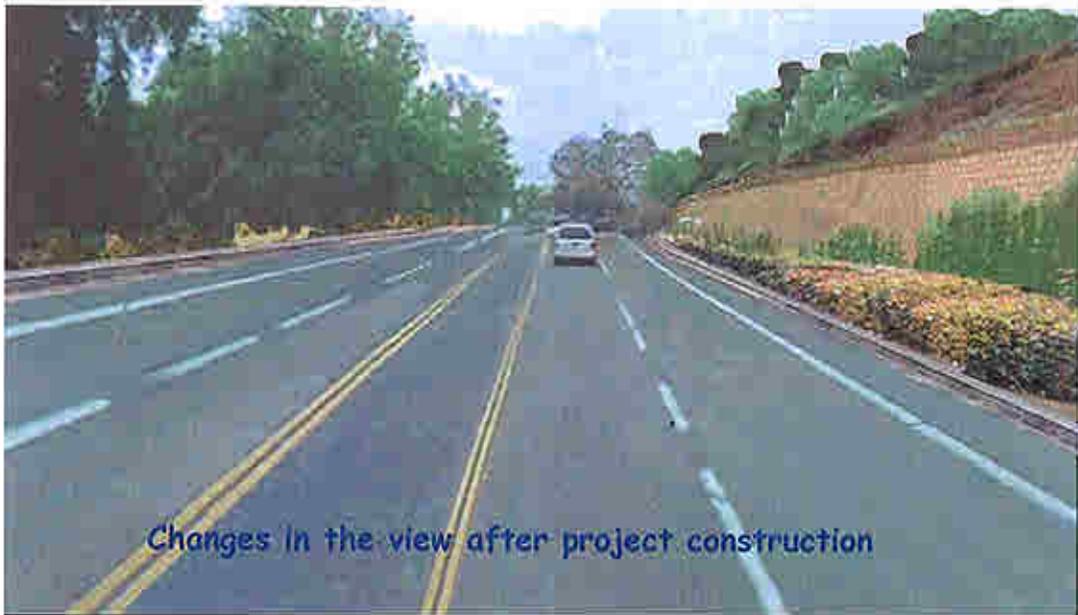
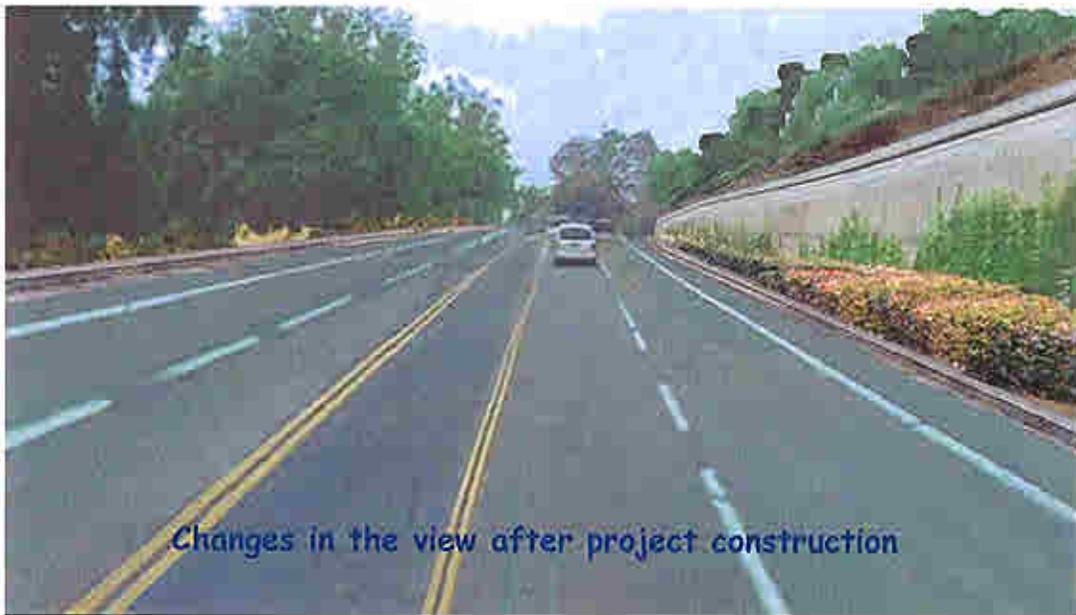
There is a major addition to the view a 12-foot (3.8-meter) retaining wall on the north side of Route 74 and the removal of the existing vegetation to accommodate the wall and widened highway. Possible aesthetic treatments for the retaining walls need further studied.

- The removal of the existing shrubs at the bottom of the slope was necessary to accommodate the retaining wall.
- There is to be a relocation of power lines. There are trees visible up slope.
- The visual analysis shows that the addition of the 3.8-meter retaining wall negatively impacts the visual quality at this location.
- Both the perceptual quality factors and sensitivity to change factors are of moderate/low quality from the addition of the retaining wall and the removal of existing vegetation.
